GROUP	P NUMBER	
RECALL	24-01-039H	
DATE	MODEL(S)	
MAY 2024	PALISADE (LX2)

LAMBDA 3.8L ENGINE SUB-ASSEMBLY REPLACEMENT (RECALL 255)

**Description:** Certain 2024MY Palisade (LX2) vehicles contain engine valve springs that may fracture while driving due to fatigue cracking as a result of damage to the springs during manufacturing by the supplier. A fractured valve spring may result in a sudden loss of motive power. In rare cases, a hole in the engine block may occur due to a broken valve entering the combustion chamber.

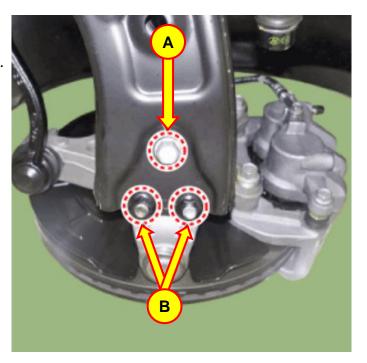
2. During the removal of the front subframe from the vehicle, loosen and unbolt the LH and RH lower control arm ball joint assemblies (A & B).

The lower control arm ball joints do **not** need to be removed from the steering knuckle as shown in the Shop Manual.

lb-ft	86.8
N.m	117.7

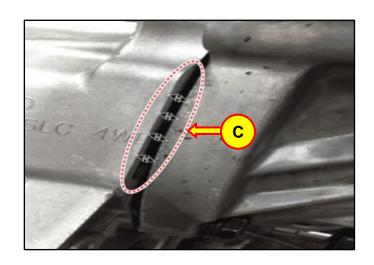
- Do not torque the fasteners that join the engine block to the automatic transmission if a gap exists (C) and proper seating cannot be achieved by hand.
- Check the depth of the torque converter to confirm it's fully installed in the transmission otherwise the oil pump may be damaged resulting in transmission failure.
