Safety Recall Code: 20UF

Suction Jet Pump

The suction jet pump inside the fuel tank is designed to purge fuel from the Evaporative Emissions (EVAP) system. If a specific seal inside an affected suction jet pump fails, the fuel may flow directly into the EVAP system. If this happens, fuel could accumulate in the EVAP system and may leak through the charcoal canister filter element. Leaking fuel, in the presence of an ignition source, may result in a fire.

Replace the suction jet pump.

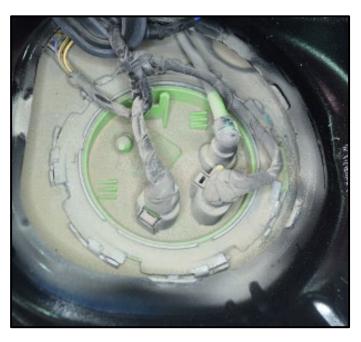
Prior to disassembly, the fuel delivery unit MUST be clean. If excessive dirt or debris is present <as shown>, clean and dry the fuel delivery unit and surrounding areas as necessary.

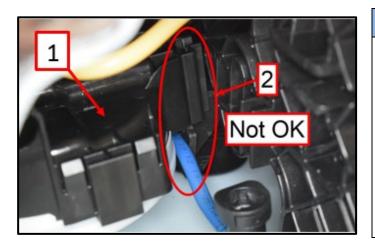
- If the Liquid-Vapor Separator <1> comes loose and is not reinstalled onto the mounting bracket, a customer comeback for rattling in the fuel tank, or EVAP system faults may occur.
- The Liquid-Vapor Separator <1> can be reinstalled onto its mounting bracket <2>.
- Replacement of the fuel tank for the Liquid-Vapor Separator dislodging from the mounting bracket is not covered under this campaign.
- If the Liquid-Vapor Separator Assembly <1> comes off the mounting bracket during suction pump removal:
 - Snap the Liquid-Vapor Separator <1> back into place by realigning it with the mounting bracket.
 - Push down on the Liquid-Vapor Seperator to reengage the clip <2>.

When correctly installed, the Liquid-Vapor Separator clip will be secured into its mounting bracket as shown.
