Safety Recall

Code: 20UF

Subject Suction Jet Pump

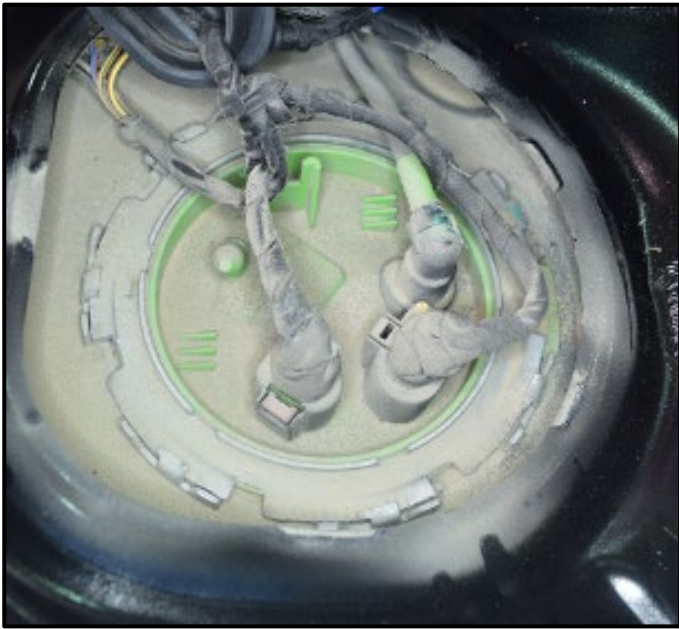
- Prior to disassembly, the fuel delivery unit **MUST** be clean. If excessive dirt or debris is present <as shown>, clean and dry the fuel delivery unit and surrounding areas as necessary.

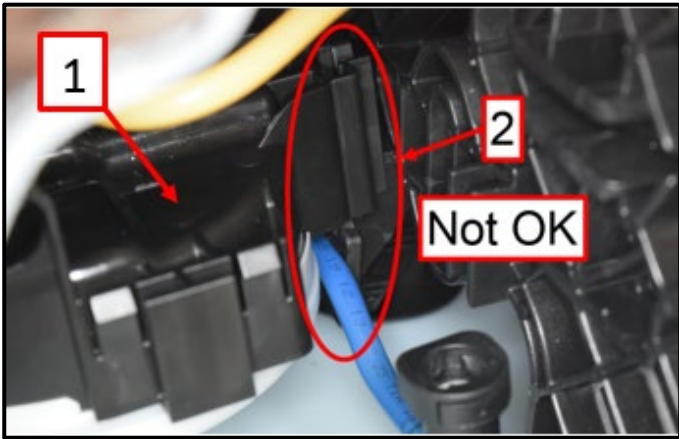
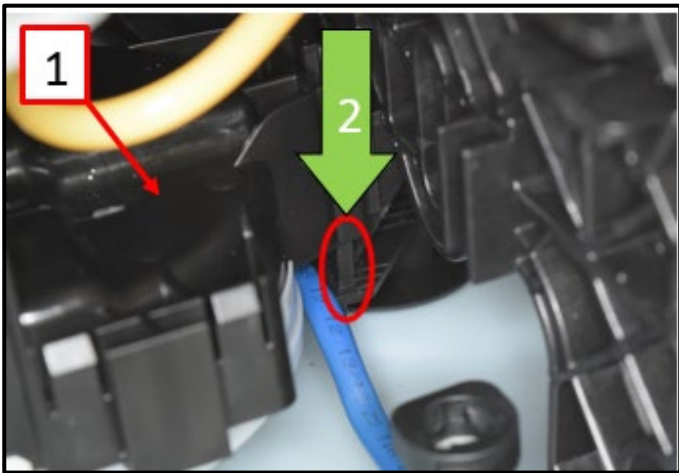
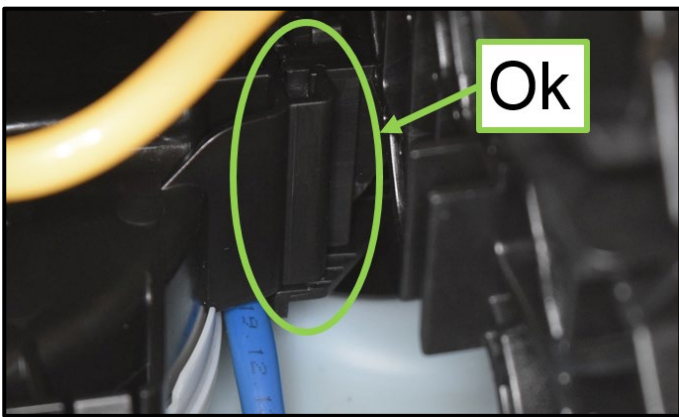
- If the Liquid-Vapor Separator <1> comes loose and is not reinstalled onto the mounting bracket, a customer comeback for rattling in the fuel tank, or EVAP system faults may occur.
- The Liquid-Vapor Separator <1> can be reinstalled onto its mounting bracket <2>.
- Replacement of the fuel tank for the Liquid-Vapor Separator dislodging from the mounting bracket is not covered under this campaign.

- If the Liquid-Vapor Separator Assembly <1> comes off the mounting bracket during suction pump removal:
 - Snap the Liquid-Vapor Separator <1> back into place by realigning it with the mounting bracket.
 - Push down on the Liquid-Vapor Separator to reengage the clip <2>.

- When correctly installed, the Liquid-Vapor Separator clip will be secured into its mounting bracket as shown.
