Recall Campaign Bulletin

Campaign No. 2024030009, March 2024

SUBJECT: **Model GLE (167 platform)**
Model Year 2024

Rework Accelerator Pedal Module Bracket

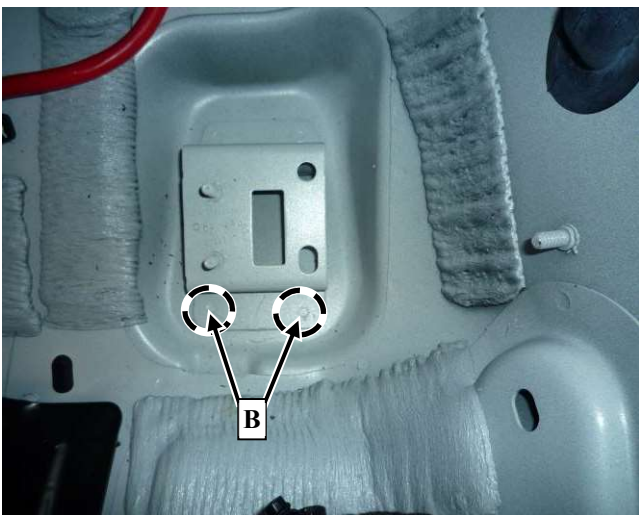
Figure 3

Mercedes-Benz AG, the manufacturer of Mercedes-Benz vehicles, has determined that on certain MY 2024 GLE (167 platform) vehicles, the spot welds on the accelerator pedal module bracket might not meet current production specifications. During driving, the bracket might deform over time if the spot welds were to fracture. A complete detachment of the accelerator pedal module bracket from the body cannot be ruled out completely. In that event, the position of the accelerator pedal might shift, and thus potentially remain in the applied position, which would prevent kickdown or impair the application of the brake pedal. In this case, an increased risk of a crash or injury cannot be ruled out. An authorized Mercedes-Benz dealer will drill through the respective spot welds on the affected vehicles and secure the bracket with rivets.

3. Drill the two lower resistance spot welds (**Figure 3, B**) on accelerator pedal module bracket using a **6.7 mm drill bit**.

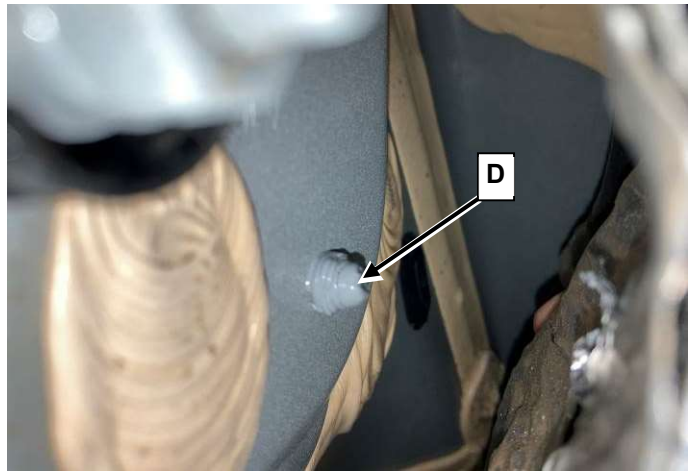
Figure 8 (rivet D, view from below)

- Completed rivet should be visible from below after seam seal is applied (**Figure 8, D**)

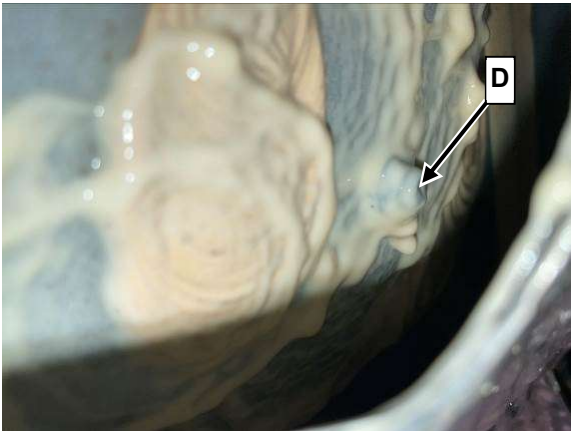
Figure 9 (rivet D, view from below with cavity preservation)

4. Clean the riveted area and apply **cavity preservation (A 000 986 32 01 09)** to both locations shown in **Figures 9 and 10**.

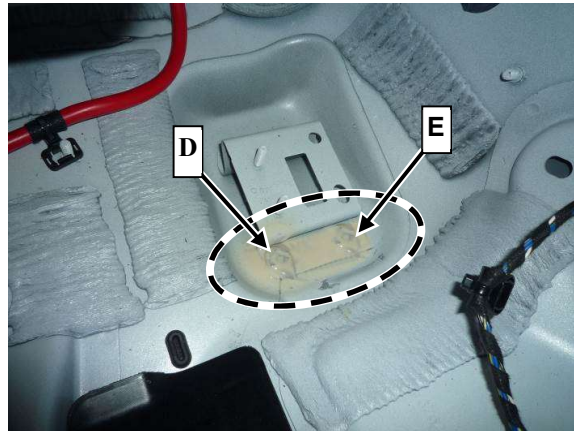
Figure 10 (rivets D & E, view from above with cavity preservation)
