**◀ IMPORTANT UPDATE ▶**

DATE	TOPIC
2/26/2024	Updated flow chart
2/28/2024	Added additional step in Vehicle Preparation section

**TECHNICAL INSTRUCTIONS**  
**FOR**  
**24LA02**  
**Vehicle May Move While Neutral In Motion**  
**2022 - 2024 LX600 VEHICLES**

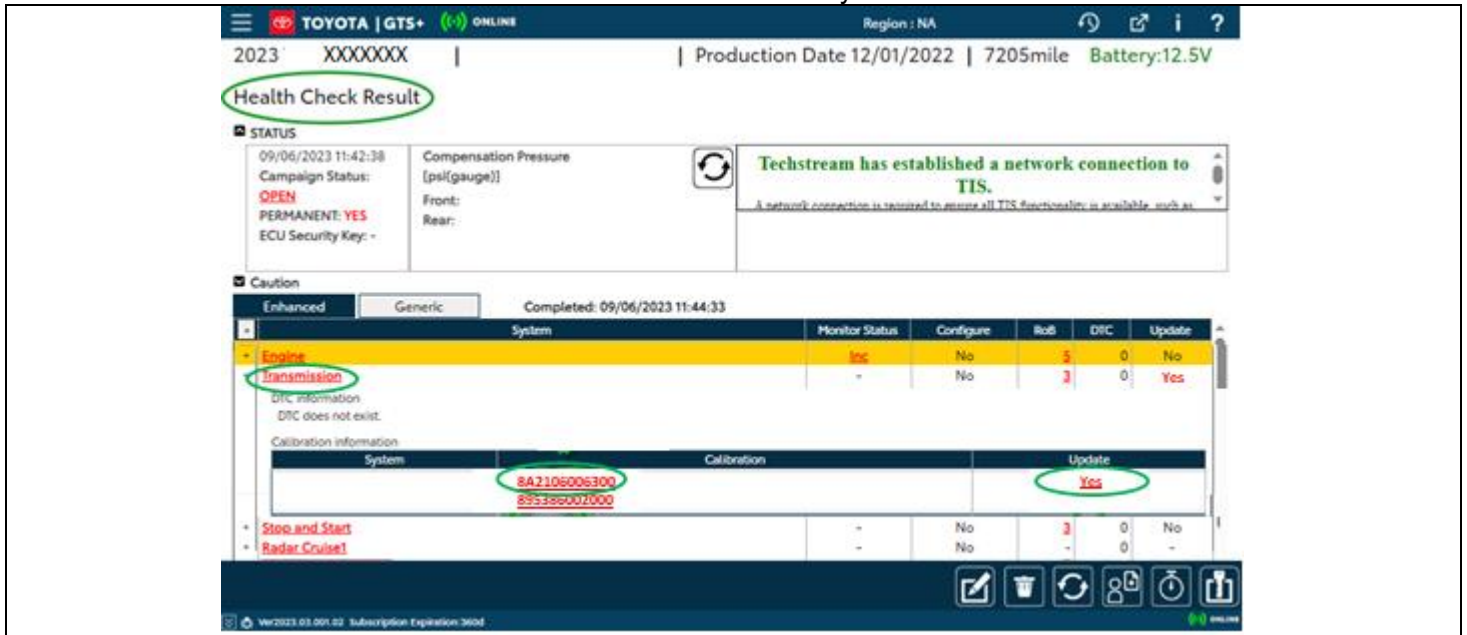
Confirm the current calibration ID in the Transmission System.

The calibration IDs to re-flash in this campaign are as shown in the table below.

Transmission Control Computer Calibrations		
System	Current Calibration ID	<b>New</b> Calibration ID
Transmission	<b>8A2106011200</b>	<b>8A2106011300</b>
	895386002000	895386002000
	<b>8A2106030000</b>	<b>8A2106030100</b>
	895386002000	895386002000
	<b>8A2106032000</b>	<b>8A2106032100</b>
	895386002000	895386002000

If the TRANSMISSION CONTROL COMPUTER has the **New CID's**, no update is necessary.

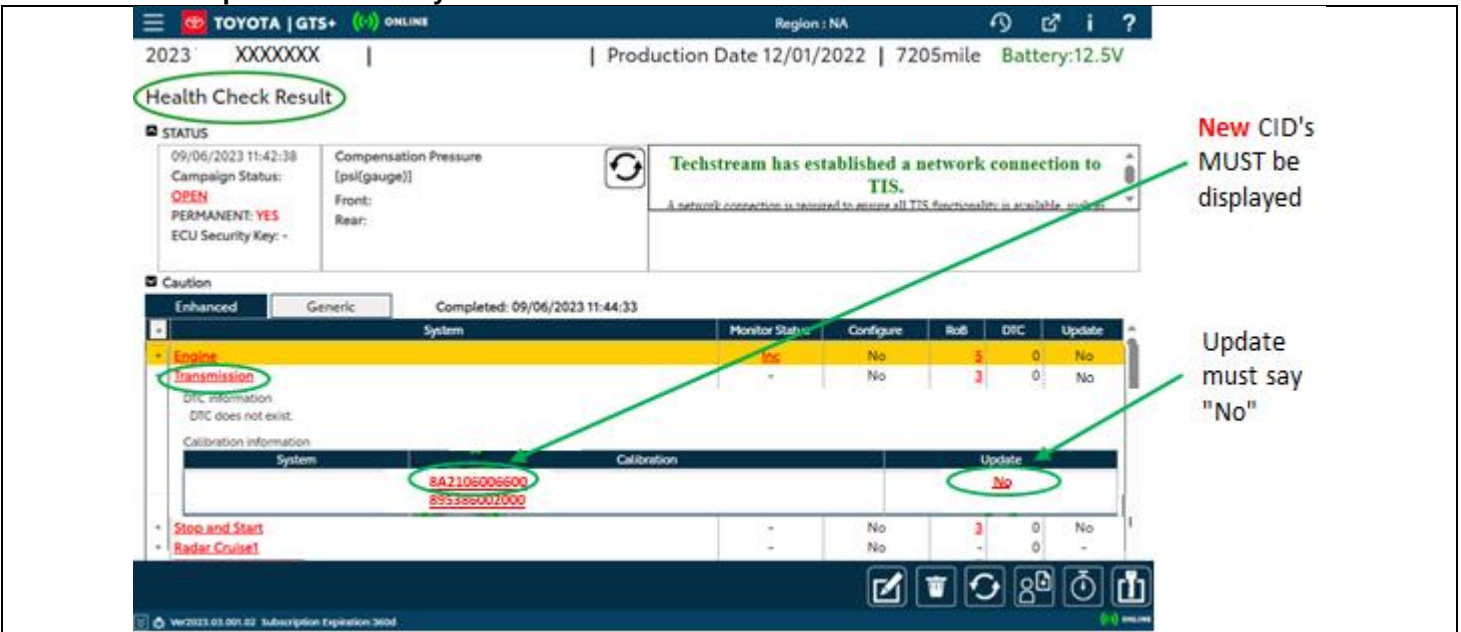
- a) On the Stored Data tab, confirm the following for the Transmission System:
  - The Calibration number has the “New CID” number.
  - The Update column says “No”.

**Critical** Confirm the CID's has been updated successfully to the **NEW** CID's by someone other than the individual who performed the repair. Refer to page 5.
