TECHNICAL INSTRUCTIONS

24TA02

Vehicle May Move While In Neutral Position

**2022 - 2024 TUNDRA / TUNDRA HV
2023 AND 2024 SEQUOIA HV**

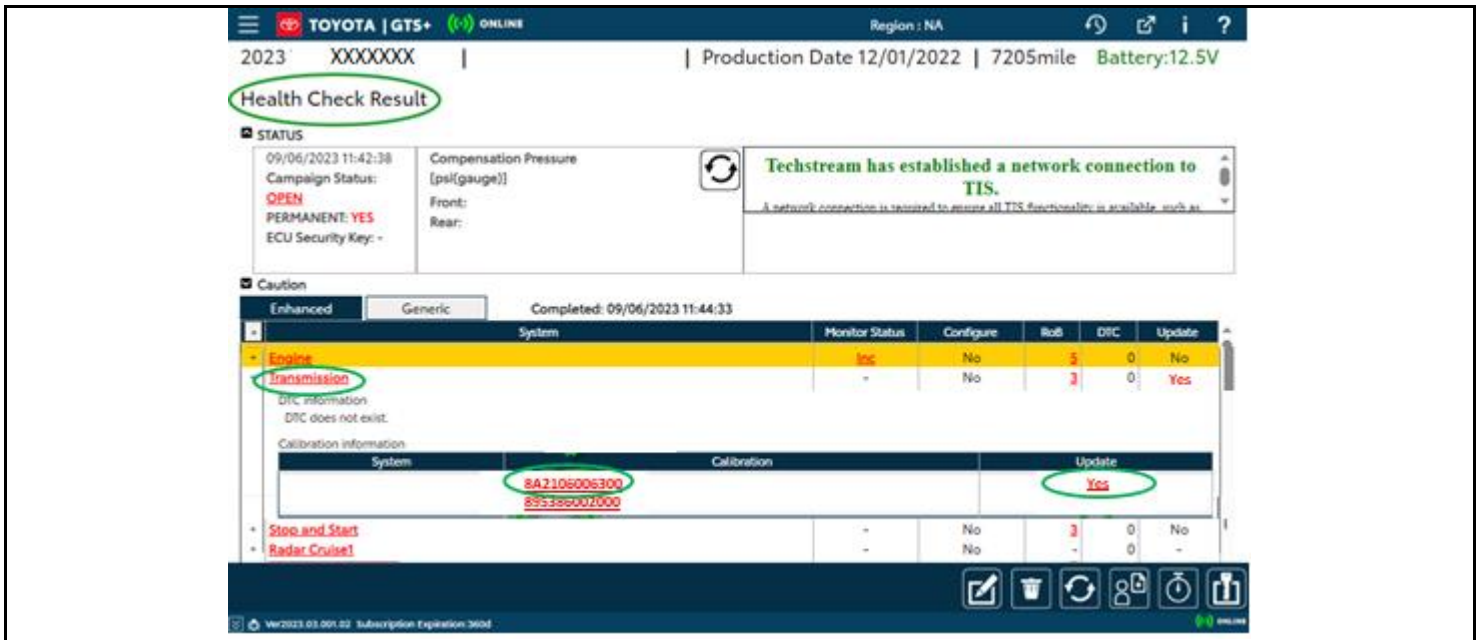
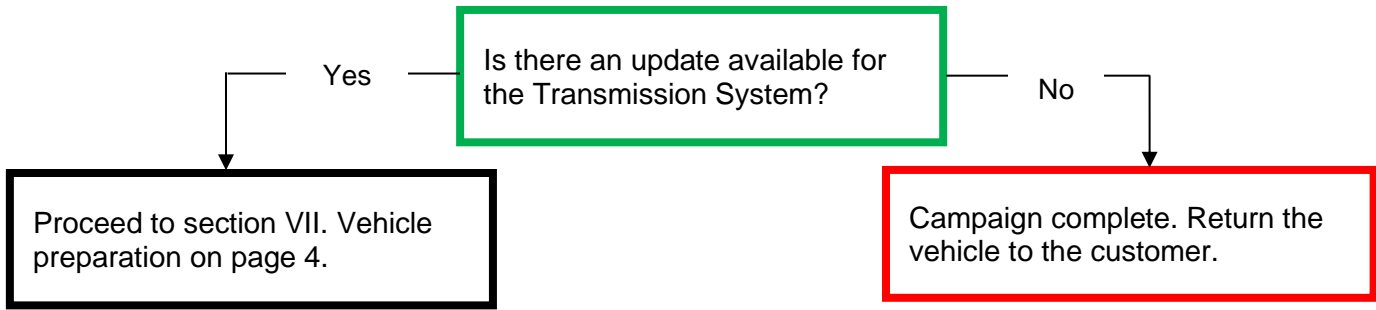
If the CID's indicate 'Yes', proceed with the update procedure.

- a) Locate the "Update" column of the "Calibration Information" for the Transmission system on the "Health Check Result" screen.
- b) Determine the status of an available update; indicated by a YES or NO.

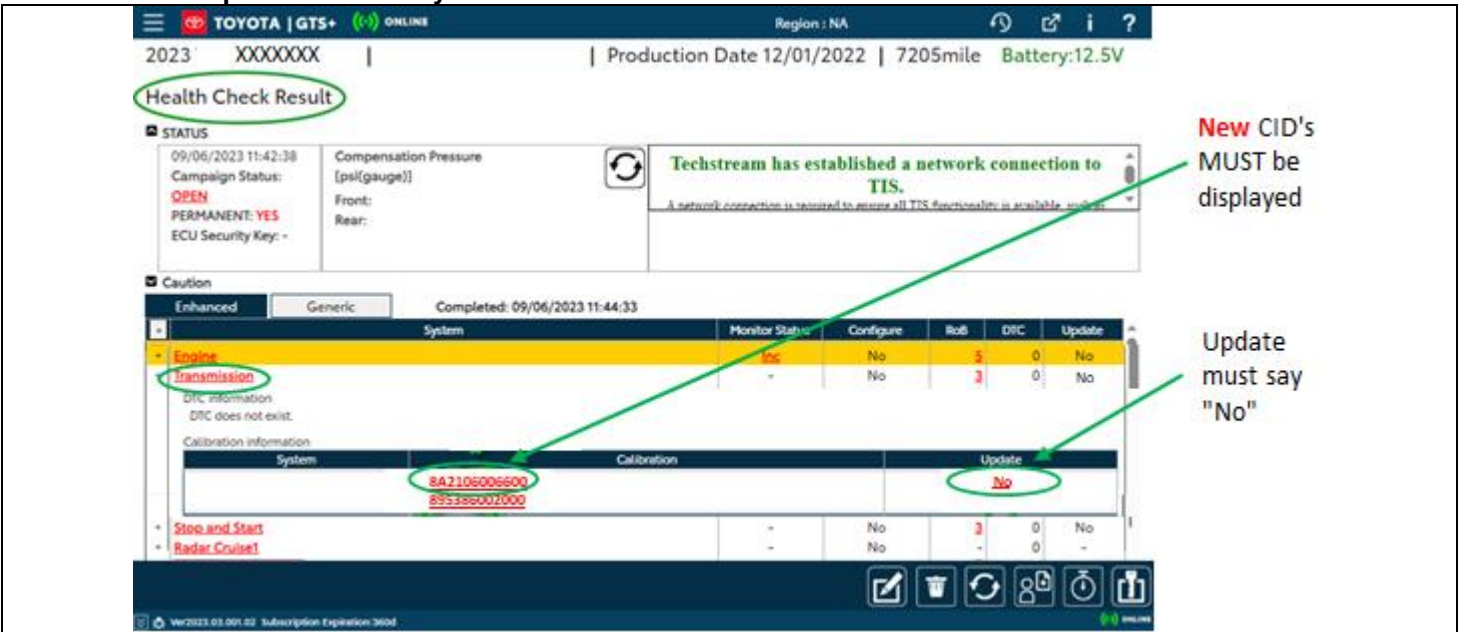
New CID's MUST be displayed

Update must say "No"

- a) On the Stored Data tab, confirm the following for the Transmission System:
 - The Calibration number has the "New CID" number.
 - The Update column says "No".
