SIB 51 07 24

RECALL 24V-139: TAILGATE OUTER BODY PANEL

E-Series	Model Description	Production Date
G09	BMW XM Sports Activity Vehicle (SAV)	September 21 – November 2, 2023

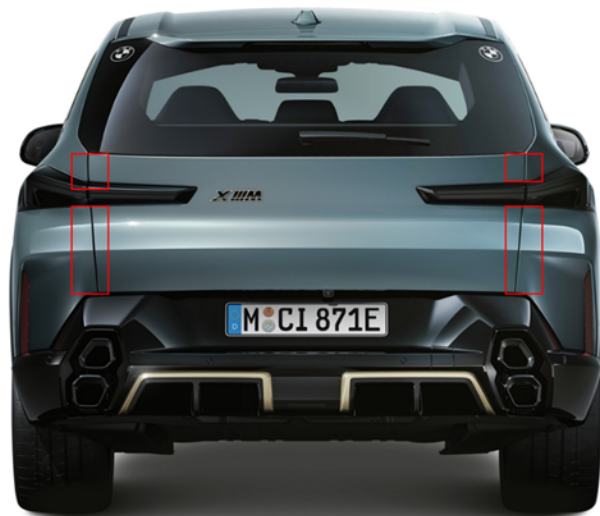
The outer body panel of the tailgate can partially detach from the inner panel in one or more areas of the tailgate due to poor bonding of the adhesive.

If the outer body panel separates from the inner panel, a rattling sound can be heard while driving.

Poor bonding of the adhesive on the tailgate body panel (painted outer panel to the inner panel/metal frame).

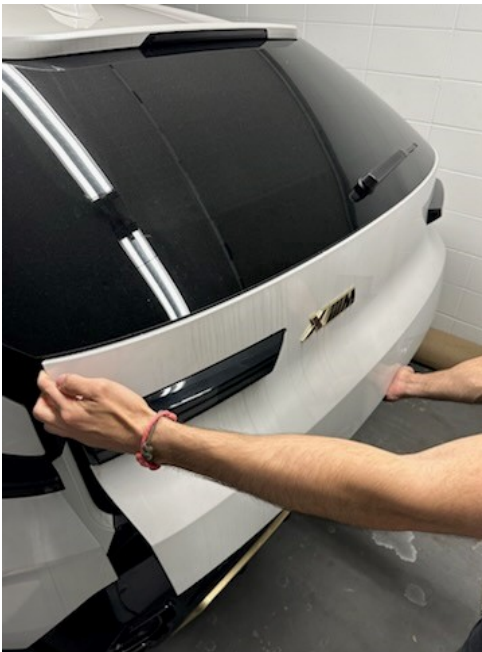
With the tailgate open:

Left hand located above the taillamp; pull the outer panel with light to moderate force.

Right hand holds the tailgate in place.

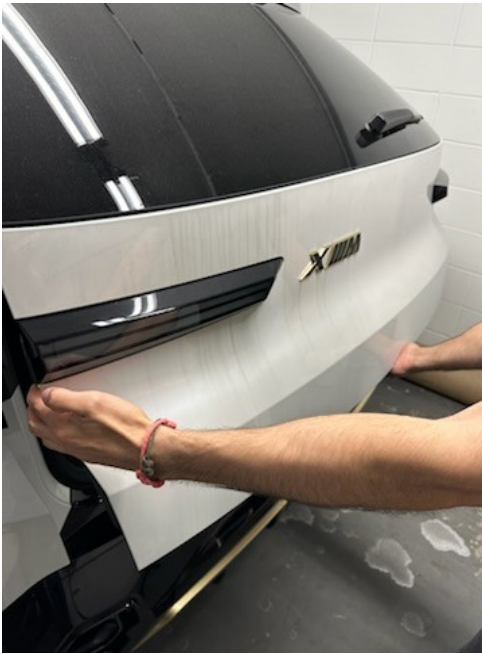
Left hand located below the taillamp.

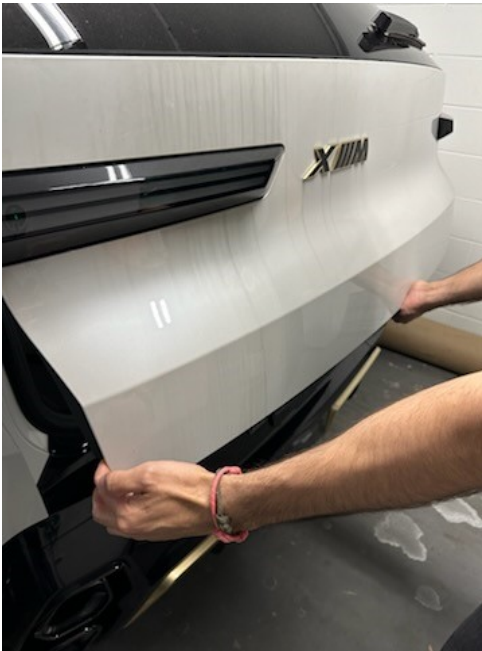
Left hand located at lower left corner of the tailgate.

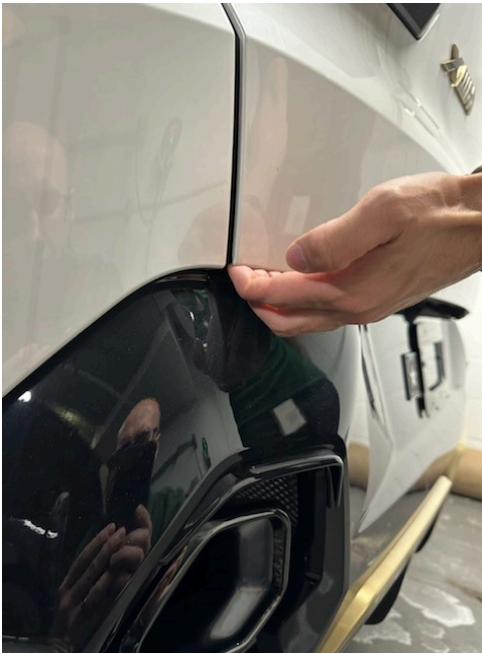
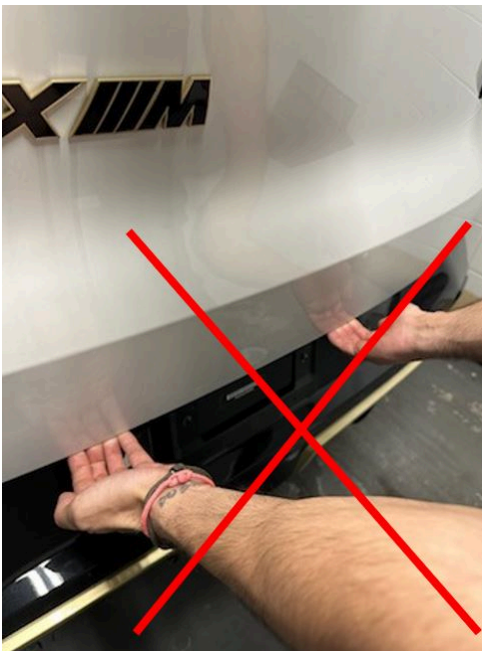
**With the tailgate closed:**

Using one hand, pull the outer panel using light to moderate force.

Note: This is done on both sides of the tailgate (left and right).

DO NOT pull on the tailgate panel using both hands while it is in the closed position.
