SIB 51 07 24

2024-03-05

## RECALL 24V-139: TAILGATE OUTER BODY PANEL

E-Series	Model Description	Production Date
G09	BMW XM Sports Activity Vehicle (SAV)	September 21 – November 2, 2023

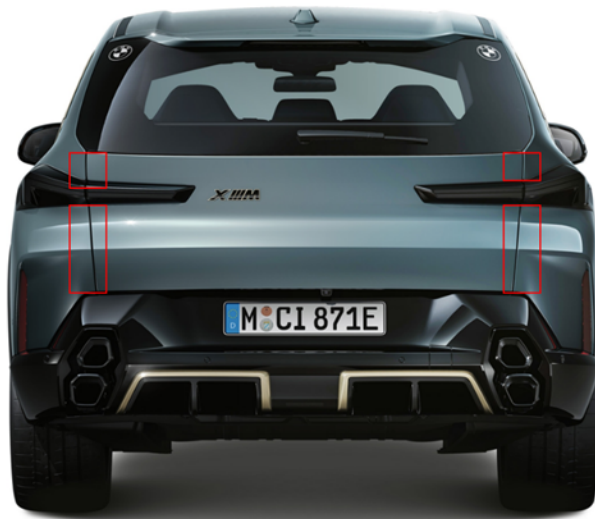
The outer body panel of the tailgate can partially detach from the inner panel in one or more areas of the tailgate due to poor bonding of the adhesive.

If the outer body panel separates from the inner panel, a rattling sound can be heard while driving.

The outer body panel completely detaching from the inner panel cannot be ruled out.

Poor bonding of the adhesive on the tailgate body panel (painted outer panel to the inner panel/metal frame).

Inspect the outer tailgate panel for proper adhesion. Replace if necessary.

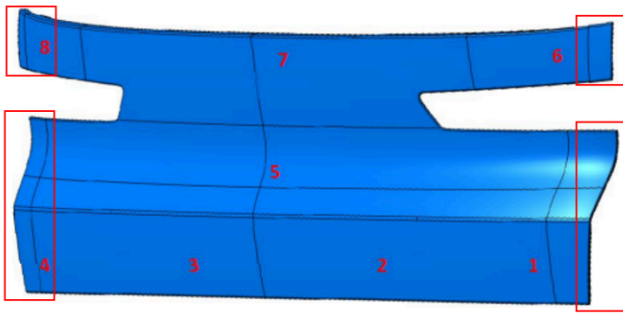
1. Inspect the four areas of outer panel on the tailgate for protruding edges.
2. Open the tailgate and inspect the adhesive around the entire outer panel of the tailgate.
3. If separation of the outer to inner panel is seen, the outer panel will need to be replaced following the repair instruction listed in ISTA/AIR 51 13 421.

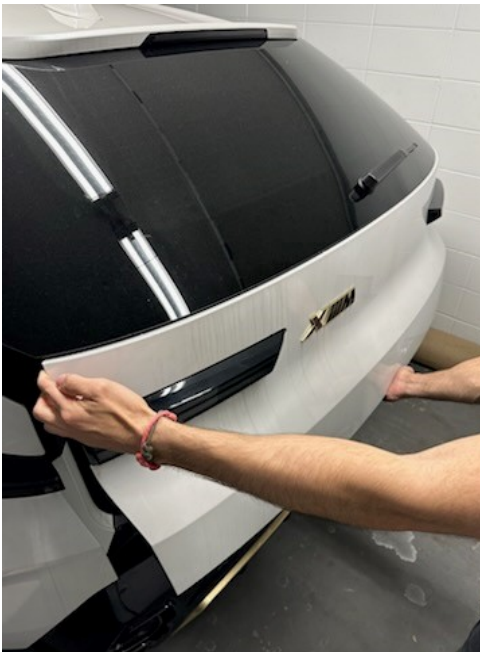
Left hand located above the taillamp; pull the outer panel with light to moderate force.

Right hand holds the tailgate in place.

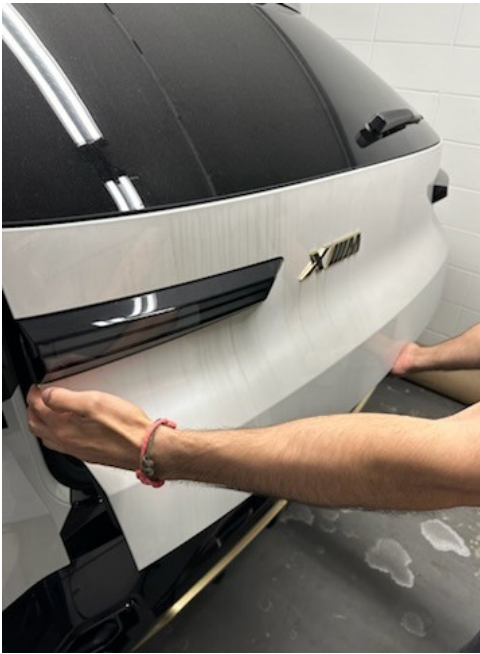
Left hand located below the taillamp.

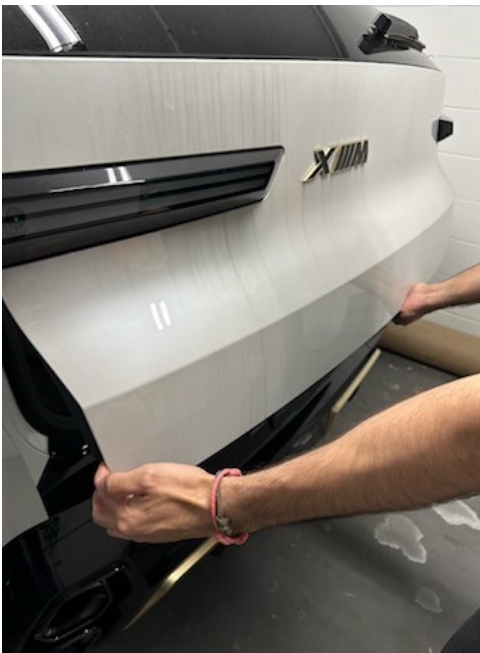
Left hand located at lower left corner of the tailgate.

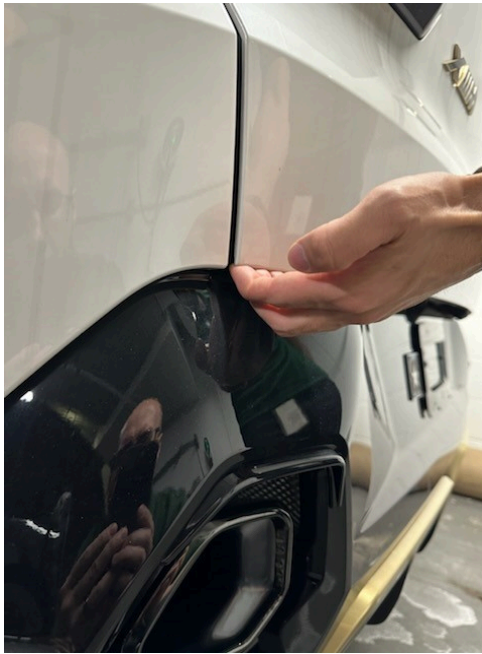
Using one hand, pull the outer panel using light to moderate force.

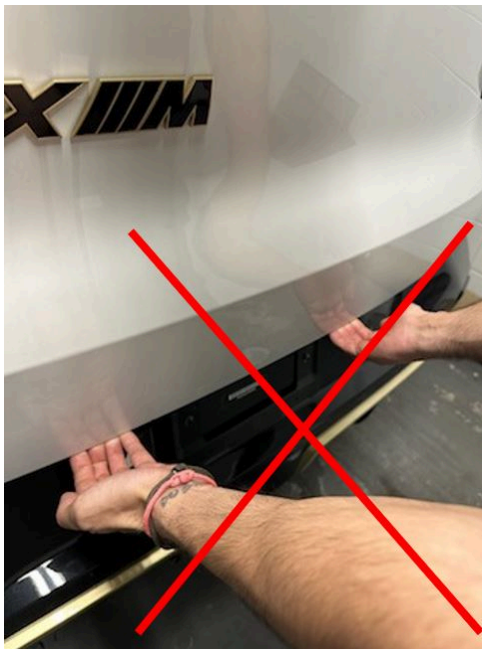
**DO NOT** pull on the tailgate panel using both hands while it is in the closed position.

5. If the outer panel of the tailgate cannot be separated, no repair is needed; the vehicle can be returned to the customer.
