**HYUNDAI**
Technical Service Bulletin

GROUP RECALL	NUMBER 24-01-025H
DATE MARCH 2024	MODEL(S) ELANTRA (MD) ELANTRA (UD)

SUBJECT: TRUNK LATCH BASE REPLACEMENT (RECALL 256)

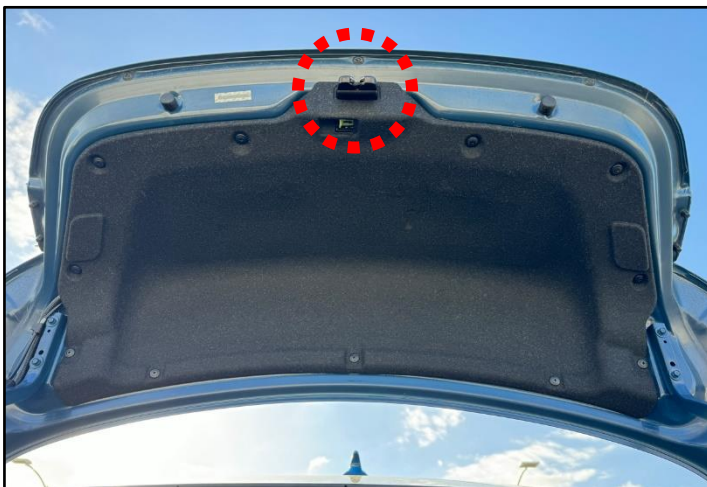
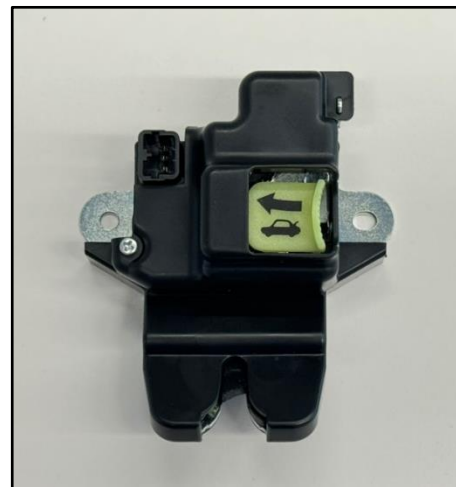
Description: On certain Elantra (MD) and Elantra (UD) vehicles, the trunk latch pawl can thermally contract when exposed to high ambient temperatures. An attempt to release the pawl and open the trunk lid in this condition could result in damage to the pawl, preventing opening of the trunk lid through actuation of the emergency trunk release and presenting risk of injury to an occupant locked in the trunk. This bulletin describes the procedure to replace the trunk latch base with revised parts.

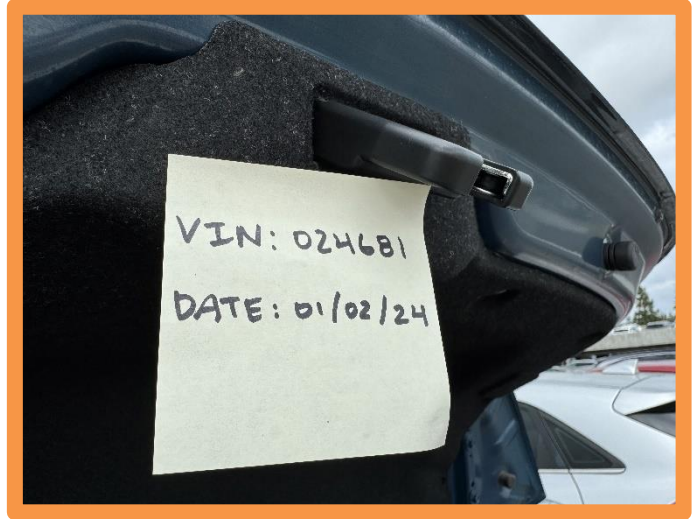
GOOD: Black plastic inside the latch exposed.

Using STUI, take a photo of the black part inside the trunk lid latch containing the new base with the last 6 digits of the VIN and the date of repair on a piece of paper. Upload the photo to STUI.

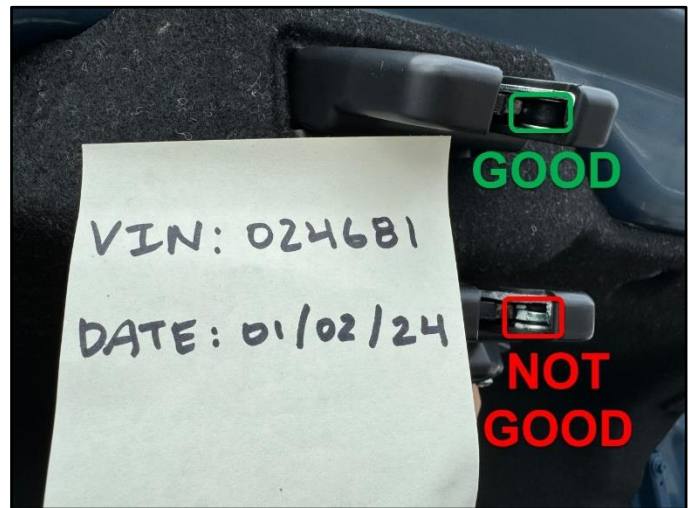
NOT GOOD: Metal inside the latch exposed.
