Safety Recall Campaign

SC299

2020MY
Telluride (ON)
w/Halogen Headlamps

HALOGEN HEADLAMP (HIGH BEAM) ASSEMBLY
INSPECTION & REPAIR/REPLACEMENT (SC299)

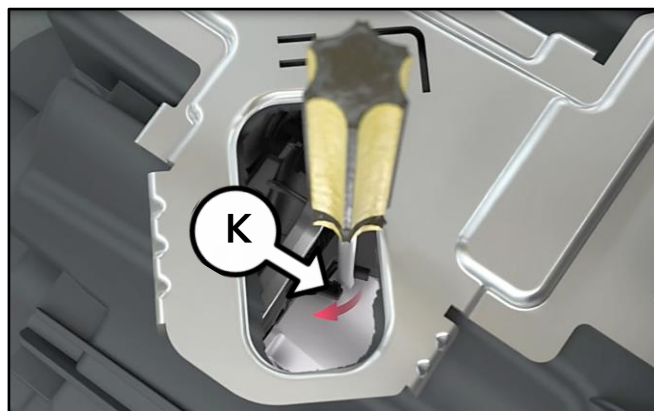
15. Confirm the gear tab (K) position (IN/OUT).

- If the gear tab (K) is **(OUT)** visible/exposed outward, use a flat head screw driver to gently slide it back inward as shown.
- If the gear tab (K) is **(IN)** not visible/exposed outward, no action is needed.
