Safety Recall Campaign

SC299 (Rev 1, 09/30/2024)

2020MY
Telluride (ON)
w/Halogen Headlamp

HALOGEN HEADLAMP (HIGH BEAM) ASSEMBLY
INSPECTION & REPAIR/REPLACEMENT (SC299)

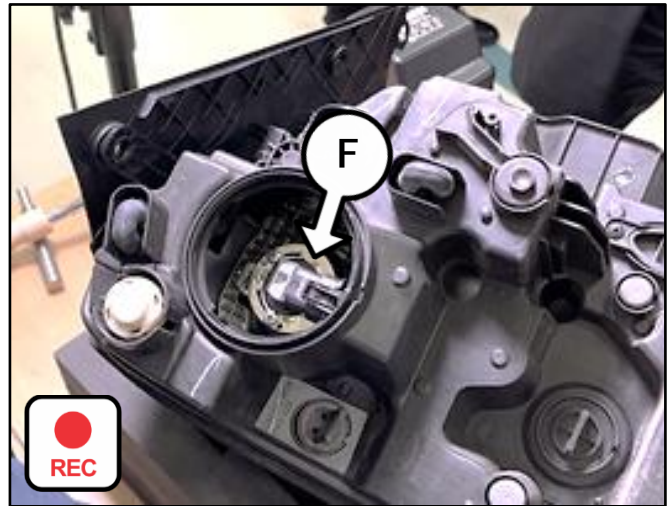
5. Confirm that the projection unit (F) has not become detached/loose from the head lamp assembly (D).

- If the projection unit (F) is detached/loose **(NG)** from the headlamp assembly (D), attach a KVID video showing the VIN label and the condition, and then replace the headlamp assembly in the reverse order of removal, and skip to step 38.
- If the projection unit (F) has **NOT** detached/or is loose **(OK)** from the headlamp assembly (D), proceed to step 6.

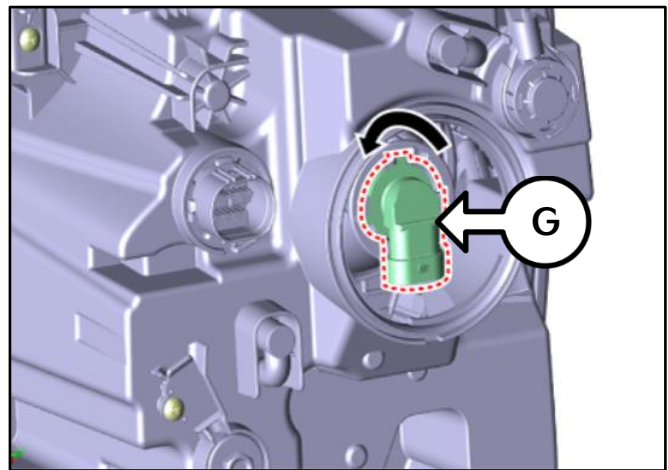
- 6a. Remove the low/high beam halogen bulb (G) by turning it counterclockwise.

- 6b. Inspect the low/high beam halogen bulb (G).

- **If the halogen bulb is NOT burnt**, save the bulb in a safe area to be reused.
- **If the halogen bulb IS burnt**, discard it. A new bulb is required to be installed during reassembly.

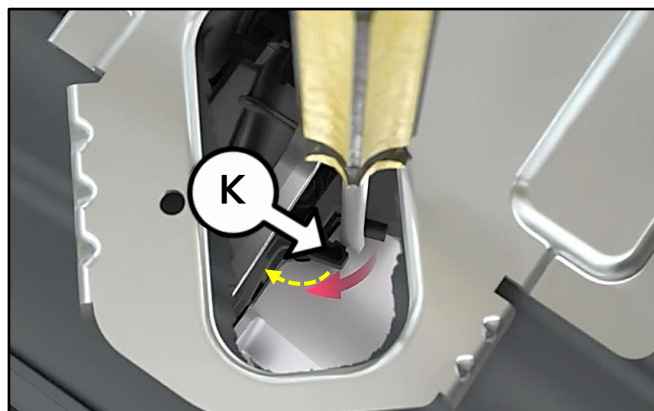
15. Confirm the gear tab (K) position (IN/OUT).

- If the gear tab (K) is **(OUT)** visible/exposed outward, use a flat head screw driver to gently slide it back inward as shown.
- If the gear tab (K) is **(IN)** not visible/exposed outward, no action is needed.

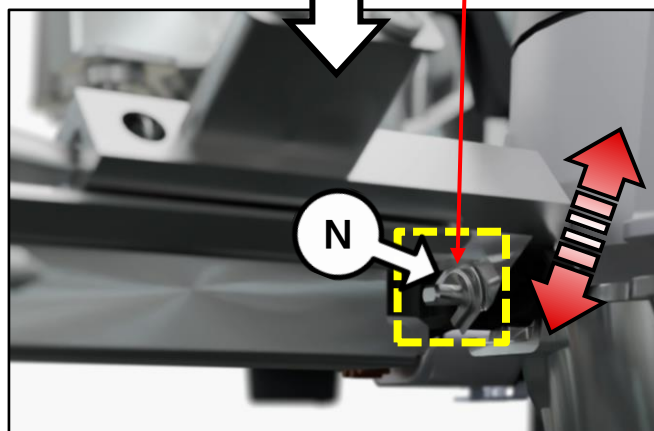
23. Firmly close (tighten) the clip insertion tool (M) to secure the gear retaining clip (N) onto the gear mechanism shaft.

Note: Verify that a “snap/click” sound is heard when the retaining clip (N) attaches to the gear shaft to confirm it is properly secured.

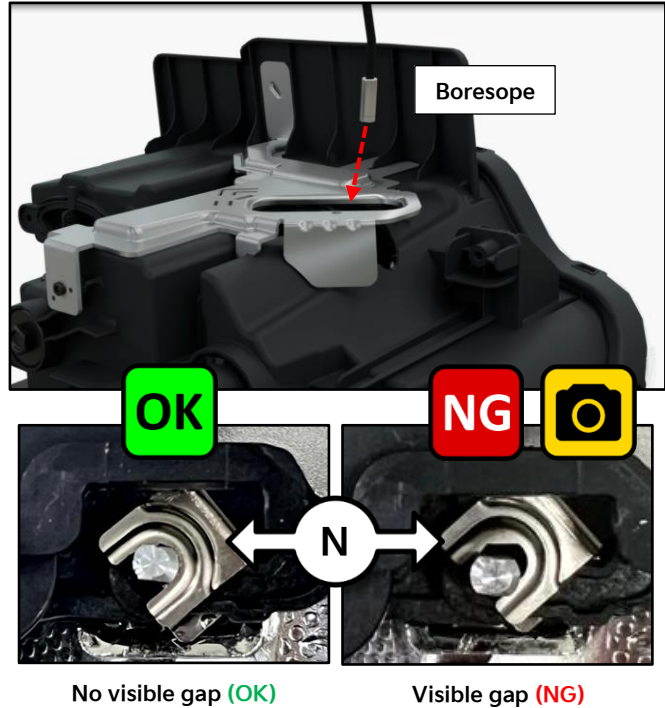
26. To confirm that the gear retaining clip (N) is correctly installed/secured to the shaft, use a borescope (SST JSP79184) to view inside the projection unit gear mechanism.

- If **NO** visible gap is present between the retaining clip (N) and gear shaft **(OK)** proceed to step 27.
- If a visible gap **IS** present between the retaining clip (N) and gear shaft **(NG)**, repeat steps 16a - 20.

Note: DO NOT use a new retaining clip (N) for a **(NG)** condition.

IMPORTANT: If the retaining clip gap to the shaft cannot be adjusted to an (OK) condition, take one clear KVID photo of the (NG) retaining clip clearly showing the gap from the borescope image, including the RO information.

If this occurs, replace the affected (LH and/or RH) headlamp assembly in the reverse order of removal, and skip to step 38 to inspect the opposite side headlamp.

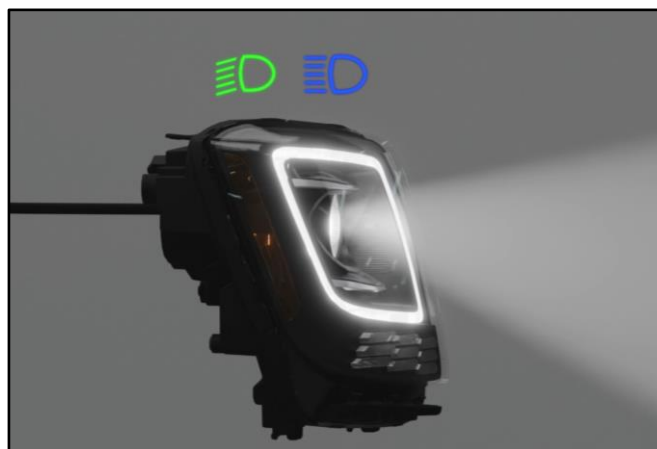
30. Confirm that both the low and high beams operate/illuminate normally.

- If the low/high beams operate normally, proceed to step 31.
- If the low/high beams do **NOT** operate normally, then replace the affected (LH and/or RH) headlamp assembly in the reverse order of removal.
