Daimler Buses

TI No.: 83.10T24281A

Model: Tourrider USA

TITLE: **Tourrider USA - Replacing the operating levers of the emergency exit hatches**

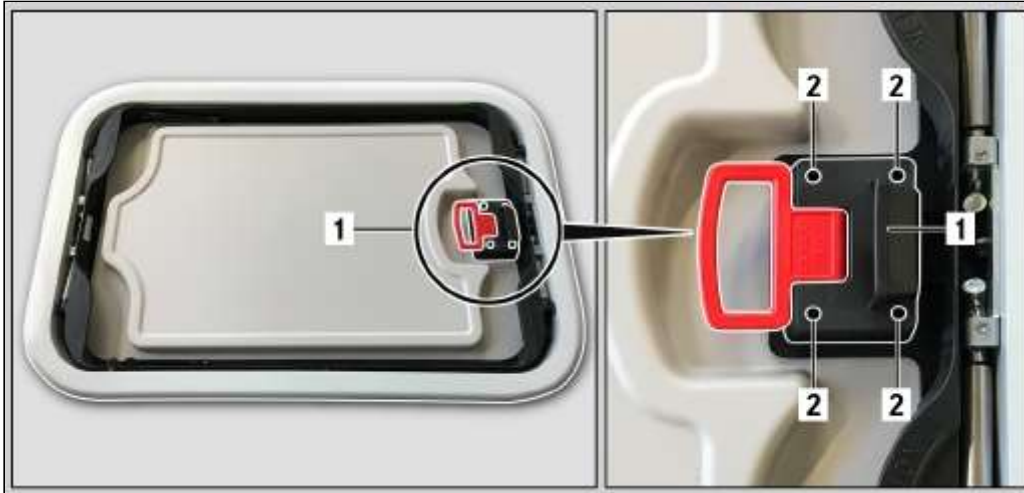
M83.10-A019-80

The operating levers of the emergency exit hatches could break.

Inadequate material strength of the operating levers.

1. Remove screws **(2)**.
2. Remove operating lever **(1)**.
3. Fit the new operating lever and fasten in place.

2 Nm

4. Open and close the emergency exit hatch 2-3 times to ensure trouble-free operation.
