SAFETY RECALL - 24TA05

POTENTIAL AXLE SHAFT SEPARATION

CERTAIN 2022-2023 TACOMA

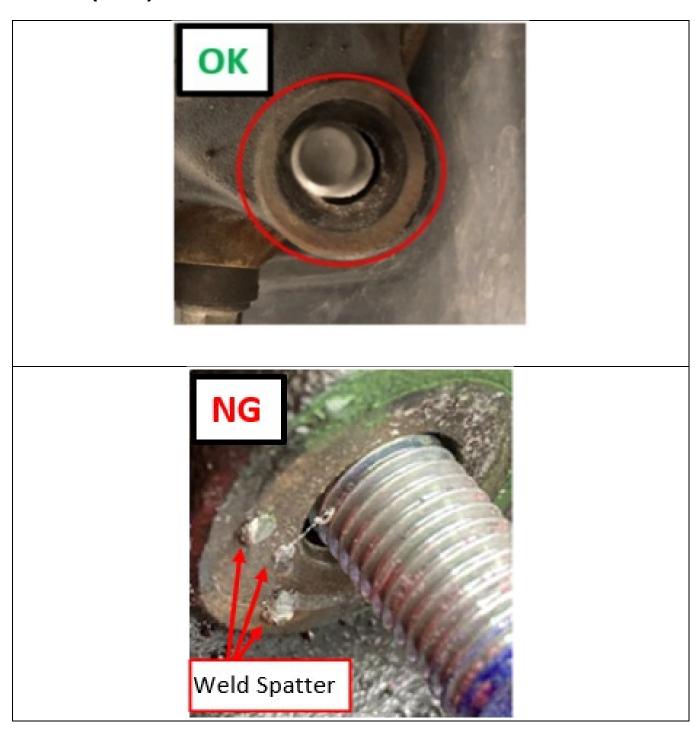
c. Carefully inspect the flat surface behind the axle nut to ensure the area is free of any weld spatter.

HINT: See examples of the "OK" condition vs. "NG" weld spatter condition in the corresponding illustration.

Does any weld spatter exist?

NG: Proceed to Step 4.

OK: Re-install axle nut and torque to specification.

Torque:

55 N·m {41 ft·lbf}

4. REMOVE WELD SPATTER

a. Install spare vinyl tubing or tape to protect the rear axle housing bolt threads.

- b. Using a cold chisel, remove the weld spatter by carefully striking the weld spatter with the chisel.
- c. Any weld spatter that cannot be removed using a chisel will be removed using a file.

HINT: Use a hard flat file to remove any remaining weld spatter that could not be removed by using a chisel.

<u>NOTICE</u>: Use Extreme Caution to avoid altering the flange surface beyond removing the weld spatter

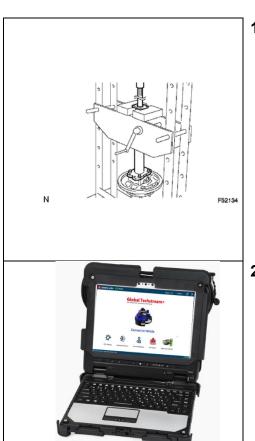
IX. REAR AXLE HOUSING BOLT REPAIR PROCEDURE

<u>NOTE</u>: Flanges marked with a red "X" will require the replacement of the rear axle housing bolt in Section IX.

1. FOLLOW THE APPROPRIATE REPAIR MANUAL SECTION FOR REPLACING REAR AXLE HOUSING BOLT(S)

- a. <u>Removal</u>: AXLE: REAR AXLE SHAFT: REMOVAL; 2018 2023 MY Tacoma
- b. <u>Disassembly</u>: AXLE: REAR AXLE SHAFT: DISASSEMBLY; 2016 2023 MY Tacoma
- c. <u>Reassembly</u>: AXLE: REAR AXLE SHAFT: REASSEMBLY; 2016 2023 MY Tacoma
- d. <u>Installation</u>: AXLE: REAR AXLE SHAFT: INSTALLATION; 2018 2023 MY Tacoma

NOTE: Be sure to remove all red "X" marks from the rear axle housing flange upon completion of all repairs.
