# Safety Recall

## N242441050 Mobileye Camera Cable Pinched

**Release Date:** March 2024

Make	Model	Model Year		RPO	Description
		From	To		
Chevrolet	6500 XD/7500 XD Low Cab Forward	2020	2024	Y65	Forward Collision Alert and Lane Departure Warning (Mobileye)

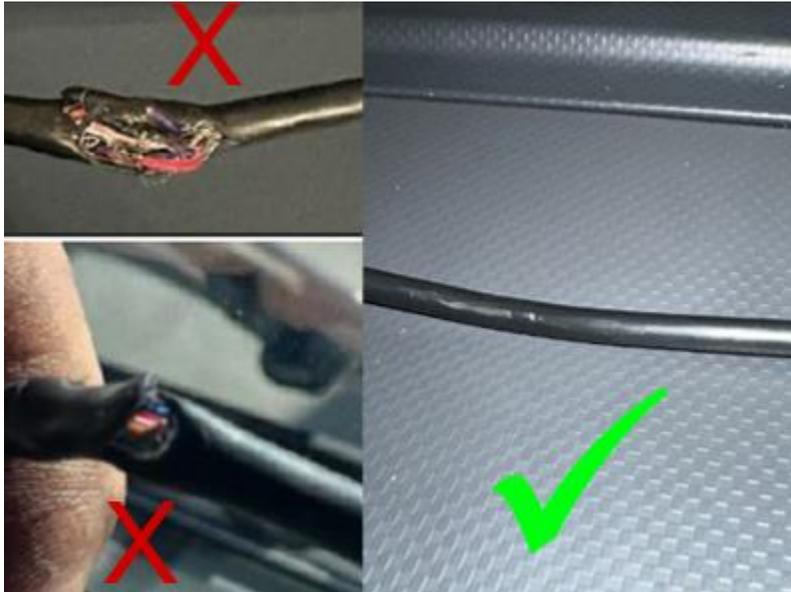
6584481

14. Inspect the cable in the two (2) areas nearest the IP mounting bolt locations indicated by arrows marked (1).

15. Is the Mobileye camera cable damaged?
  - a. If Yes (insulation is cut or crushed or wires are visible), the Mobileye camera cable is damaged and must be replaced. Take a photo of the damaged section of the cable and refer to the Parts Information section above for further information.
  - b. If No, continue to the next step to reroute the camera cable.
