BULLETIN

BULLETIN NUMBER:
CB24-R-001

IMPORTANT SAFETY RECALL

F-SERIES MOBILEYE CAMERA CABLE ROUTING – 24V-157

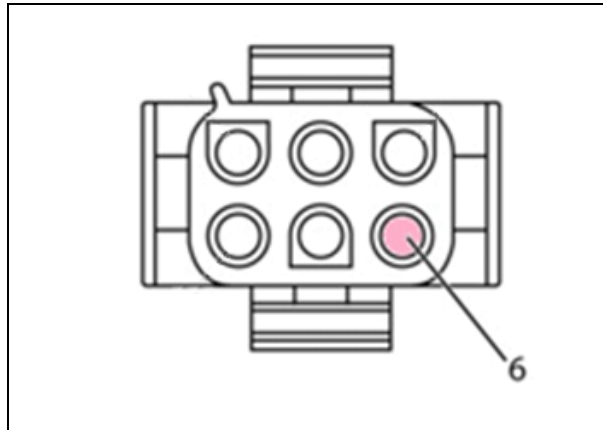
Figure 10
1. Pin 6 of Connector MH-2

7. Using an ohm meter, test for continuity between the male end of connector MH-2 Pin 6 (pink wire) and body ground. (See Figure 10.)

- a. If the wire has continuity to ground, the camera cable must be replaced. See the Parts Information section above for more information.
- b. If the wire has no continuity to ground, reconnect connector MH-2 and go to Step 8.

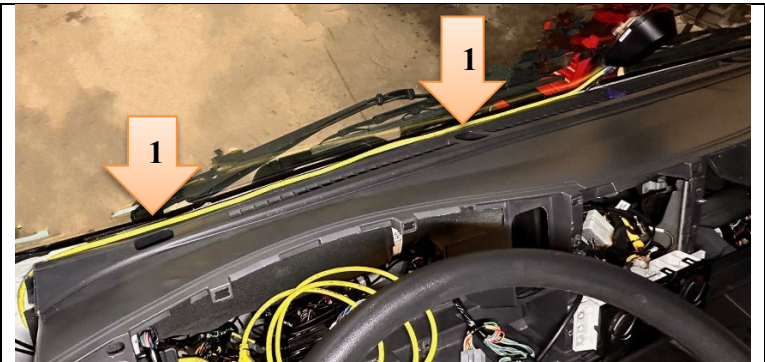
Figure 17
1. Inspection Points

14. Inspect the cable in the two (2) areas nearest the IP mounting bolt locations. (See Figure 17.)

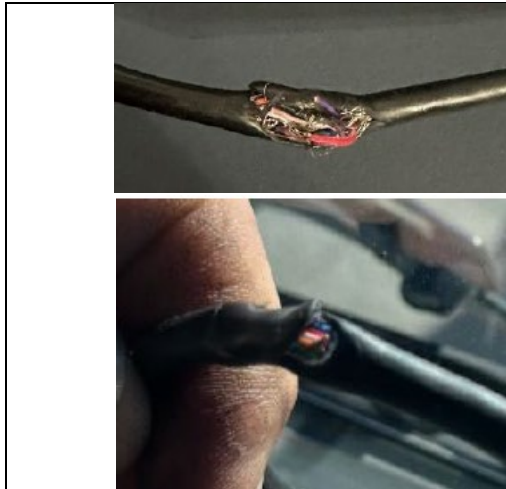
15. Is the Mobileye camera cable damaged? (See examples of cable damage in Figure 18.)
- If Yes, the Mobileye camera cable is damaged and must be replaced. Take a photo of the damaged section of the cable and refer to the Parts Information section above for further information.
 - If No, (see Figure 19) and continue to the next step to reroute the camera cable.

Figure 18
Damaged Harness: cut or crushed insulation that exposes the internal wires.

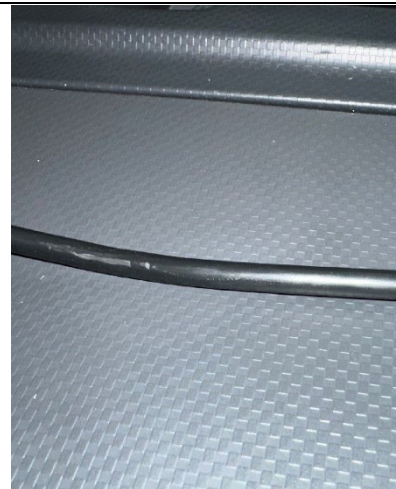
Figure 19
OK Harness: light scuffing or witness marks from handling with no major deformation of the insulation.
