# Campaign Service

**BULLETIN NUMBER:**  
CB24-R-001B

## IMPORTANT SAFETY RECALL

### F-SERIES MOBILEYE CAMERA CABLE ROUTING – 24V-157

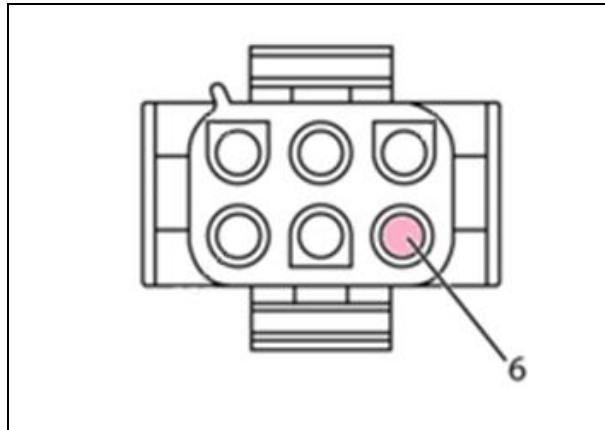
**Figure 10**  
1. Pin 6 of Connector MH-2

7. Using an ohm meter, test for continuity between the male end of connector MH-2 Pin 6 (pink wire) and body ground. (See Figure 10.)

- a. If the wire has continuity to ground, the camera cable must be replaced. See the Parts Information section above for more information.
- b. If the wire has no continuity to ground, reconnect connector MH-2 and go to Step 8.

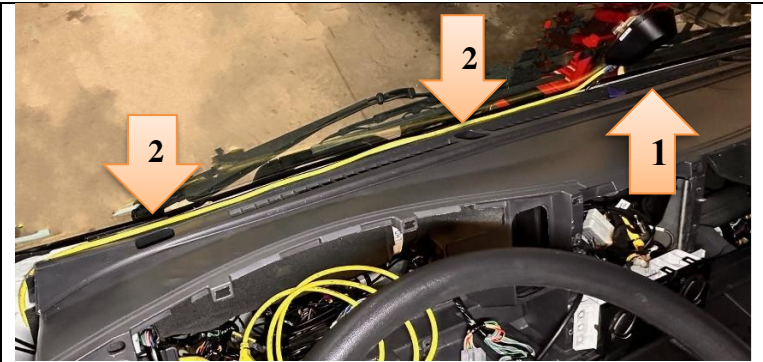
**Figure 17**  
1. Below the Camera Area  
2. Mounting Bolt Area

14. Inspect the cable in the three (3) areas; two (2) nearest the IP mounting bolt locations and one (1) where the camera cable passes between the IP and the windshield directly below the camera. (See Figure 17.)

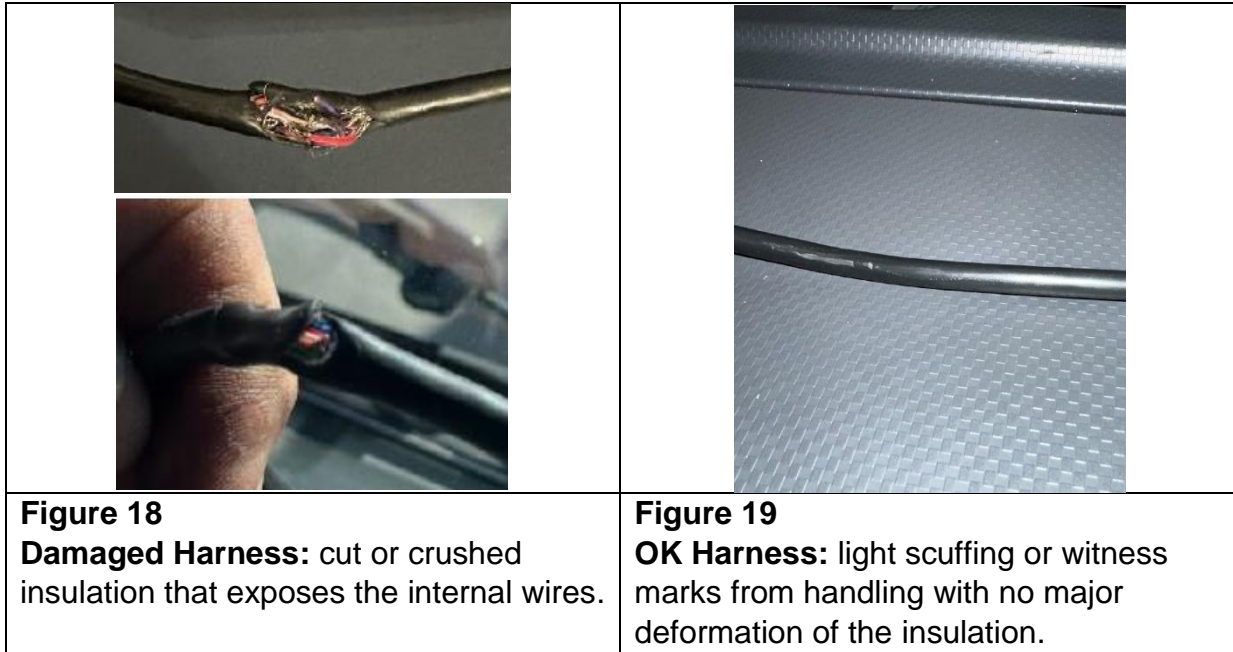
15. Is the Mobileye camera cable damaged? (See examples of cable damage in Figure 18.)
- If Yes, the Mobileye camera cable is damaged and must be replaced. Take a photo of the damaged section of the cable and refer to the Parts Information section above for further information.
  - If No, (see Figure 19) and continue to the next step to reroute the camera cable.

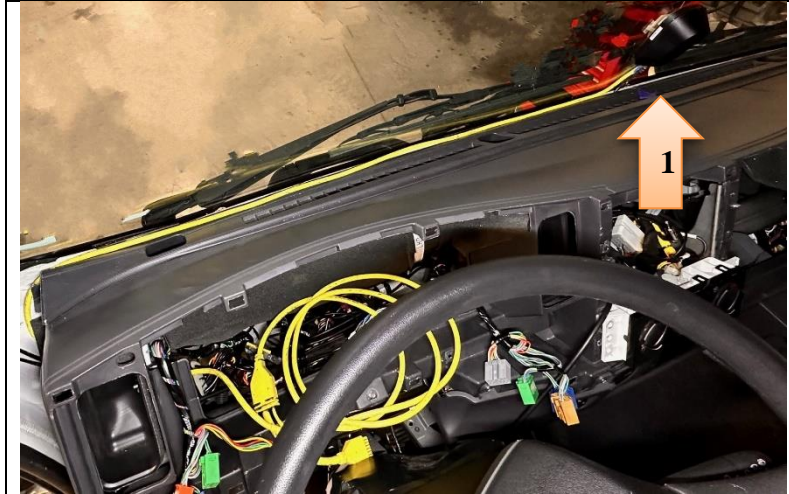
**Figure 27**  
Current Cable Routing (painted yellow for reference.)  
1. Tape Location

22. Pull out the entire camera cable from its current routing and lay it on top of the IP to the right of the tape mark placed in Step 8. (See Figure 27.)
