GROUP	MODEL
Safety Recall Campaign	2019-2020MY K900 (RJ) and 2018-2023MY Stinger (CK) w/Lambda II 3.3L T-GDI
NUMBER	DATE
SC300 (Rev 3, 10/31/2024)	April 2024

### LEFT-HAND OIL FEED PIPE AND HOSE ASSEMBLY REPLACEMENT (SC300)

This bulletin provides information to replace the left-hand (LH) turbocharger oil feed pipe and hose assembly on certain 2019-2020MY K900 (RJ) vehicles produced from August 8, 2018 through August 24, 2020 and 2018-2023MY Stinger (CK) vehicles produced from September 21, 2017 through June 29, 2022, equipped with a Lambda II 3.3L T-GDI engine. Over time, the left-hand (LH) turbocharger oil feed pipe and hose assembly may deteriorate due to exposure to radiant heat from the exhaust manifold. Such deterioration can lead to oil leaks, which in the presence of hot exhaust components, increases the risk of an engine compartment fire while driving. A fire increases the risk of injury. Customers may experience oil leaking, burning smell, white smoke from engine compartment and/or illumination of the engine oil pressure warning light. Follow the procedure outlined in this publication to replace the LH turbocharger oil feed pipe and hose assembly with an improved one on

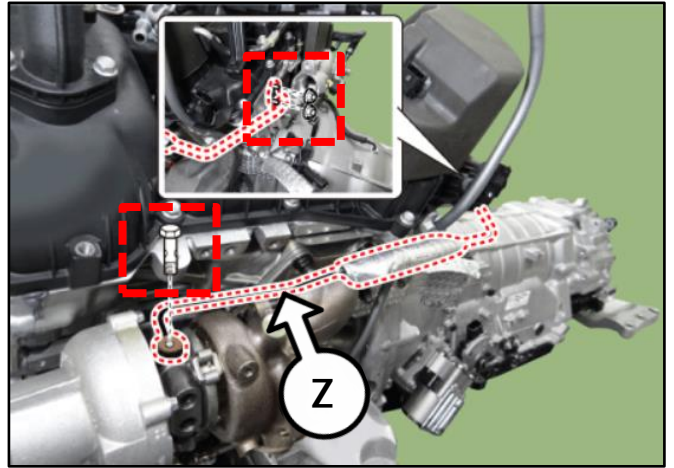
28. Refill the lost engine oil from LH oil feed pipe and hose assembly leak.  
Refer to KGIS for oil specifications NPNENG5W30

26a. Loosen the two (2) oil feed pipe nuts.

26b. Loosen the oil feed pipe eye bolt.

26c. **Replace** the LH oil feed pipe (Z) with the new and improved part.

**Note: DO NOT reuse eye bolt copper gasket and oil feed pipe gasket.**

**Tightening torque for nuts:**  
7.2 - 8.7 lb.ft (9.8 - 11.8 N.m)

**Tightening torque for eye bolt:**  
8.7 - 13.0 lb.ft (11.8 - 17.7 N.m)
