GROUP	MODEL
Safety Recall Campaign	2019-2020MY K900 (RJ) and 2018-2023MY Stinger (CK) w/Lambda II 3.3L T-GDI
NUMBER	DATE
SC300 (Rev 1, 5/16/2024)	April 2024

LEFT-HAND OIL FEED PIPE AND HOSE ASSEMBLY REPLACEMENT (SC300)

This bulletin provides information to replace the left-hand (LH) turbocharger oil feed pipe and hose assembly on certain 2019-2020MY K900 (RJ) vehicles produced from August 8, 2018 through August 24, 2020 and 2018-2023MY Stinger (CK) vehicles produced from September 21, 2017 through June 29, 2022, equipped with a Lambda II 3.3L T-GDI engine. Over time, the left-hand (LH) turbocharger oil feed pipe and hose assembly may deteriorate due to exposure to radiant heat from the exhaust manifold. Such deterioration can lead to oil leaks, which in the presence of hot exhaust components, increases the risk of an engine compartment fire while driving. A fire increases the risk of injury. Customers may experience oil leaking, burning smell, white smoke from engine compartment and/or illumination of the engine oil pressure warning light. Follow the procedure outlined in this publication to replace the LH turbocharger oil feed pipe and hose assembly with an improved one on the a

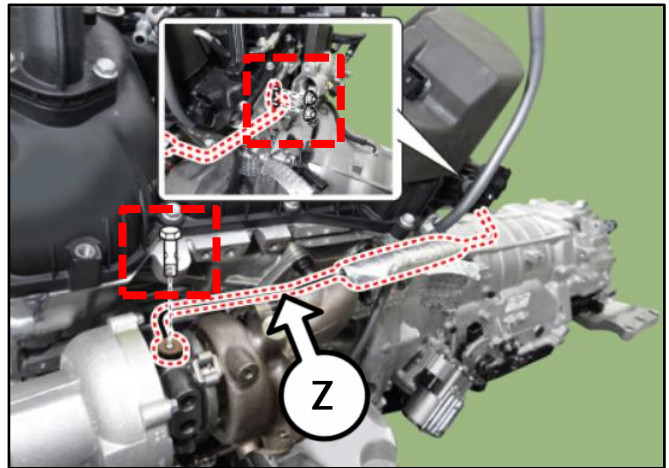
26c. **Replace** the LH oil feed pipe (Z) with the new and improved part.

26a. Loosen the two (2) oil feed pipe nuts.

26b. Loosen the oil feed pipe eye bolt.

Note: DO NOT reuse eye bolt copper gasket and oil feed pipe gasket.

Tightening torque for nuts:
7.2 - 8.7 lb.ft (9.8 - 11.8 N.m)

Tightening torque for eye bolt:
8.7 - 13.0 lb.ft (11.8 - 17.7 N.m)
