VOLUNTARY RECALL CAMPAIGN

RS24-003
 NTB24-021
 March 5, 2024

VOLUNTARY SAFETY RECALL CAMPAIGN 2024 PATHFINDER; DRIVER SEATBELT PRE-TENSIONER

CAMPAIGN ID #: PD106

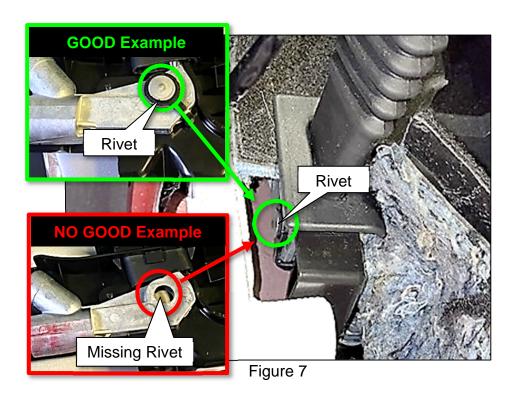
- 7. Inspect the Driver Seatbelt Pre-tensioner for the presence of a rivet, as shown in Figure 7.
 - If the rivet is present on the Driver Seatbelt Pre-tensioner, no further action is needed. Continue to step 8 to reassemble the vehicle.
 - If the rivet is missing from the Driver Seatbelt Pre-tensioner, replace the Driver Seatbelt Pre-tensioner, and then continue to step 8 to reassemble the vehicle.
 - Refer to the ESM: RESTRAINTS > SEAT BELT > REMOVAL AND INSTALLATION > FRONT SEAT BELT > SEAT BELT RETRACTOR > FOR USA AND CANADA > Removal and Installation
