Remedy available for
 2018 - 2021 Chrysler 300

SAFETY RECALL

SABIC Inflator

Reference: 19B / NHTSA 24V-198

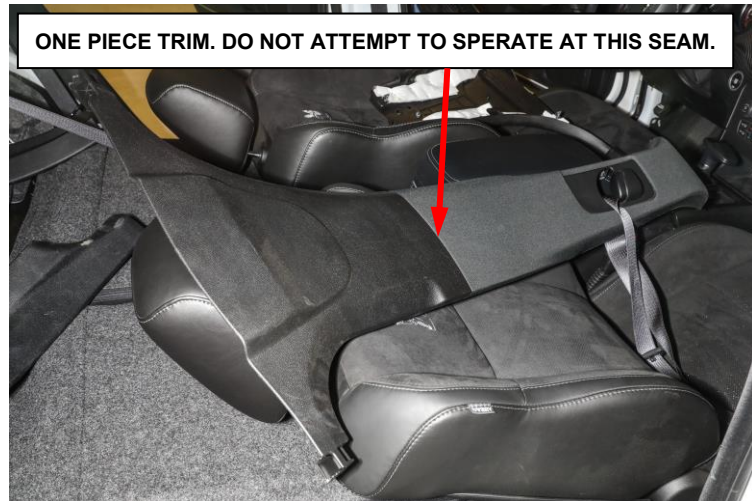
Figure 1 – B-Pillar Trim

NOTE: B-Pillar trim is ONE PIECE. Do not try to separate the upper from the lower (Figure 1).
