Remedy available for  
 2023 (WL) Jeep Grand Cherokee and  
 Grand Cherokee L and 2023-2024 (WS)  
 Wagoneer and Grand Wagoneer

**SAFETY RECALL**  
NORTH AMERICA  
**SCCM Internal Failure**

Reference: 36B / NHTSA 24V-199

## SCCM Internal Failure

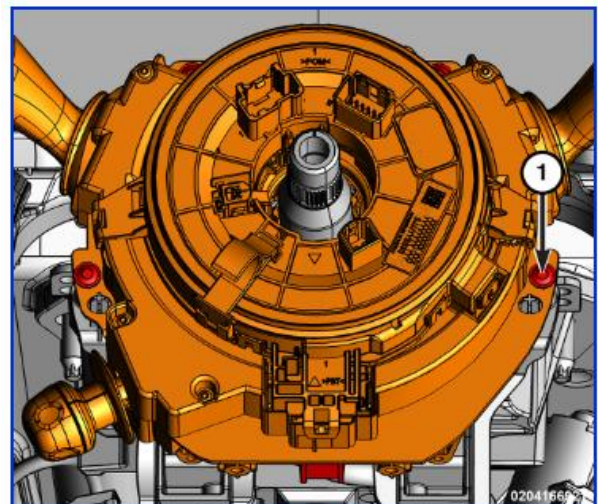
**Figure 1 – SCCM Bracket Screws**

1 - SCCM Bracket Screws

1. Place the front wheels in the straight-ahead position and inhibit the steering column shaft from rotation.
2. Extend the steering column to the fully extended position and lower it to its lowest (down) position.
3. Disconnect and isolate the negative battery cable(s) (Refer to 08 - Electrical / 8F - Engine Systems / Battery System / Standard Procedure).
4. Remove the steering wheel (Refer to 19 - Steering/Column/WHEEL, Steering/Removal and Installation).
5. Remove the steering column shroud (Refer to 19 - Steering/Column/SHROUD, Steering Column/Removal and Installation).
6. Remove the SCCM bracket screws (1) and position the bracket away from the SCCM (Figure 1).

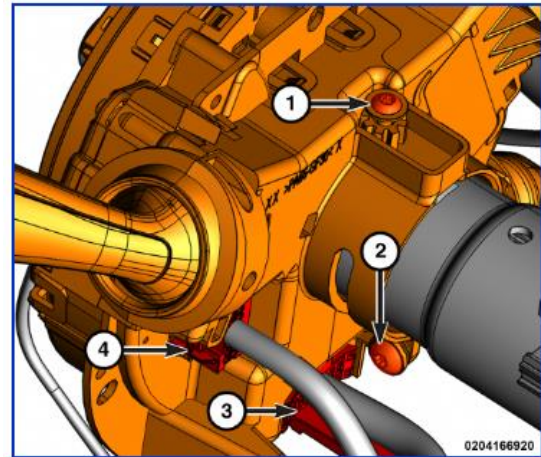
**Figure 2 – SCCM Screws and Connectors**

- 1 - SCCM Screw
- 2 - SCCM Clamp Screw
- 3 - SCCM Wire Harness Connectors
- 4 - SCCM Wire Harness Connectors

7. Disconnect the SCCM wire harness connectors.
8. Loosen the SCCM screw (1), do not remove the screw completely (Figure 2).
9. Loosen the SCCM clamp screw (2), do not remove the screw completely (Figure 2).
10. Remove the SCCM from the steering column.
