RAM Remedy available for
 2023-2024 RAM (DT) 1500 Pickup

SAFETY RECALL
NORTH AMERICA
SCCM Internal Failure

Reference: 33B / NHTSA 24V-199

SCCM Internal Failure

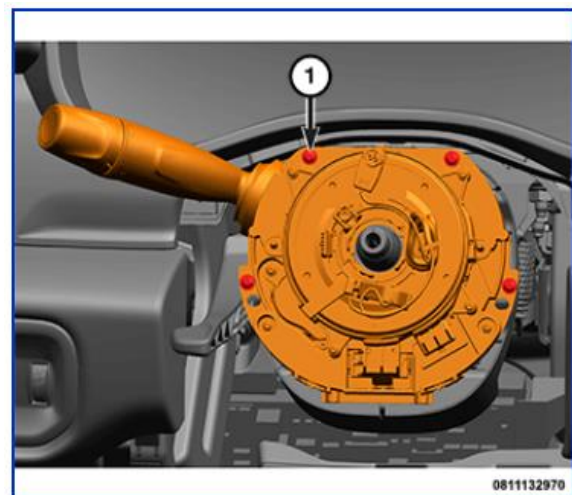
Figure 1 – SCCM Fasteners

1 - Fastener

1. Place the front wheels in the straight-ahead position and inhibit the steering column shaft from rotation.
2. Extend the steering column to the fully extended position and lower it to its lowest (down) position.
3. Disconnect and isolate the negative battery cable(s) (Refer to 08 - Electrical/Battery System/Standard Procedure).
4. Remove the steering wheel (Refer to 19 - Steering/Column/WHEEL, Steering/Removal and Installation).
5. Remove the outer shroud from the steering column (Refer to 19 - Steering/Column/SHROUD, Steering Column/Removal and Installation).
6. Remove the fasteners (1) from the SCCM (Figure 1).
7. Release the integral retainers for the inner shroud and push the inner shroud toward the instrument panel as far as it will go.

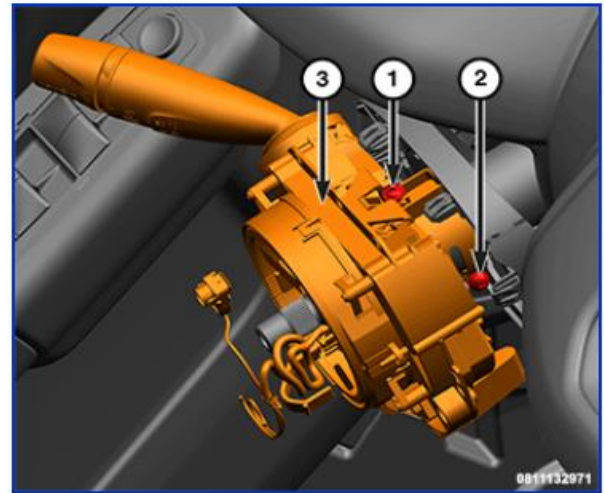
Figure 2 – SCCM Fasteners

- 1 - Attachment Fastener
- 2 - Clamp Fastener
- 3 - SCCM

8. Loosen the centering attachment fastener (1) on the top, rear of the SCCM. Do not remove the fastener completely (Figure 2).
9. Loosen the clamp fastener (2) to allow the SCCM to be removed. Do not remove the fastener completely (Figure 2).
10. Pull the SCCM (3) away from the steering column inner shroud far enough to disconnect the instrument panel wire harness connectors (Figure 2).
11. Remove the SCCM from the steering column.
