GROUP	MODEL
Safety Recall Campaign	2022-2024MY EV6, EV6 GT (CV)
NUMBER	DATE
SC302 (Rev 1, 05/20/2024)	May 2024

### SUBJECT: ICCU AND FUSE INSPECTION/REPLACEMENT AND ICCU SOFTWARE UPGRADE (SC302)

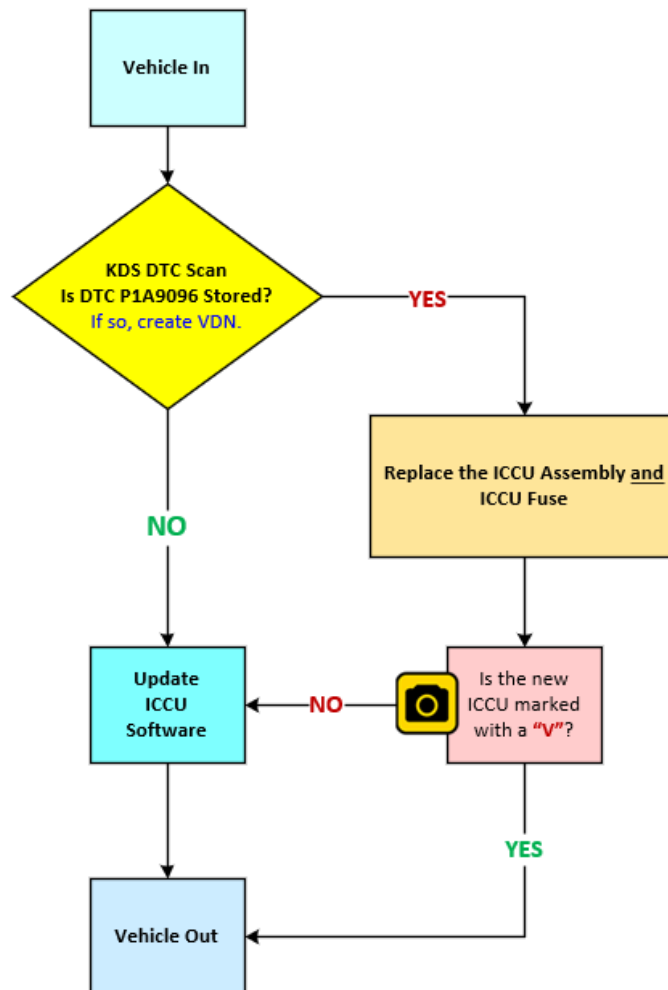
## Flowchart:

## Using KDS, scan the vehicle for DTC P1A9096 - Is DTC stored?

## Does the 'new' ICCU Assy marked with a letter "V"?

- If DTC is not stored, update the ICCU software (Pages 3-4).
- If DTC is stored, replace the ICCU Assembly + ICCU Fuse (Page 5)

- No - Take a KVID photo of ICCU marked "V" + Update the ICCU software (Pages 3-4)
- Yes - Vehicle Out
