GROUP	MODEL
	Subsequent Repair Action	2022-2024MY EV6, EV6 GT (CV)
	NUMBER	DATE
	SC302Y	June 2024

SUBJECT: **ICCU AND FUSE REPLACEMENT (SC302Y)**

This bulletin provides information related to the Technical Service Bulletin previously published under SC302, titled "ICCU and Fuse Inspection/Replacement and ICCU Software Upgrade." If DTC P1A9096 is present or stored after ICCU Software Upgrade has been performed per SC302, follow the instruction in this bulletin to replace the ICCU and ICCU fuse. Before conducting the procedure, verify that the vehicle is included in the list of affected VINs.

DTC Description:
P1A9096 - DC/DC Converter Input Voltage Sensor Fault

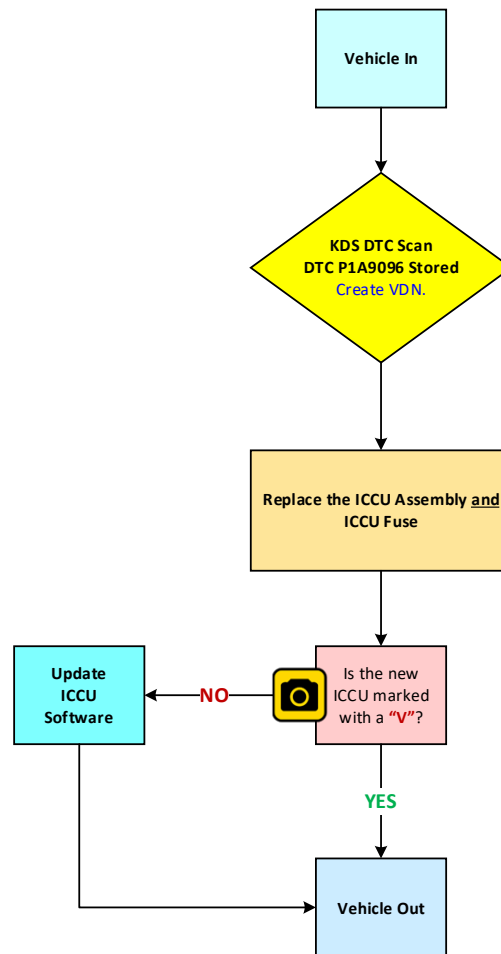
Flowchart:

'Vehicle In' with DTC P1A9096 (after completing SC302 with the latest software)

DTC P1A9096 Stored + ICCU Assembly and ICCU Fuse Replacement

Is the 'new' ICCU Assembly marked with a letter "V"?

- If DTC is stored, replace the ICCU Assembly + ICCU Fuse (Page 5)

- No - Take a KVID photo of ICCU + Update the ICCU software (Pages 3-4)
- Yes - Vehicle OUT
