RECALL 24V202 / 2024-172 REMEDY INSTRUCTIONS

Make(s): ISATA
Model(s): MANY, SEE BELOW
Model Year(s): 2023 - 2025

Concern:
The nut on the backside of the Main 12V Disconnect may have been inconsistently tightened.

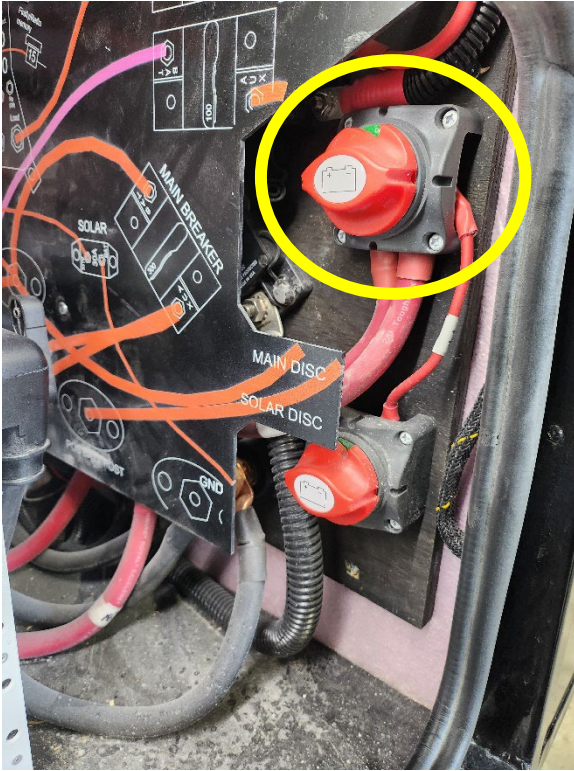
FIGURE 1

STEP 1: LOCATE THE MAIN 12V SERVICE DISCONNECT (FIGURE 1);

- REMOVE AND DISCARD THE FASTENERS, THEY WILL BE TOO LONG TO REUSE;

STEP 2: REMOVE THE 12V CABLES HOOKED TO THE STUD(S) ON THE DISCONNECT;
