## Technical Service Bulletin

<b>GROUP</b>	<b>NUMBER</b>
<b>RECALL</b>	<b>24-01-023G</b>
<b>DATE</b>	<b>MODEL(S)</b>
<b>MARCH 2024</b>	<b>GV60 (JW1 EV) GV70 ELECTRIFIED (JK1a EV) G80 ELECTRIFIED (RG3 EV)</b>

**SUBJECT:** DTC P1A9096 CHECK FOR ICCU & FUSE REPLACEMENT  
& ICCU SOFTWARE UPDATE (RECALL 021G)

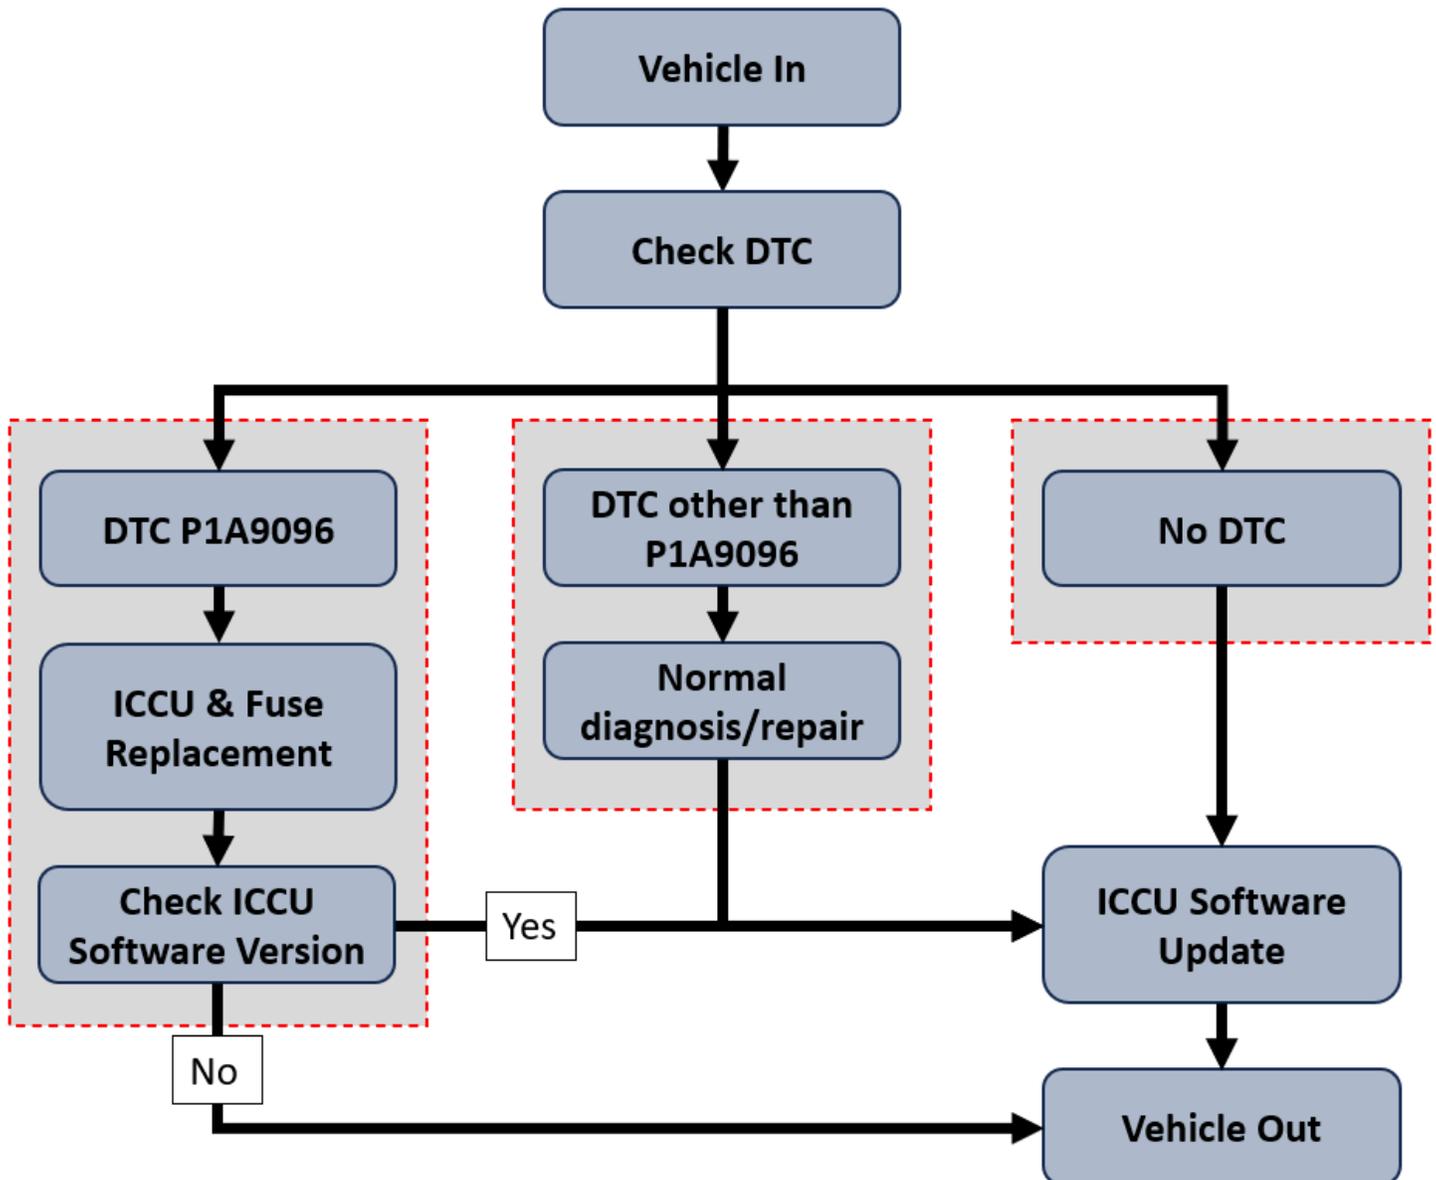
1. Turn ignition switch on and check for DTC's using the GDS.

- 1) No DTC Found. Proceed with ICCU software upgrade for the applicable model following TSB.
- 2) DTC P1A9096 Confirmed. Follow the outline procedure in TSB to replace the ICCU & High Voltage Fuse. Complete ICCU software upgrade if applicable for replacement ICCU.

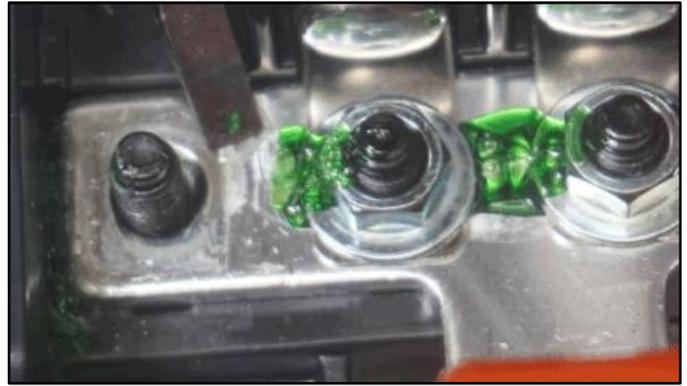
Any foreign substance in this area may cause poor contact between terminals.

- D4. After removing the fuse carefully clean the fuse mating surface prior to installation.
