Technical Service Bulletin

GROUP	NUMBER
RECALL	24-01-023H
DATE	MODEL(S)
MARCH 2024	IONIQ 5 (NE1) IONIQ 6 (CE1) IONIQ 5 (NER) ROBOTAXI

SUBJECT: DTC P1A9096 CHECK FOR ICCU & FUSE REPLACEMENT & ICCU SOFTWARE UPDATE (RECALL 257)

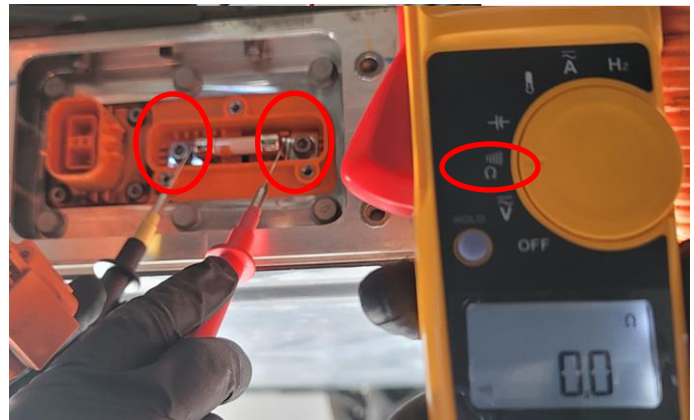
E6. Using a commonly available multimeter. Set at the ohmmeter measuring mode and inspect the fuse condition by checking the fuse's resistance value:

- **Fuse is Good:** Less than 1.0 ohm.

**DO NOT REPLACE THE FUSE.
Do not follow the remaining steps to
replace the fuse.**

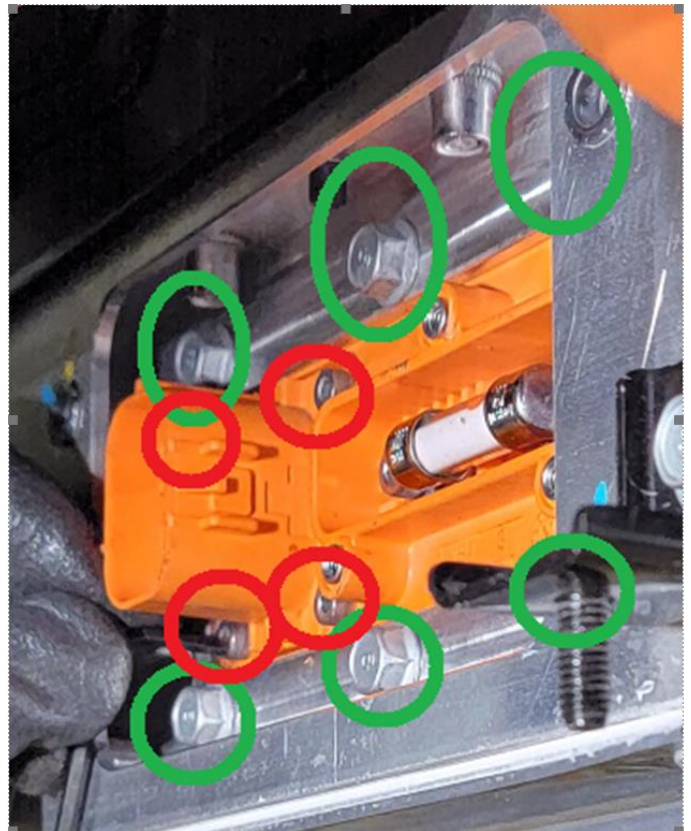
SPECIAL INSTRUCTION: Only applies when ICCU Fuse rear nut(s) falls back into the battery.

1. Remove:
 - 6 qty. 10mm bolts (Green marked),
 - 4 qty. bolts by Allen wrench (Red marked).
2. Push in bottom area. Pull out top area.
3. Reach in and grab the nut behind the plate on the bottom surface.
4. Hold the nut at the back side.
5. Install the fuse bolt at the place that the nut had dropped.
6. Install all the other bolts in reverse order of removal.
7. Install the rest of the fuse bolts.

NOTE: Contact Techline if the above procedure did not resolve a dropped nut problem.
