## Technical Service Bulletin

<b>GROUP</b> RECALL	<b>NUMBER</b> 24-01-022G
<b>DATE</b> MARCH 2024	<b>MODEL(S)</b> GV70 (JK1a)

**SUBJECT:** TRANSMISSION CONTROL HARNESS/E-MODULE CONNECTOR & PIN REWORK (RECALL 020G)

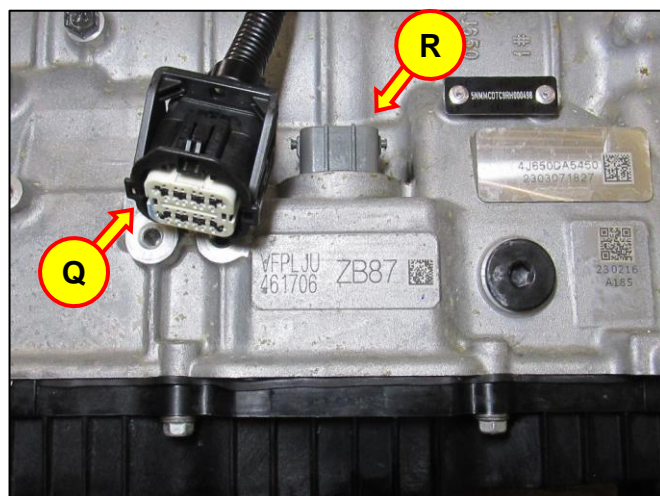
14. Gently maneuver the E-module female connector (Q) down and inspect for corrosion on pins.

Using a mirror or borescope, inspect the E-module male connector (R) for corrosion on pins.

If any corrosion is found on either of the E-module connectors shown above: Reassemble the components such as to provide a means of placing the vehicle in Neutral (N) gear. Safely move the vehicle to a suitable location until a remedy procedure for harness and E-module replacement is available.

If corrosion is found on either connector, **both** connectors must be replaced. This requires replacement of the control harness and E-module. The remedy procedure for replacement will be provided once available.

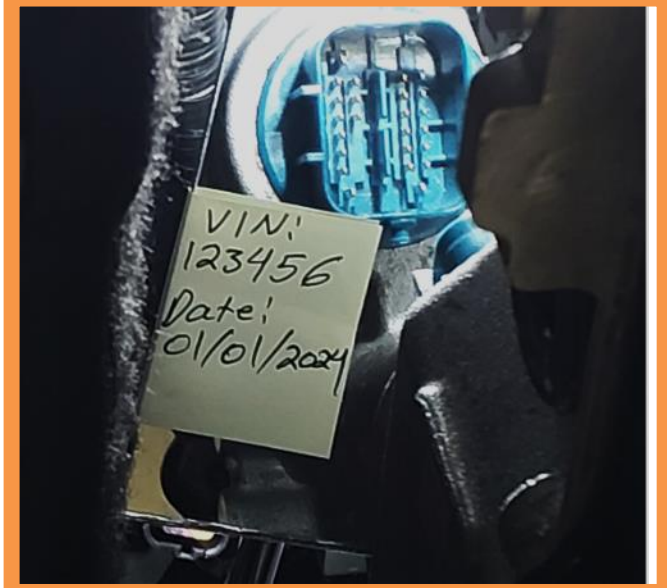
<b>E-module Male Connector</b>	<b>OK – No corrosion</b>	<b>NG - Corrosion</b>
Inspect the male connector for corrosion as shown to the right.

Using STUI, take a photo with either a borescope or camera and mirror of the E-module male connector with the last 6 digits of the VIN and the date of repair on a piece of paper.

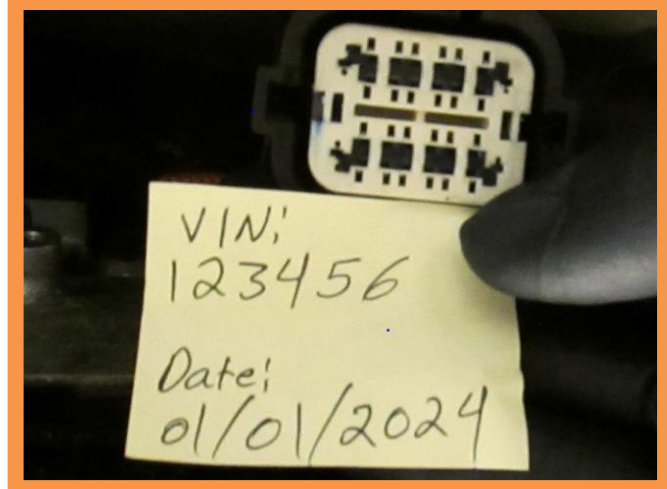
<b>E-module Female Connector (Harness)</b>	<b>OK – No corrosion</b>	<b>NG - Corrosion</b>
Inspect the female connector for corrosion as shown to the right.

Using STUI, take a photo of the E-Module female connector with the last 6 digits of the VIN and the date of repair on a piece of paper.
