Technical Service Bulletin

GROUP	NUMBER
RECALL	24-01-022G-1
DATE	MODEL(S)
MARCH 2024	GV70 (JK1a)

SUBJECT: TRANSMISSION CONTROL HARNESS/E-MODULE CONNECTOR & PIN REWORK (RECALL 020G)

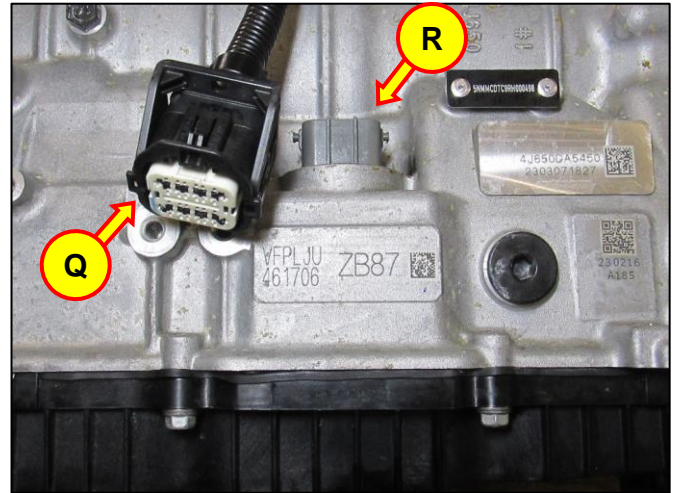
14. Gently maneuver the E-module female connector (Q) down and inspect for corrosion on pins.

Using a mirror or borescope, inspect the E-module male connector (R) for corrosion on pins.

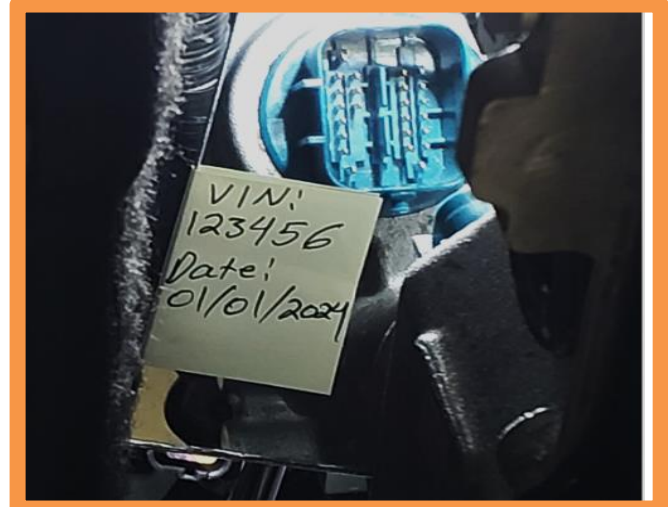
Using STUI, take a photo with either a borescope or camera and mirror of the E-module male connector with the last 6 digits of the VIN and the date of repair on a piece of paper.

If any corrosion is found on either of the E-module connectors shown above: Reassemble the components such as to provide a means of placing the vehicle in Neutral (N) gear. Safely move the vehicle to a suitable location until a remedy procedure for harness and E-module replacement is available.

If corrosion is found on either connector, **both** connectors must be replaced. This requires replacement of the control harness and E-module. The remedy procedure for replacement will be provided once available.

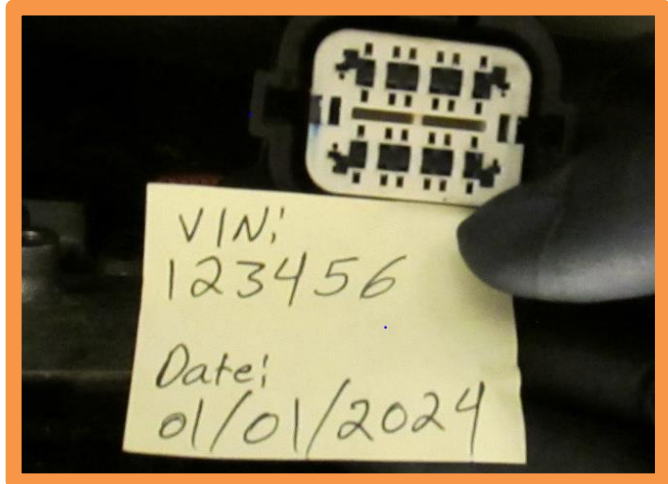
Using STUI, take a photo of the E-Module female connector with the last 6 digits of the VIN and the date of repair on a piece of paper.

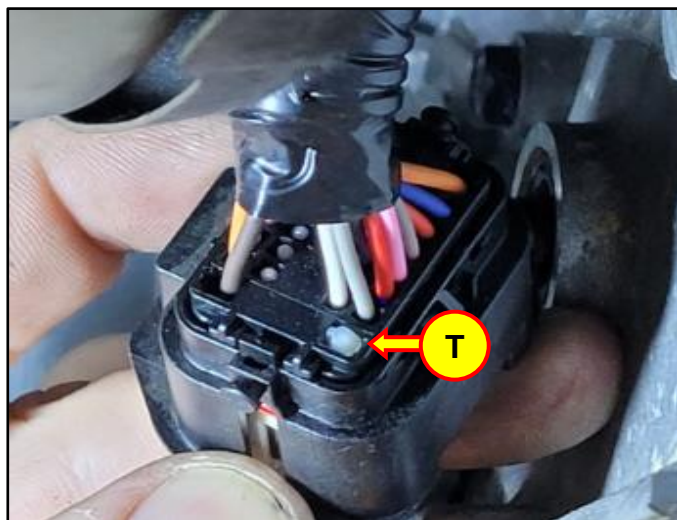
17. Follow the steps below to remove and correctly reinstall the blanking pin (T). If the blanking pin is missing, replace it with a new one.

Order part number GV70CAMPPIN for additional blanking pins.
