# Technical Service Bulletin

<b>GROUP</b>	<b>NUMBER</b>
<b>RECALL</b>	<b>24-01-022G-2</b>
<b>DATE</b>	<b>MODEL(S)</b>
<b>OCTOBER 2024</b>	<b>GV70 (JK1A)</b>

**SUBJECT:** TRANSMISSION CONTROL HARNESS/E-MODULE CONNECTOR PIN REWORK & REPLACEMENT (RECALL 020G)

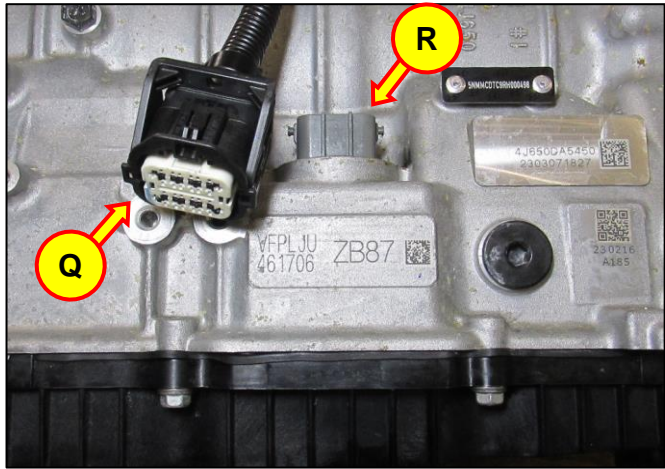
14. Gently maneuver the harness female connector (Q) down and inspect for corrosion on pins.

Using a mirror or borescope, inspect the E-module male connector (R) for corrosion on pins.

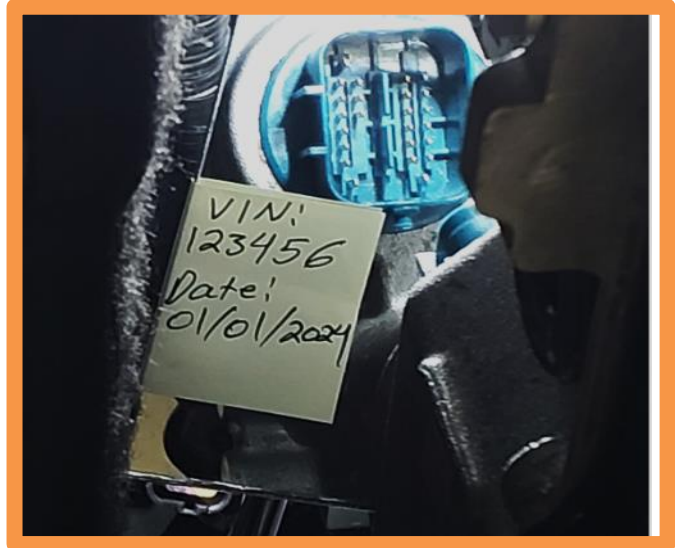
Using STUI, take a photo with either a borescope or camera and mirror of the E-module male connector with the last 6 digits of the VIN and the date of repair on a piece of paper.

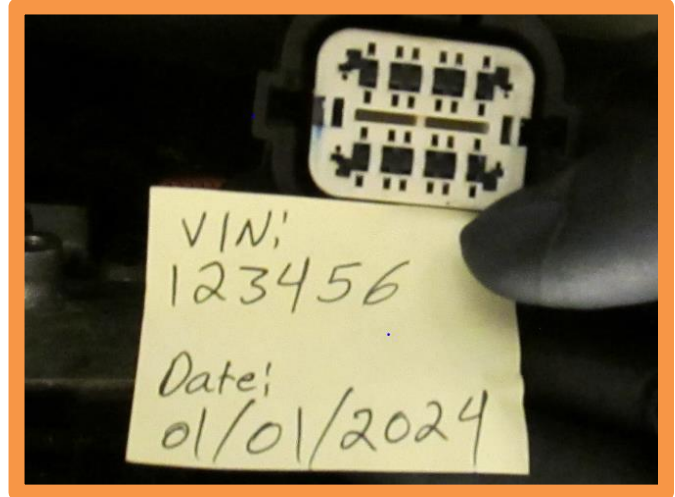
Using STUI, take a photo of the E-Module female connector with the last 6 digits of the VIN and the date of repair on a piece of paper.

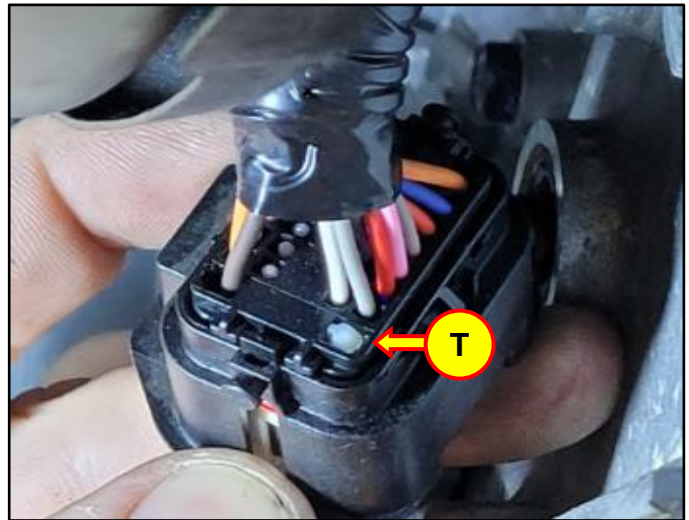
19. Follow the steps below to remove and correctly reinstall the blanking pin (T). If the blanking pin is missing, replace it with a new one.

If necessary, order part number GV70CAMPPIN for additional blanking pins. Please note that these pins should only be replaced if missing upon inspection or lost by technician during inspection.

The pin does not need to be replaced for every rework.

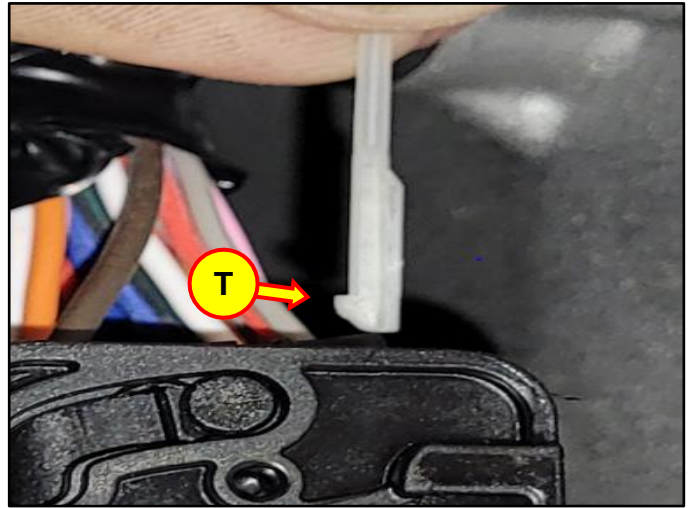
21. Confirm the blanking pin (T) is installed with the tab facing the brown wire in the opposing corner of the connector.

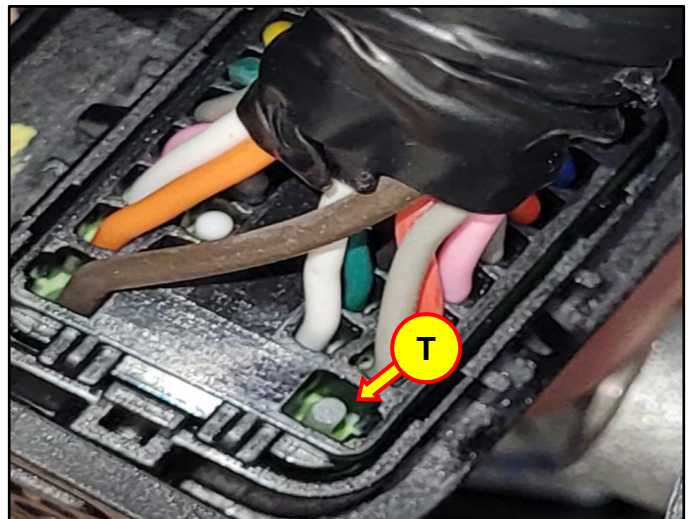
23. Verify proper repair by referencing the correctly installed pin (T) in the image to the right.

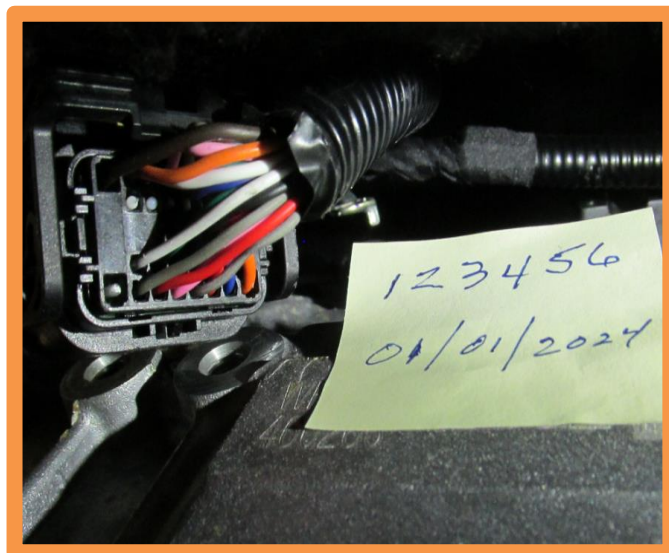
Using STUI, take a photo of the harness connector wiring side with the blanking pin (T) correctly installed. Include the last 6 digits of the VIN and the date of repair on a piece of paper.

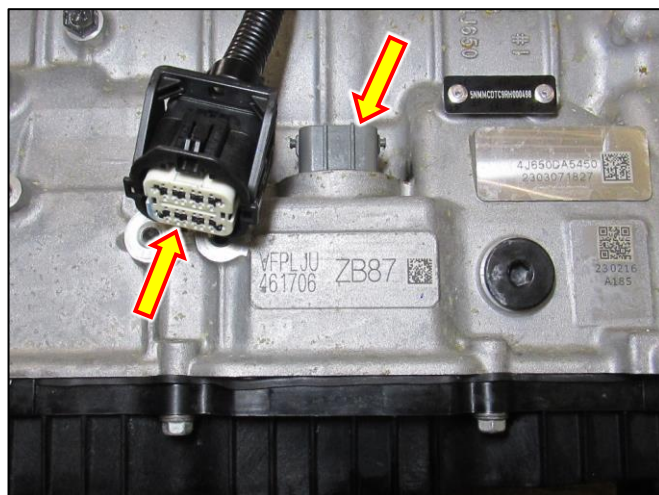
25. Use compressed air to blow out any debris or residual moisture in both the E-Module male and female connectors.

Reconnect the E-Module.
