Recall Campaign Bulletin

Campaign No. 2024040002, April 2024

SUBJECT: **Model GLE/GLS (167 platform)**
Model Year 2019 – 2024

Check 48V Ground Connection on Passenger Seat

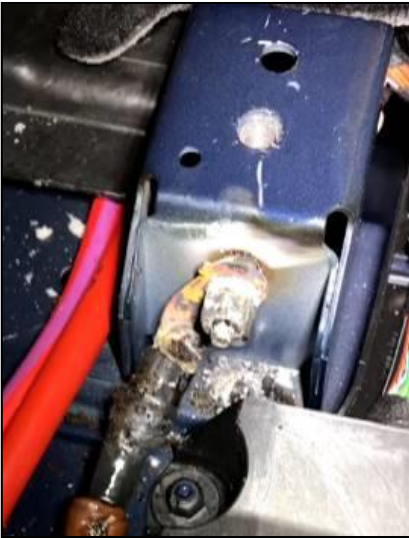
Figure 4 (not OK image)

i Inspect ground connection for traces of thermal overload or damage (**Figure 4**).

A. If **traces of thermal overload or damage** are **present** on the wiring harness at the "W106/1" ground point:

- Carry out **Work Procedures A and B.**
