Recall Campaign Bulletin

Campaign No. 2024040007, April 2024

SUBJECT: Model E-Class (214 platform)

Check Transmission Wiring Harness Routing

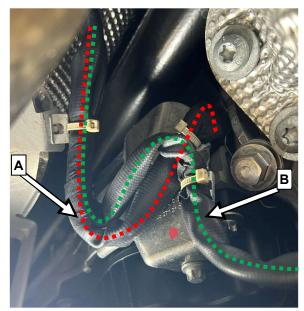
Figure 1 - Red (A): Power supply line Green (B): Signal wires

- 1. Check routing (**Figure 1**) and distance (**Figure 2**) between electrical wiring harnesses and the <u>transmission tunnel/drive</u> <u>shaft</u> and the <u>transfer case to front axle differential</u> (indicated parts).
 - it is **not necessary** to remove the rear underfloor paneling to check the routing.
 - The electrical wiring harnesses *must not* be in contact with the transfer case to front axle differential.
 - The distance between the electrical wiring harness and the drive shaft *must be* at least 10 mm (Figure 2, A).

- a. Electrical wiring harness is in contact with indicated parts but is not damaged: Carry out Work Procedure 1.
- b. Electrical wiring harness is in contact with indicated parts and
 is damaged: Carry out Work Procedure 2:
 Work Procedure 2a: Only protective sheathing is damaged.
 Work Procedure 2b: Signal lines (Figure 1, B) are damaged.
- Electrical power supply line (Figure 1, A) (line cross-section
 10 mm²) is damaged: Carry out Work Procedure 3.
- d. Electrical wiring harness is *routed correctly*: End Measure.

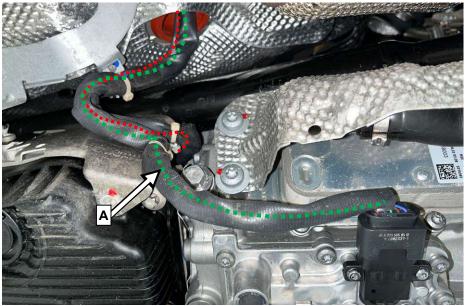
Figure 4

- Li Electrical wiring harness is in contact with indicated parts and *is damaged* (chafing, melting, tears/scoring).
- Li If only the protective sheathing is damaged, and the electrical harness wiring has no signs of damage:
- 1. Wrap affected area with fabric tape.
- 2. Route electrical wiring harness (Figure 4, A) correctly as shown
 - The electrical wiring harness (Figure 4, A) must not be in contact with indicated parts *in any location*.

One or more of the electrical signal lines (line cross section 0.35 mm² to 0.75 mm²) in the electrical wiring harness (Figure 4, A) shows signs of damage.

- 1. Remove rear section of underfloor paneling.
 - i For basic information, see AR61.30-P-1001WT.
- 2. Repair the respective affected electrical signal line (line cross section 0.35 mm² to 0.75 mm²) in the electrical wiring harness (Figure 4, A) using a line connector.
 - i For basic information, see AR00.19-P-0100A.
 - To do this, cut the protective sheathing, repair wire harness using a line connector, and reinstall the protective sheathing using fabric tape to connect the cut sides.
- 3. Route electrical wiring harness (Figure 4, A) correctly as shown.
 - 1 The electrical wiring harness (Figure 4, A) must not be in contact with indicated parts in any location.
- 4. Assemble in reverse order.

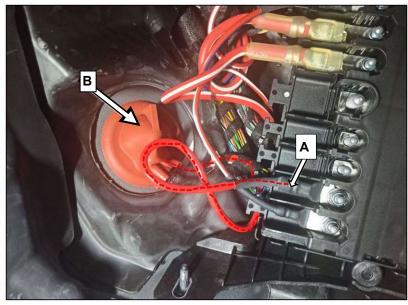
Figure 5

if the electrical power supply line (Figure 5, A) (line cross section 10 mm²) is damaged, replace electrical power supply line (Figure 5, A):

- Disconnect ground line of 12 V on-board electrical system battery.
 For basic information, see AR54.10-P-0051WT.
- Remove rear section of underfloor paneling.
 For basic information, see AR61.30-P-1001WT.
- 3. Remove protective metal sheet (Figure 6, A).
- **4.** Disconnect electrical power supply line **(Figure 5, A)** from electrical connector at transmission.
- **5.** Remove front floor covering at front passenger side.
 - i For basic information, see AR68.80-P-0008WT.
- **6.** Remove electrical power supply line (**Figure 5, A**) with grommet (**Figure 5, B**).
- 7. Replace electrical power supply line (Figure 5, A).
