Campaign No. 2024040007, April 2024

SUBJECT: **Model E-Class (214 platform)**
Model Year 2024

Check Transmission Wiring Harness Routing

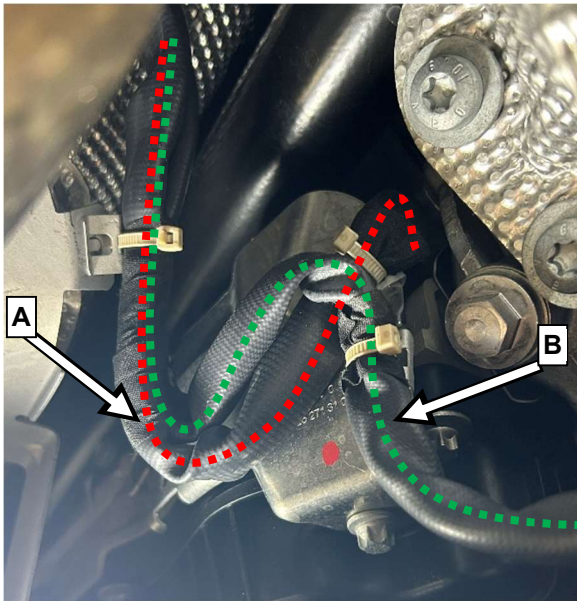
Figure 1 – **Red (A):** Power supply line
Green (B): Signal wires

1. Check routing (**Figure 1**) and distance (**Figure 2**) between electrical wiring harnesses and the transmission tunnel/drive shaft and the transfer case to front axle differential (indicated parts).

i The electrical wiring harnesses **must not** be in contact with the transfer case to front axle differential.

- a. Electrical wiring harness is in contact with indicated parts but is **not damaged**: Carry out **Work Procedure 1**.
- b. Electrical wiring harness is in contact with indicated parts and **is damaged**: Carry out **Work Procedure 2**:
Work Procedure 2a: Only protective sheathing is damaged.
Work Procedure 2b: Signal lines (Figure 1, B) are damaged.
- c. Electrical **power supply line** (Figure 1, A) (line cross-section **10 mm²**) **is damaged**: Carry out **Work Procedure 3**.
- d. Electrical wiring harness is **routed correctly**: **End Measure**.

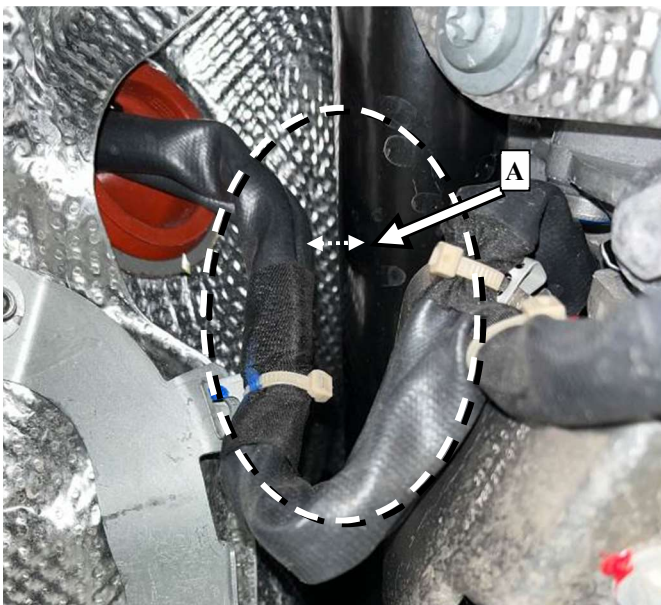
Figure 2

i The distance between the electrical wiring harness and the drive shaft **must be** at least **10 mm (Figure 2, A)**.
