Technical Service Bulletin

GROUP RECALL	NUMBER 24-01-031H
DATE APRIL 2024	MODEL(S) SANTA FE (MX5A)

SUBJECT: ccNC AVN SOFTWARE UPDATE FOR TRAILER PARKING ASSIST (TPA) MESSAGE IN REAR VIEW CAMERA (RECALL 258)

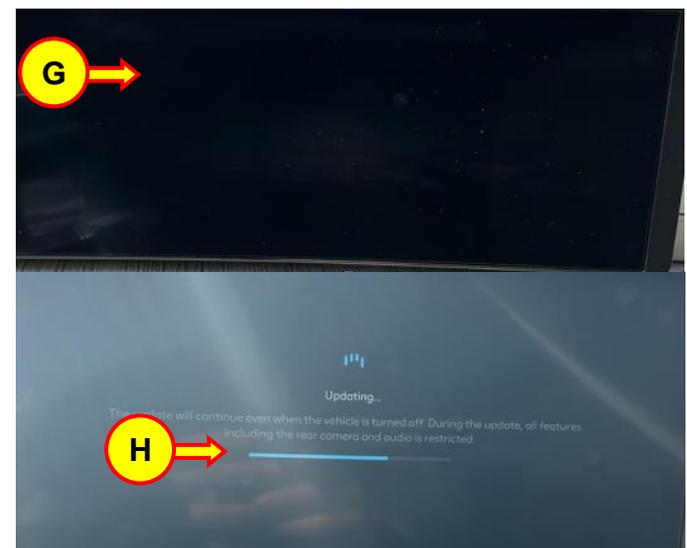
8. The screen shown to the right will indicate that the software update was successful.

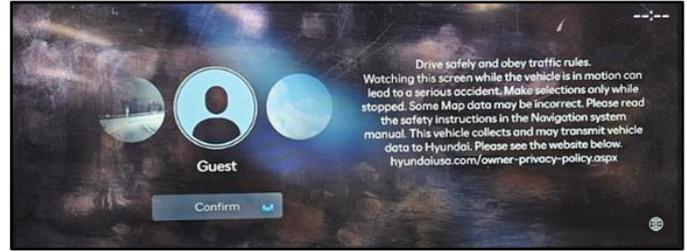
9. After the update has completed, confirm the Software Version has been correctly updated by referring to the "Version Info" screen.

- Press and hold the **SETUP** button (I).
- Confirm the Software Version now matches the new version (J).

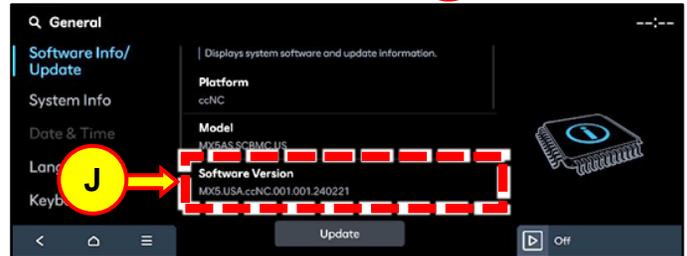
New version (after update):

- ccNC:
MX5_USA_ccNC.001.001.**240221**
- ccNC Lite:
MX5_USA_ccNC_Lite.001.001.**240221**

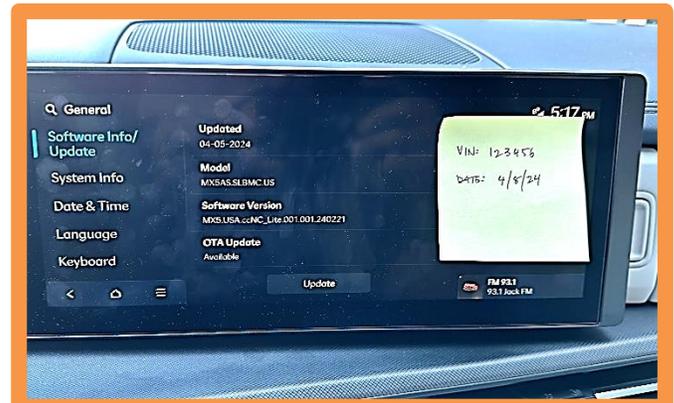
Take a photo of the 'SW Info/Update' screen showing the updated S/W version with the last 6 digits of the VIN and date of repair on a piece of paper. Put post-it/piece of paper in top right-hand corner for photo.
