RECALL ACTION

Reference number:	RA-63-1832	Issued: 05 April, 2024
Subject:	12V Battery PSS Fusebox	
Model:	DBX (all models)	
VIN Range:	Refer to the separately published list of affected Vehicle Identification Numbers (VINs)	
Applicable to:	All Markets (except China)	
Distribute to:	Aftersales Manager Executive Manager Service Manager Sales Manager	Warranty Staff Technician(s) Parts Staff

Safety Recall Action RA-63-1832 – DBX 12V Battery Fusebox

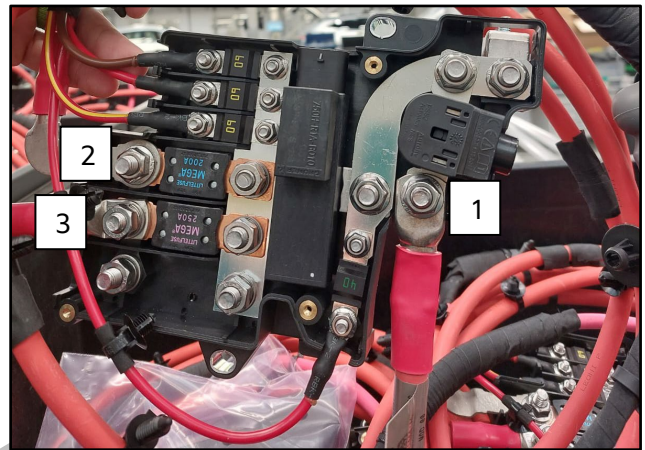
Figure 1

On the affected vehicles, it is possible that three M8 fixings in the 12V battery fusebox may work loose.

1. Disconnect the vehicle 12V battery (refer to Workshop Manual Procedure 63.01.AK).
2. Remove the cover for the fusebox (refer to Workshop Manual procedure 63.01.AR).
3. Remove the M8 fixings that follow (refer to Figure 1):

1. 'Dirty' feed - Starter motor, alternator, and front jumpstart point (pyrotechnic cut off switch)
2. Rear cabin fusebox (200A Fuse)
3. 'Clean' feed to engine fusebox (250A Fuse)

4. Do a check for any debris or signs of high temperature on the fusebox and cable eyelets.
5. Install the washer, split washer and flat M8 nut to each affected stud in the fusebox.
6. Torque the new fixings to 12 Nm.
7. Install the cover for the fusebox (refer to Workshop Manual Procedure 63.01.AR).
8. Install the liner for the spare wheel well (refer to Workshop Manual Procedure 30.03.PW).
9. Connect the vehicle 12V battery (refer to Workshop Manual Procedure 63.01.AK).
