RECALL 24V280 / 2024-232 REMEDY INSTRUCTIONS

Make(s): AURORA & CATALINA
Model(s): BART15RDX & BCAT154RDX
Model Year(s): 2024

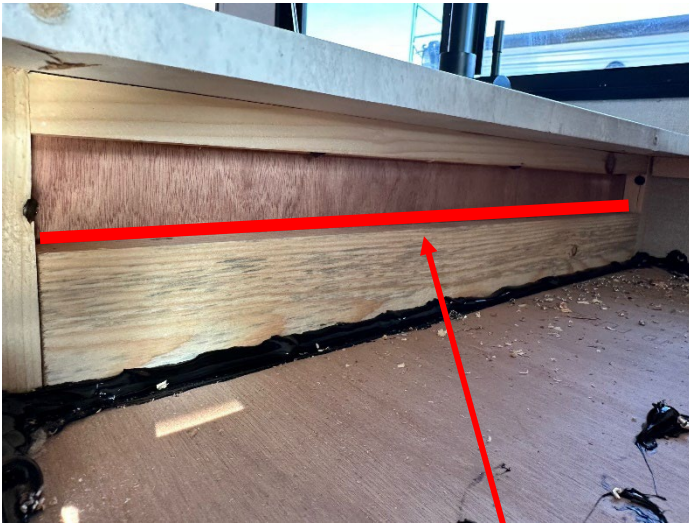
FIGURE 1

Concern:
The cooktop is not isolated from the furnace return air, which potentially causes an inverted flame on the cooktop. This condition may lead to potentially causing the propane supply line to fail, which may lead to property damage or personal injury.

STEP 2: USE SILICONE SEALANT TO SEAL THE PANEL AND THE CLEAT REPRESENTED IN FIGURES 1 & 2;

APPLY SILICONE SEALANT WHERE THE RED LINE INDICATES.
- THIS IS ON TOP OF THE CLEAT, AGAINST THE PANEL
- THIS ON BOTH RIGHT AND LEFT HAND SIDES
