GROUP	MODEL
Safety Recall Campaign	2024MY Sorento (MQ4a)
NUMBER	DATE
SC309	April 2024

MDPS WIRE HARNESS

INSPECTION AND REPAIR (SC309)

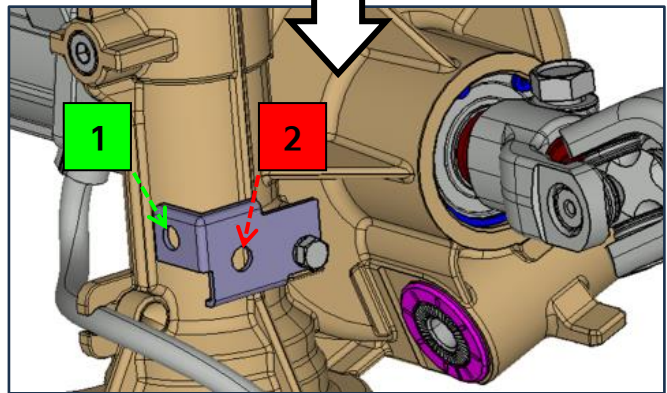
2. Confirm the steering harness clip location:
 1. Correct location (OK)
 2. Incorrect location (NG)

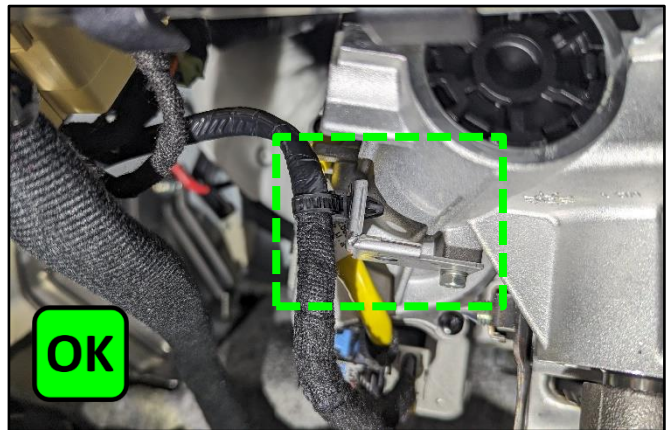
- If the harness is secured to the correct (OK) bracket hole (1), then no further action is required.

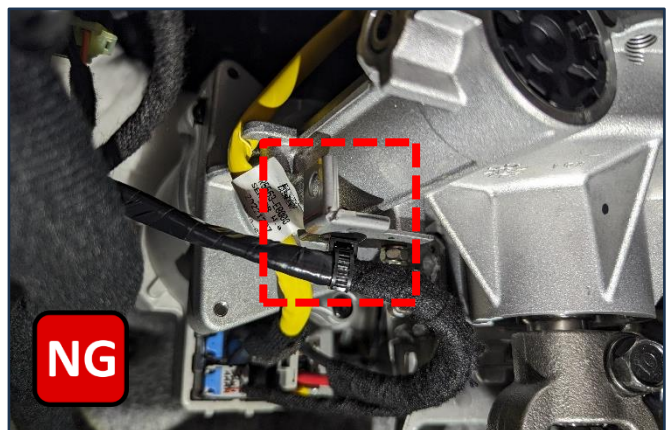
- If the harness is secured to the incorrect (NG) bracket hole (2), proceed to the 'Repair Procedure' on page 3.

- Using a pair of thin pliers, press in the harness clip tabs from behind to detach the clip from the incorrect "L" bracket hole location (2).

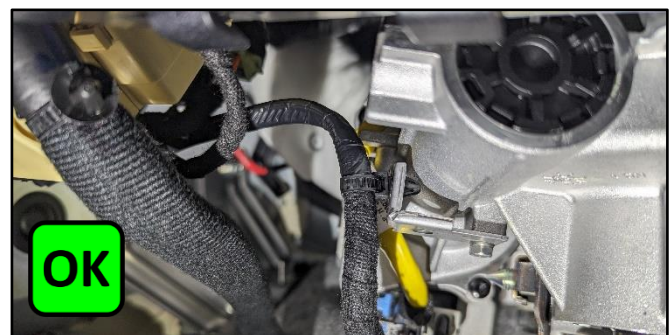
- If no damage to the wire harness insulation is present, no further action is required.
