Safety Recall Campaign

2024MY  
Sorento (MQ4a)

SC309 (Rev 1, 07/29/2024)

## MDPS WIRE HARNESS

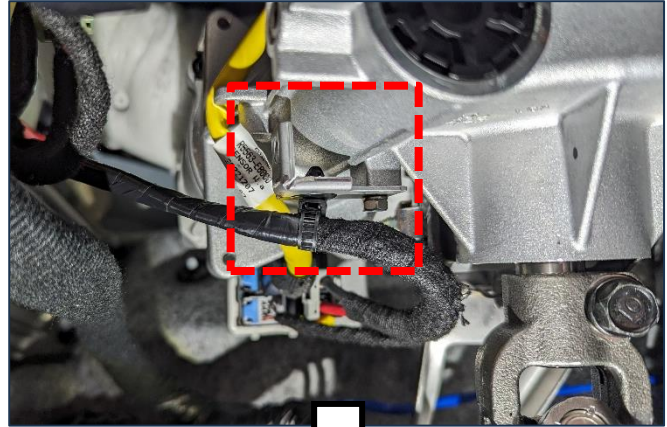
1. Under the dash (driver side) lower crash pad, locate the steering wire harness and the “L” bracket shown.

**NOTE:** The “L” bracket has two holes.

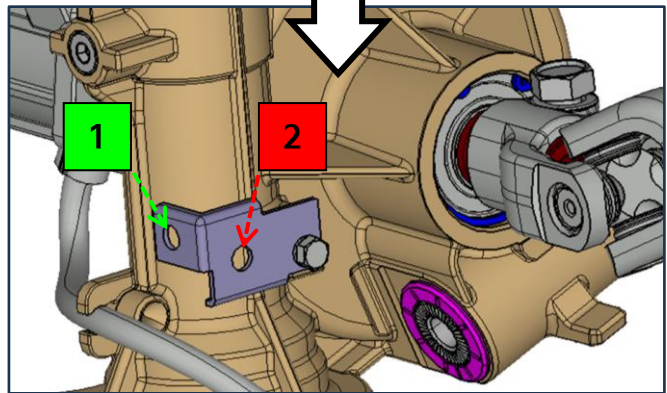
2. Confirm the steering harness clip location:

1. Correct location (OK)
2. Incorrect location (NG)

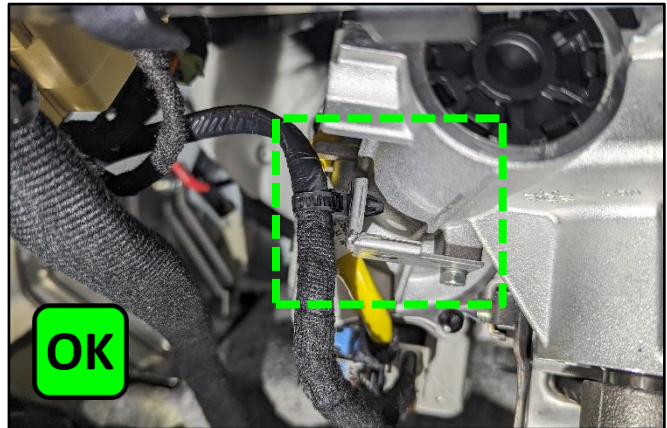
- If the harness is secured to the correct (OK) bracket hole (1), then no further action is required. Claim Inspection Labor Op Code 241A1710.

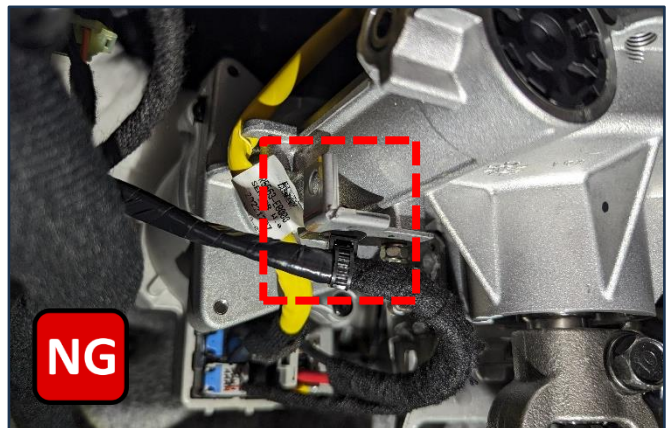
- If the harness is secured to the incorrect (NG) bracket hole (2), proceed to the 'Repair Procedure' (Main Harness) on page 3.

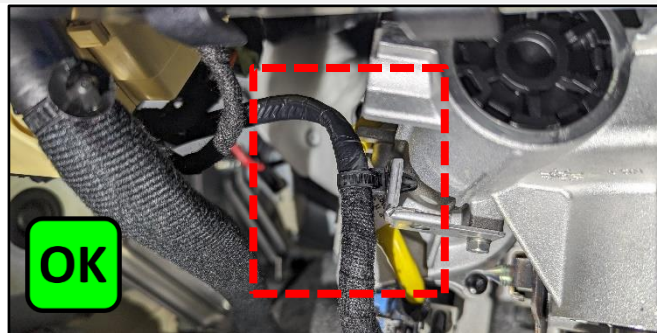
1. Inspect the main wire harness in the area shown for any insulation and wire damage:

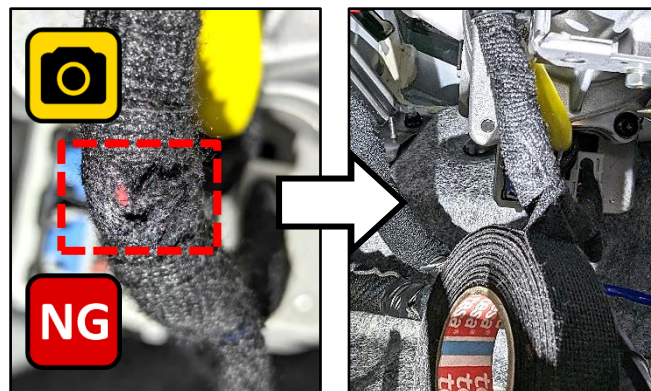
- 2b. If minor damage (NO visible signs of copper) to the wire harness insulated wrapping is present (as shown), use a 6" inch strip of Tesa (or 3M vinyl) electrical tape to repair/insulate the open area, and then proceed to step 3. **Claim Inspection Labor Op Code 241A1712.**

**IMPORTANT:** Take a KVID photo for any **(NG)** condition found and submit with claim.

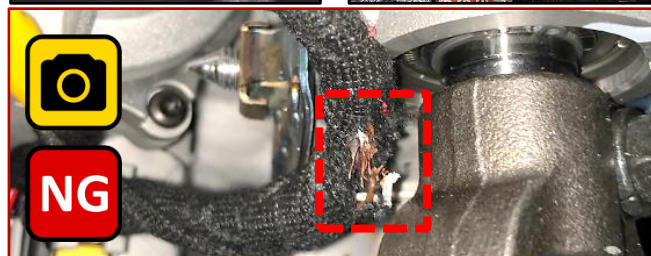
- 2c. If major damage (ANY visible signs of copper) to the wire harness insulated wrapping/wires is present (as shown), skip to the 'Replacement Procedure' (Main Harness) on page 4.

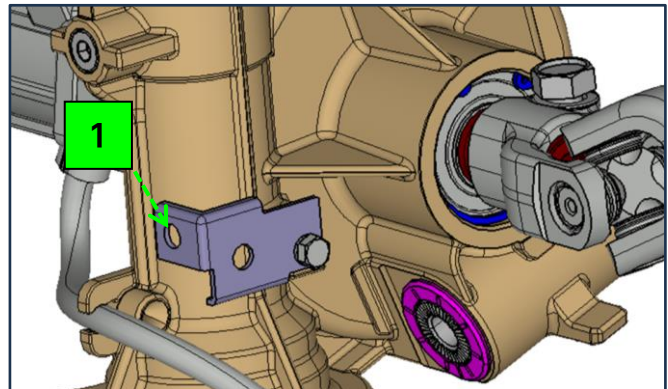
**NOTE:** The "L" bracket has two holes.

Confirm the main harness (steering harness extension) clip location during re-assembly.
