**SIB 72 01 24**

RECALL 24V-288: HEAD AIR BAGS LEFT AND RIGHT

This Service Information Bulletin (Revision 1) replaces SI B72 01 24 **dated April 2024**.

RE: Recall 24V-288: Head Air Bags Left and Right – B72 01 24

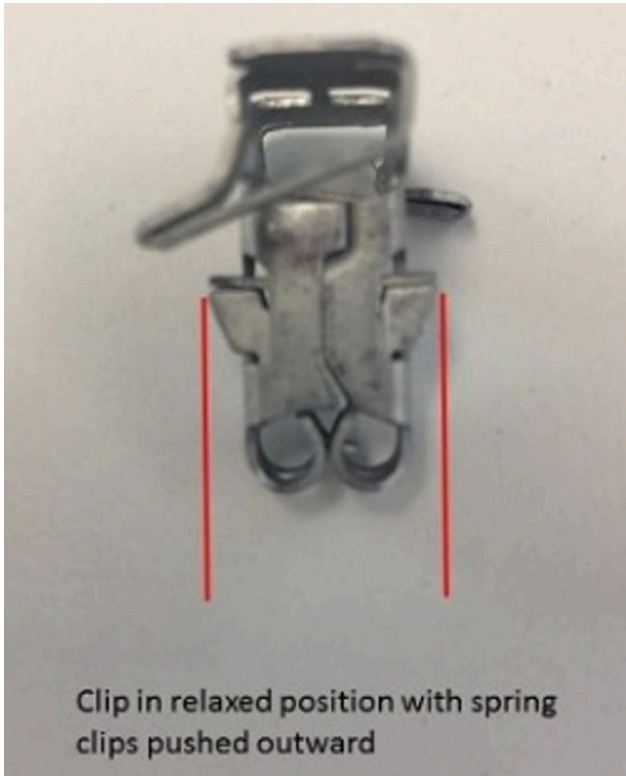
Here is a spring clip that holds the air bag assembly into the body in its installed state.

Clip in relaxed position with spring clips pushed outward

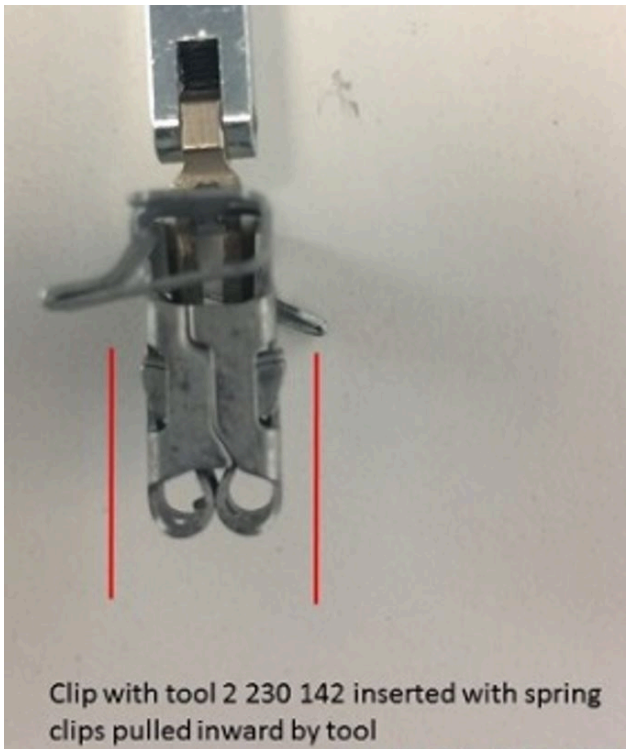
When the tool is inserted into the spring clip, it will retract the spring-loaded locking clips. This allows the clip to be removed from the blind hole in the vehicle body.

Clip with tool 2 230 142 inserted with spring clips pulled inward by tool

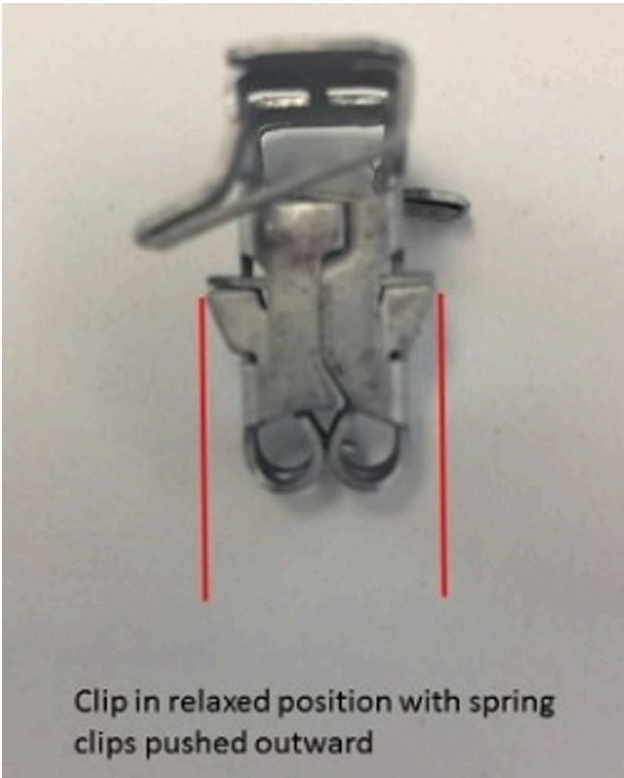
Here is a spring clip that holds the air bag assembly into the body in its installed state.

Clip in relaxed position with spring clips pushed outward

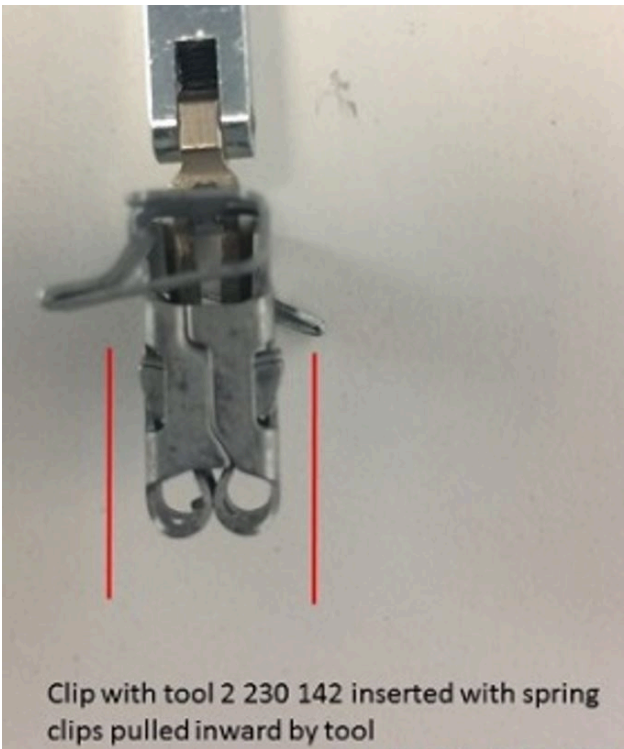
When the tool is inserted into the spring clip, it will retract the spring-loaded locking clips. This allows the clip to be removed from the blind hole in the vehicle body.

Clip with tool 2 230 142 inserted with spring clips pulled inward by tool
