SIB 72 01 24

**RECALL 24V-288: HEAD AIR BAGS LEFT AND RIGHT**

This Service Information Bulletin (Revision 3) replaces SI B72 01 24 **dated December 2024**.

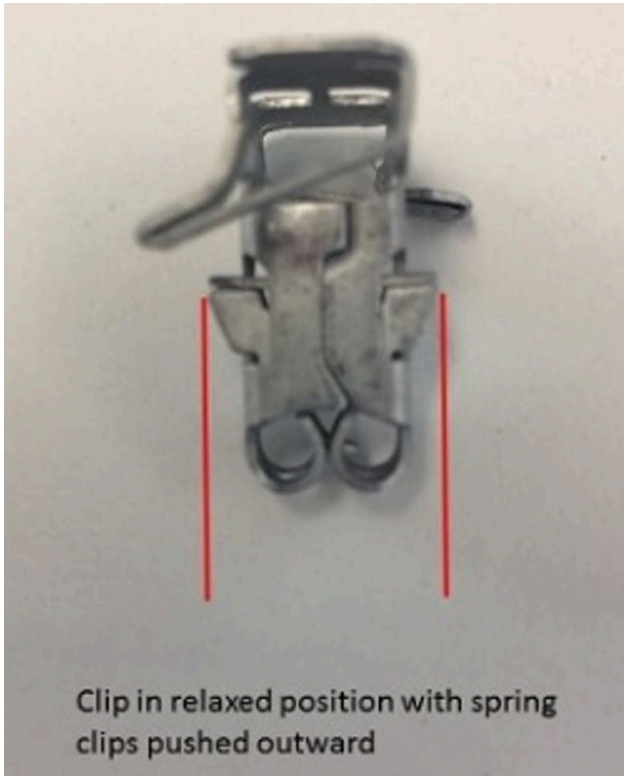
Here is a spring clip that holds the air bag assembly into the body in its installed state.

Clip in relaxed position with spring clips pushed outward

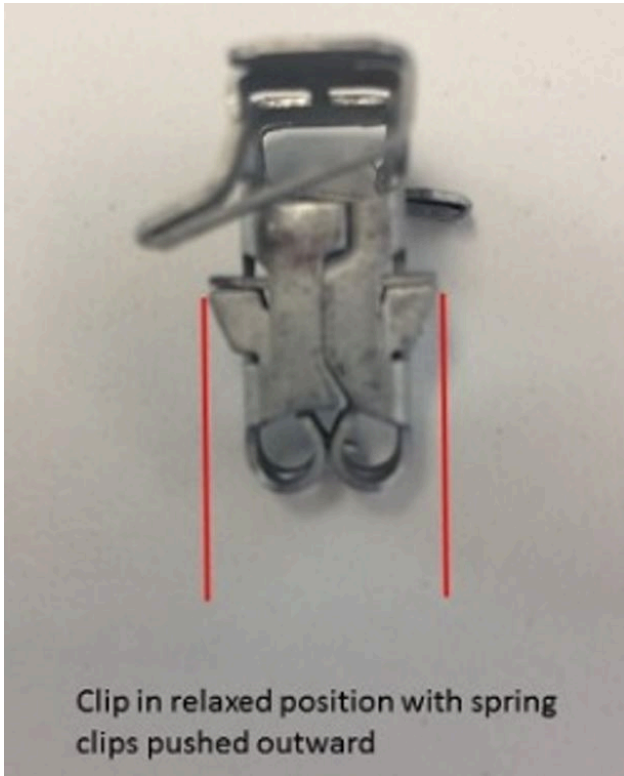
Here is a spring clip that holds the air bag assembly into the body in its installed state.

Clip in relaxed position with spring clips pushed outward

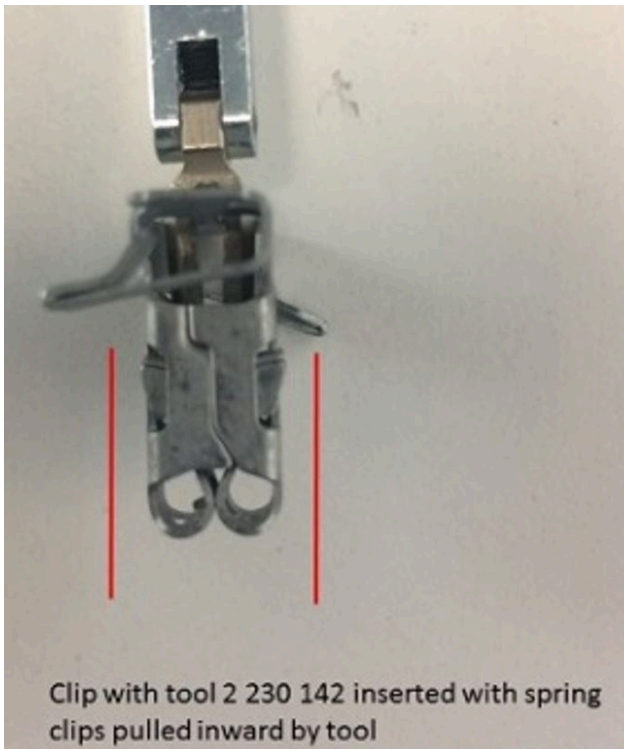
When the tool is inserted into the spring clip, it will retract the spring-loaded locking clips. This allows the clip to be removed from the blind hole in the vehicle body.

Clip with tool 2 230 142 inserted with spring clips pulled inward by tool
