SIB 72 02 24

**RECALL 24V-288: HEAD AIR BAG LEFT**

This Service Information Bulletin (Revision 2) replaces SI B72 02 24 **dated September 2024**.

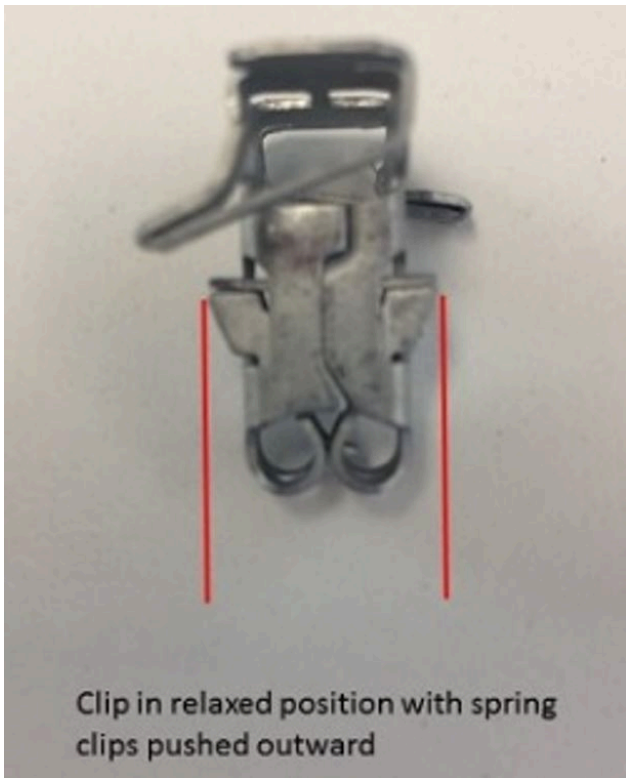
Clip in relaxed position with spring clips pushed outward

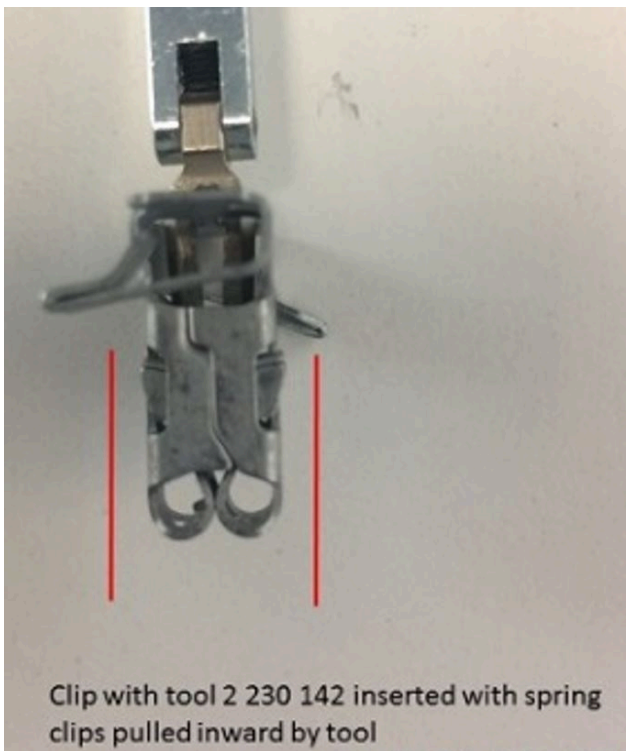
Clip with tool 2 230 142 inserted with spring clips pulled inward by tool

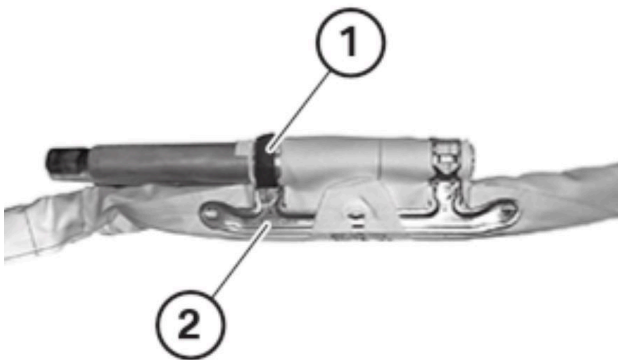
Felt (1) must be bonded to the gas generator holder (2).

Cut felt to length 15 mm x 50 mm x 1 mm

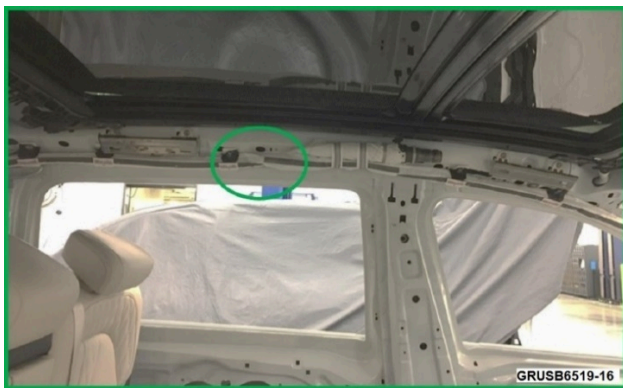
To ensure correct function for deployment, the head air bag must be positioned so that the printed, colored line points towards the vehicle interior across the entire component length.
