SIB 72 03 24

RECALL 24V-288: HEAD AIR BAG RIGHT

This Service Information Bulletin (Revision 3) replaces SI B72 03 24 dated September 2024.

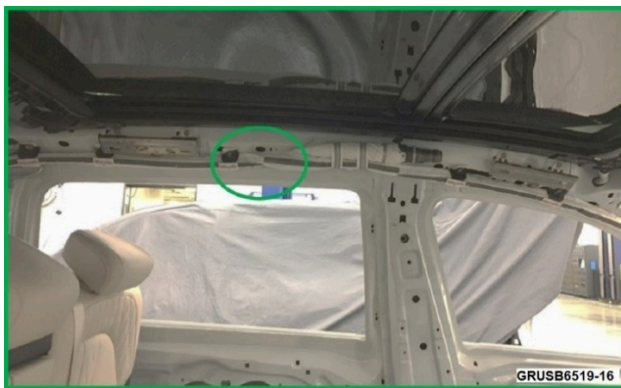
To ensure correct function for deployment, the head air bag must be positioned so that the printed, colored line points towards the vehicle interior across the entire component length.

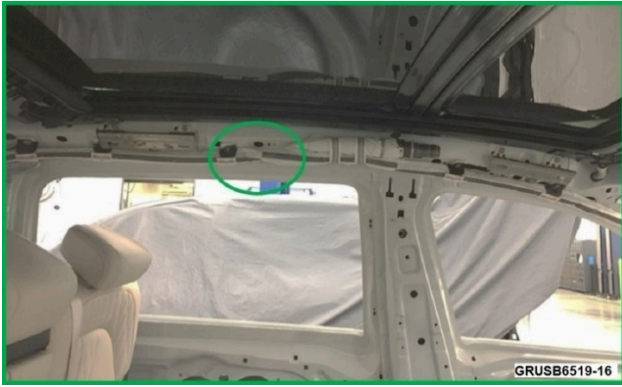
To ensure correct function for deployment, the head air bag must be positioned so that the printed, colored line points towards the vehicle interior across the entire component length.

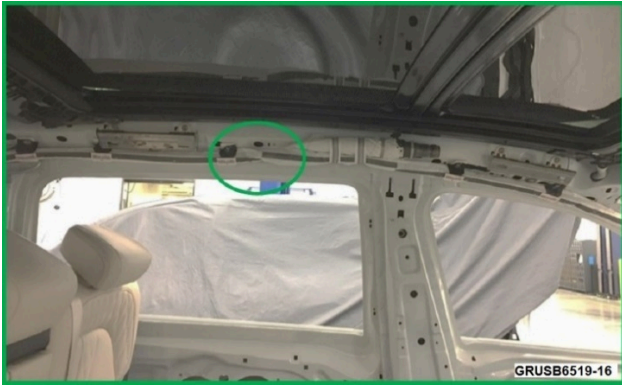
To ensure correct function for deployment, the head air bag must be positioned so that the printed, colored line points towards the vehicle interior across the entire component length.
