SIB 72 03 24

RECALL 24V-288: HEAD AIR BAG RIGHT

This Service Information Bulletin (Revision 2) replaces SI B72 03 24 **dated September 2024**.

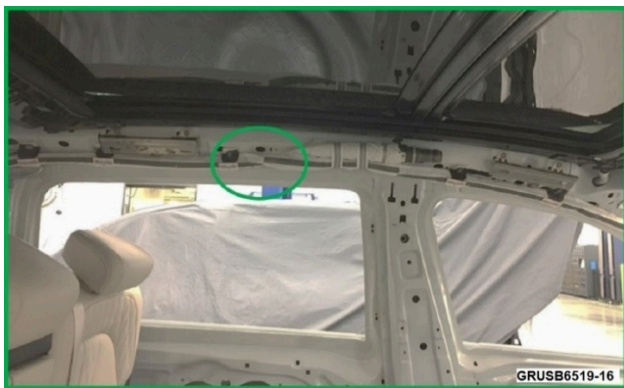
To ensure correct function for deployment, the head air bag must be positioned so that the printed, colored line points towards the vehicle interior across the entire component length.
