# Recall Campaign Bulletin

Campaign No. 2024050002, May 2024

SUBJECT: **Model GL-Class, ML-Class, and R-Class (X164, W164 and 251 platform)  
Model Year 2006 – 2012**

## **Inspect Brake Booster – with Pedal Rework**

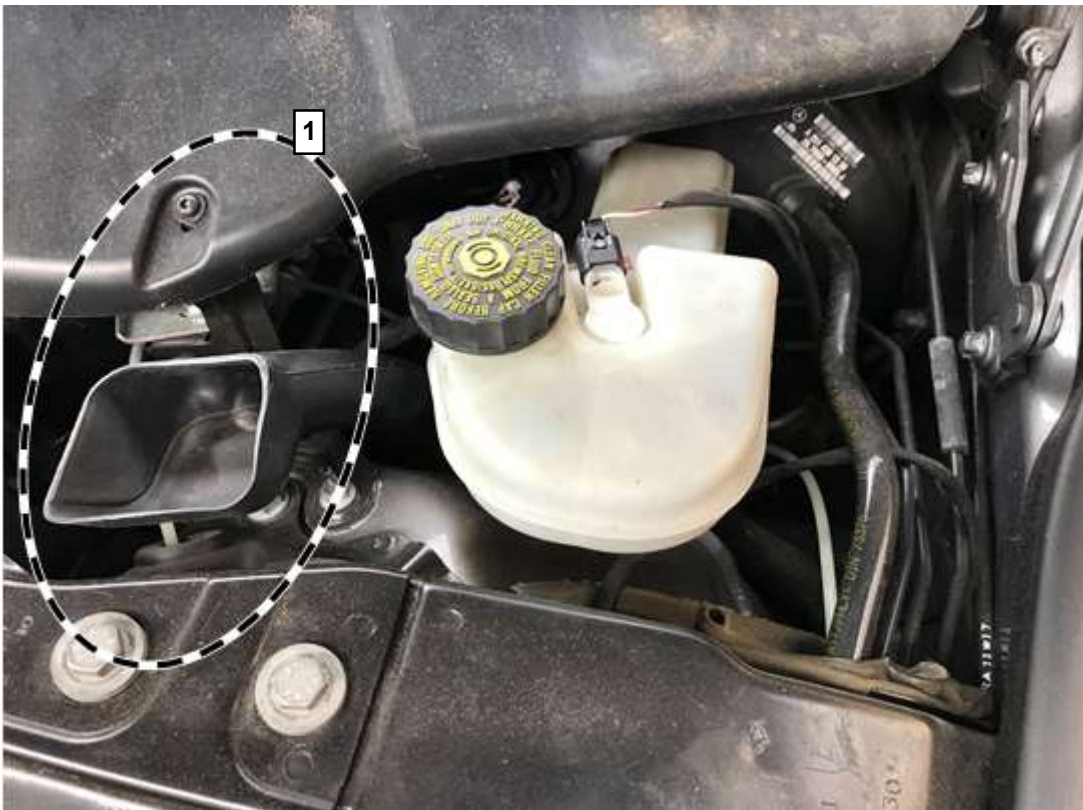
Figure 1

1. Open the hood and check the water drains (**Figure 1, 1**) for correct installation and ability to drain.
  - i** Only for model 251
  - i** Clean and correctly install water drains if necessary.

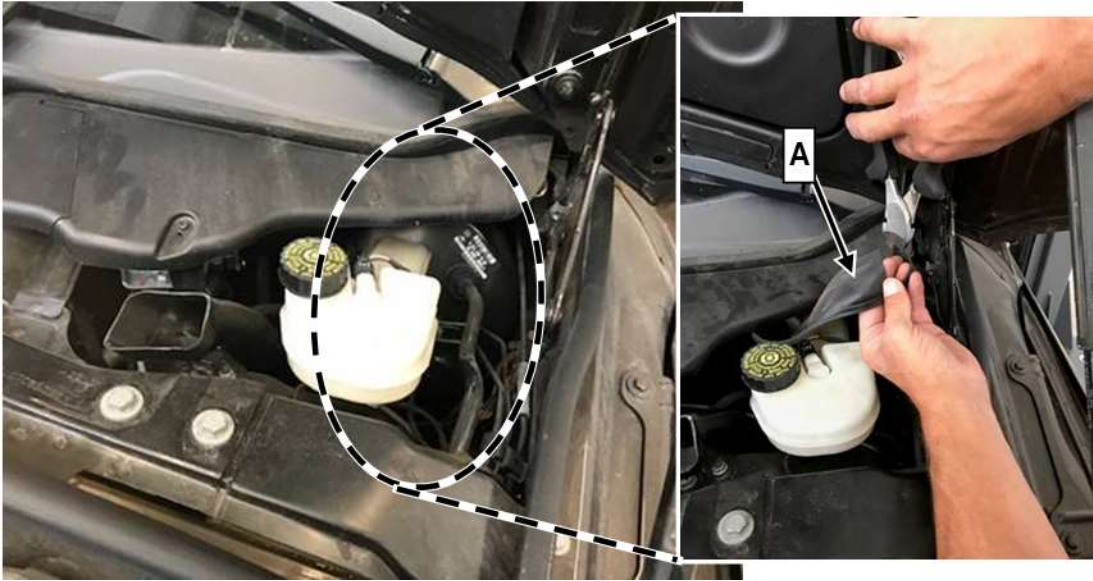
Figure 2

2. Remove the rubber sleeve wrapped around the brake booster (**Figure 2, A**) with a suitable tool (hook and side cutting pliers).
  - i** If the rubber sleeve on the brake booster is missing or **not** present, then continue with **Check/Test Procedure A1**.
  - i** The rubber sleeve should be separated above the barcode label on the brake booster as seen in (**Figure 2, A**).

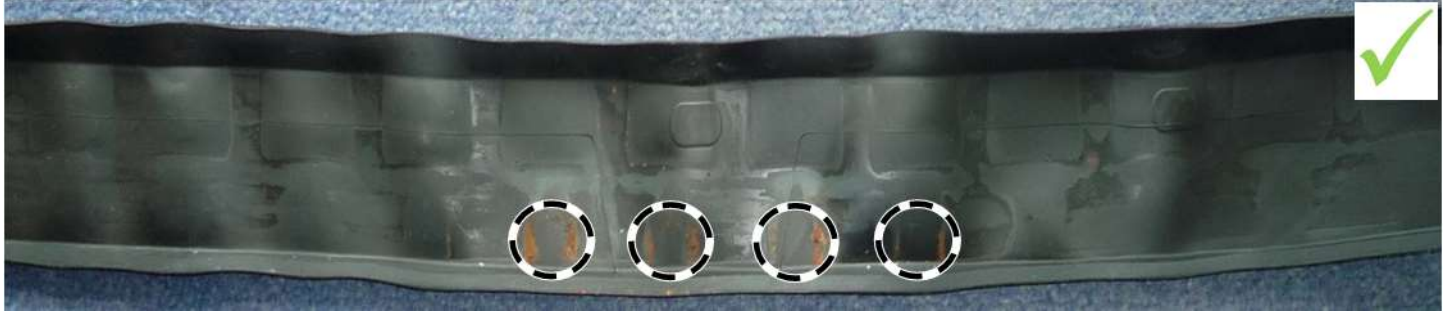
Figure 5 (OK)

Multiple point-shaped corrosion marks (Figure 5) are permissible.

- Corrosion measurements **Exceeds thresholds - Not OK:** Carry out **Work Procedure**
- Corrosion measurements **Does not exceed threshold - OK** (Figures 5, 6 or 7): **End measure.**

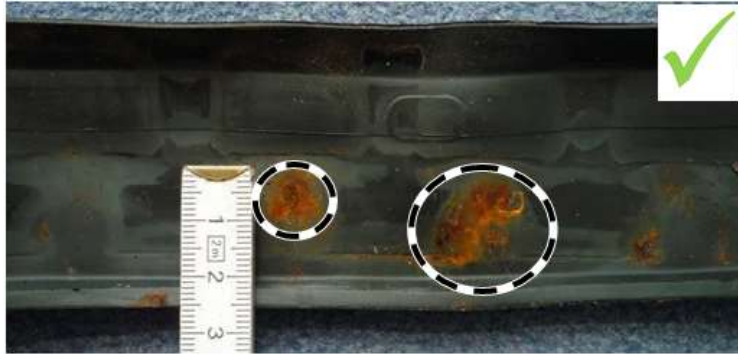
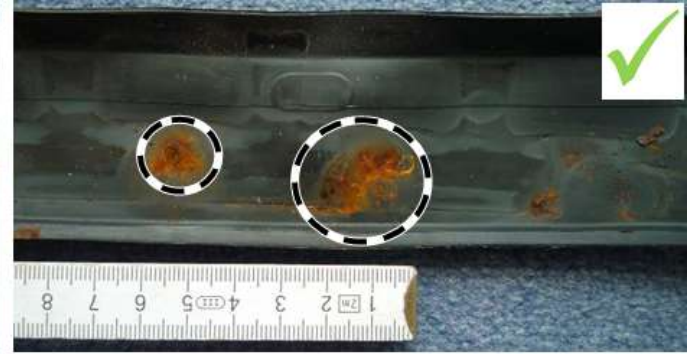
A maximum of **one point-shaped corrosion mark** with a diameter **greater than 15 mm** (Figures 6 and 7) is permitted.

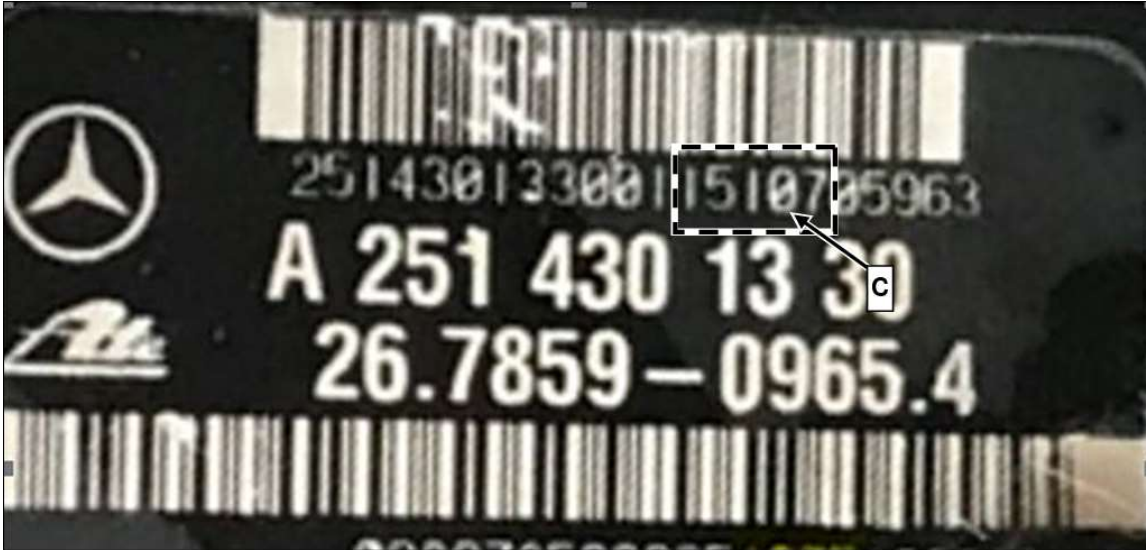
Figure 9

2. Check sequence of numbers on the barcode label (**Figure 9, C**).
  - a. If the numeric sequence between the 13<sup>th</sup> and 17<sup>th</sup> digits (**Figure 9, C**) are **less than** "15126": Carry out **Work Procedure** below.
  - b. If the numeric sequence between the 13<sup>th</sup> and 17<sup>th</sup> digits (**Figure 9, C**) are **greater than or equal to** "15126": **End measure**.
