Recall Campaign Bulletin

Campaign No. 2024050001, May 2024

SUBJECT: **Model GL-Class, ML-Class, and R-Class (X164, W164 and 251 platform)
Model Year 2006 – 2012**

Inspect Brake Booster – without Pedal Rework

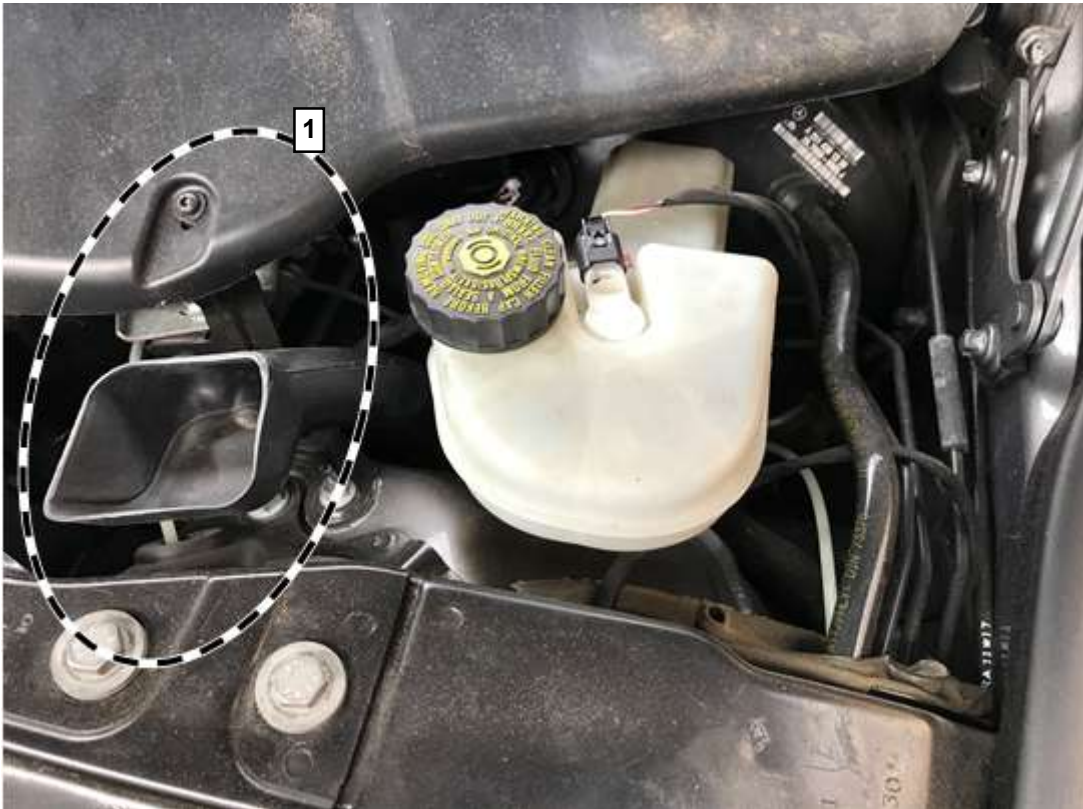
Figure 1

1. Open the hood and check the water drains (**Figure 1, 1**) for correct installation and ability to drain.
 - i** Only for model 251
 - i** Clean and correctly install water drains if necessary.

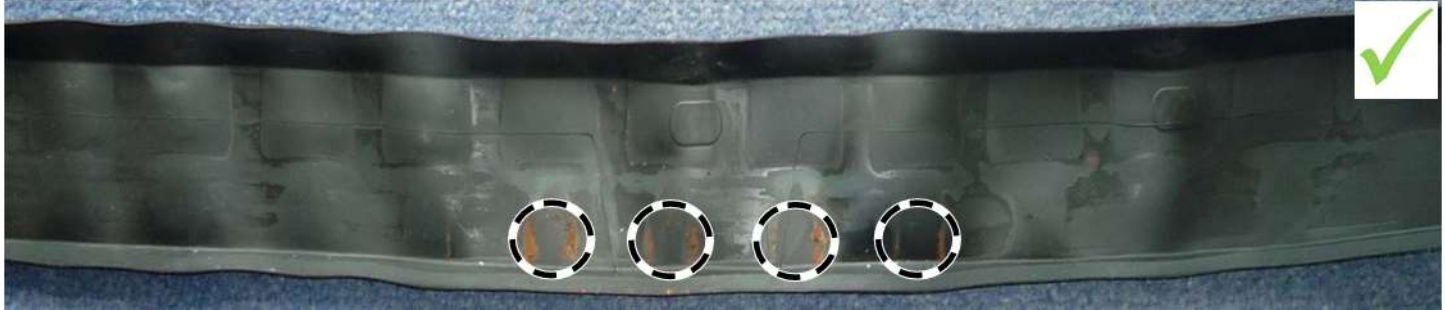
Figure 5 (OK)

Multiple point-shaped corrosion marks (Figure 5) are permissible.

- Corrosion measurements **Exceeds thresholds - Not OK:** Carry out **Work Procedure**
- Corrosion measurements **Does not exceed threshold - OK** (Figures 5, 6 or 7): **End measure.**

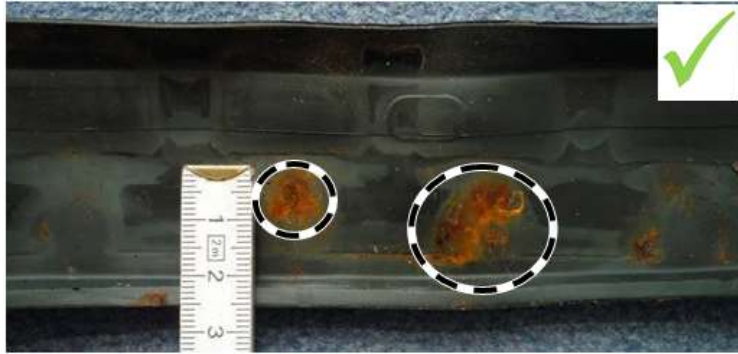
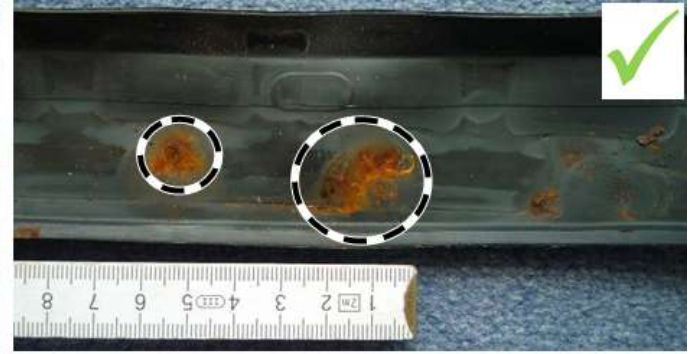
A maximum of **one point-shaped corrosion mark** with a diameter **greater than 15 mm** (Figures 6 and 7) is permitted.

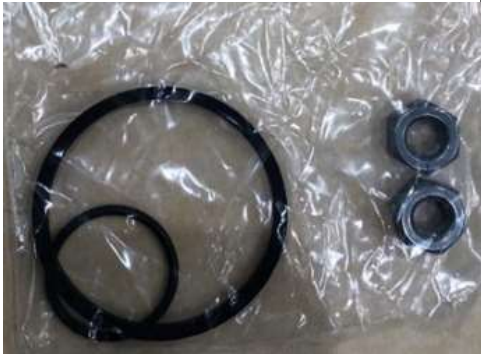
Figure 12

i The new brake booster contains a small parts kit (**Figure 12**).

1. Replace brake booster.
