VOLUNTARY RECALL CAMPAIGN

Classification: FA24-003A	Reference: NTB24-024A	Date: May 6, 2024
------------------------------	--------------------------	----------------------

VOLUNTARY SAFETY RECALL CAMPAIGN 2024 SENTRA; FRONT LH DRIVE SHAFT

CAMPAIGN ID #: PMA37
APPLIED VEHICLES: 2024 Sentra (B18)

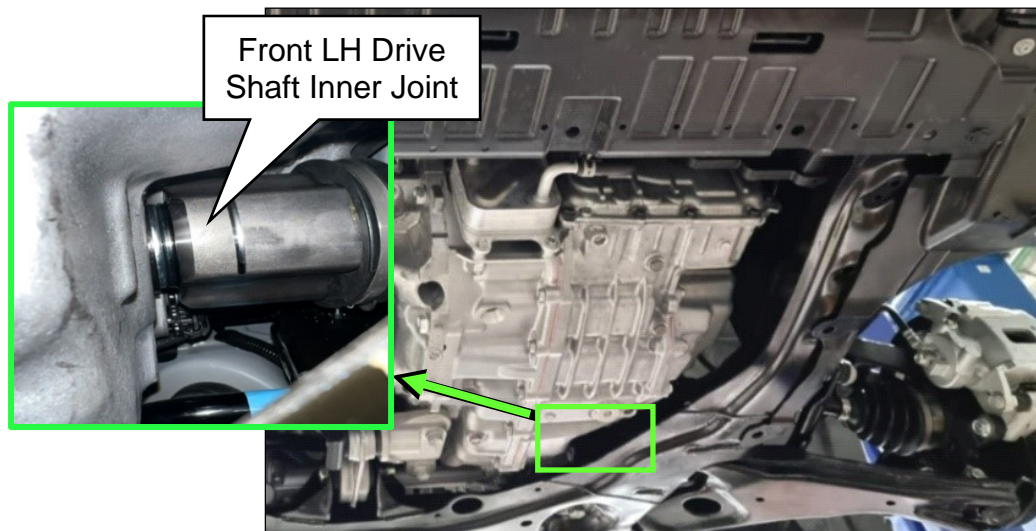
Figure 2

3. Locate the Front LH (driver side) Drive Shaft Inner Joint.

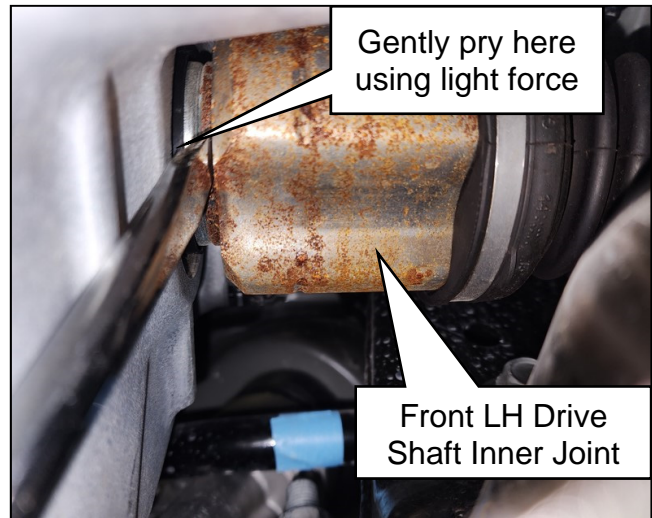
Figure 3

4. Verify the Front LH Drive Shaft is fully seated in the transaxle.

HINT: When the Front LH Drive Shaft is NOT fully seated in the transaxle, the Drive Shaft will move outward easily with little to no pry force.

- Place a long flat-blade screwdriver between the Front LH Drive Shaft and the transaxle case, as shown in Figure 3.
- Using light force, gently pry the Front LH Drive Shaft outward (away from the transaxle case) while watching the Front LH Drive Shaft Inner Joint for movement.

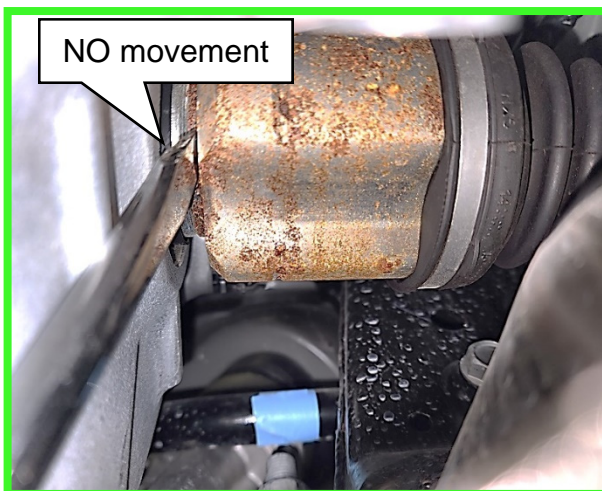
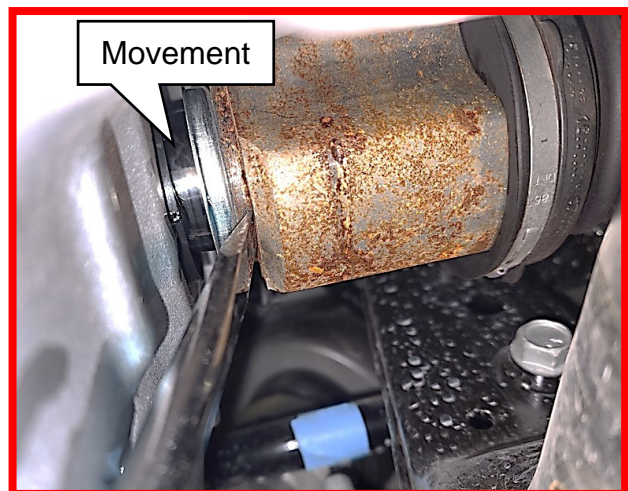
5. Did the Front LH Drive Shaft Inner Joint move outward when gently prying away from the transaxle case?

NO: Drive Shaft did NOT move, Good Result: No further action is necessary. Reinstall the Front Under Cover and proceed to **CLAIMS INFORMATION** on the last page.

YES: Drive Shaft moved, No Good Result: Continue to step 6.

6. Submit a video with the movement and the applicable VIN to VCAT for pre-approval, then continue to step 7 on page 5 to replace the Front LH Drive Shaft and the CVT.
