VOLUNTARY RECALL CAMPAIGN

Classification: FA24-003B	Reference: NTB24-024B	Date: May 15, 2024
------------------------------	--------------------------	-----------------------

VOLUNTARY SAFETY RECALL CAMPAIGN 2024 SENTRA; FRONT LH DRIVE SHAFT

CAMPAIGN ID #: PMA37
APPLIED VEHICLES: 2024 Sentra (B18)

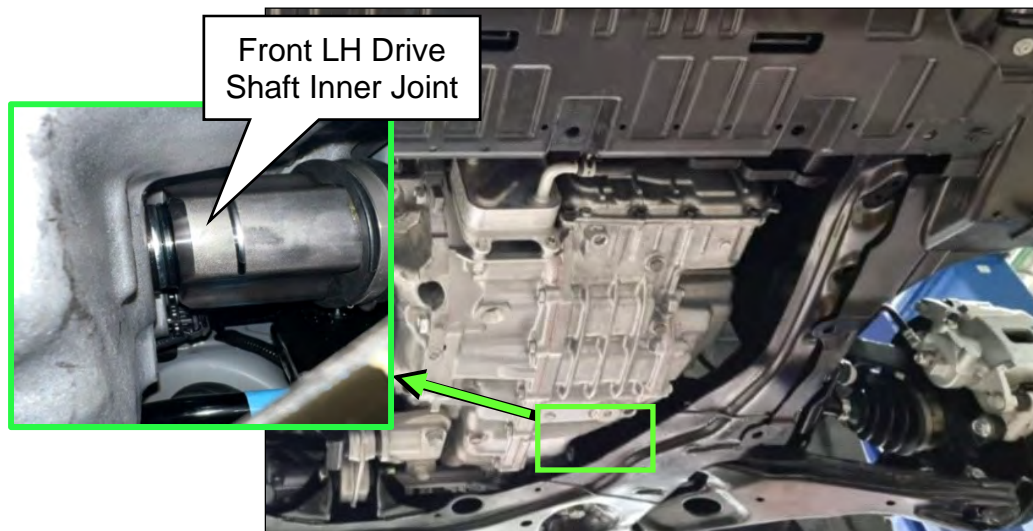
Figure 2

3. Locate the Front LH (driver side) Drive Shaft Inner Joint.

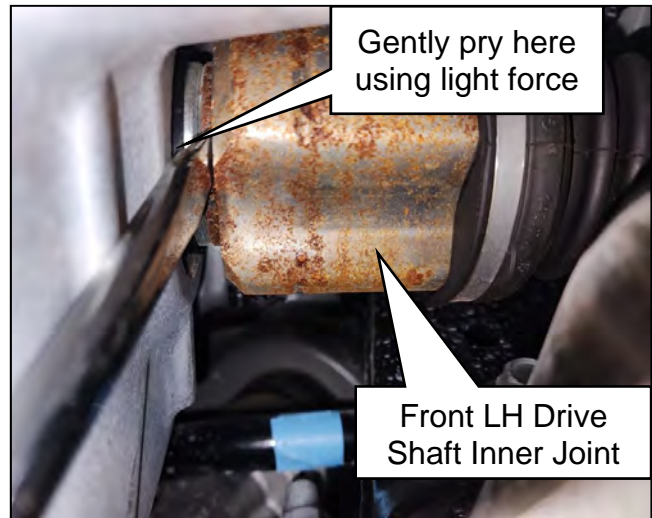
Figure 3

4. Verify the Front LH Drive Shaft is fully seated in the transaxle.

HINT: When the Front LH Drive Shaft is NOT fully seated in the transaxle, the Drive Shaft will move outward easily with little to no pry force.

- a. Place a long flat-blade screwdriver between the Front LH Drive Shaft and the transaxle case, as shown in Figure 3.
- b. Using light force, gently pry the Front LH Drive Shaft outward (away from the transaxle case) while watching the Front LH Drive Shaft Inner Joint for movement.

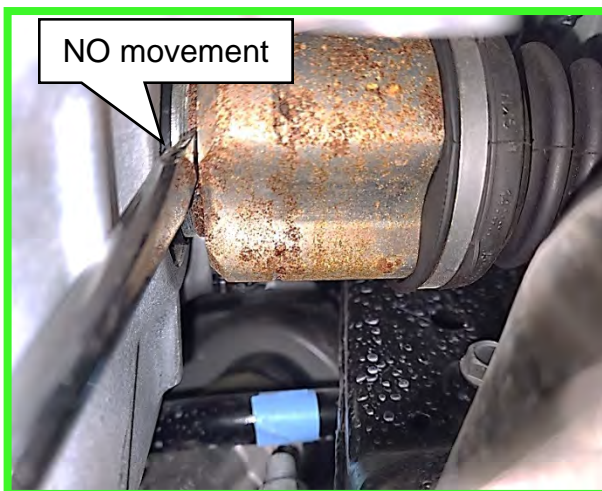
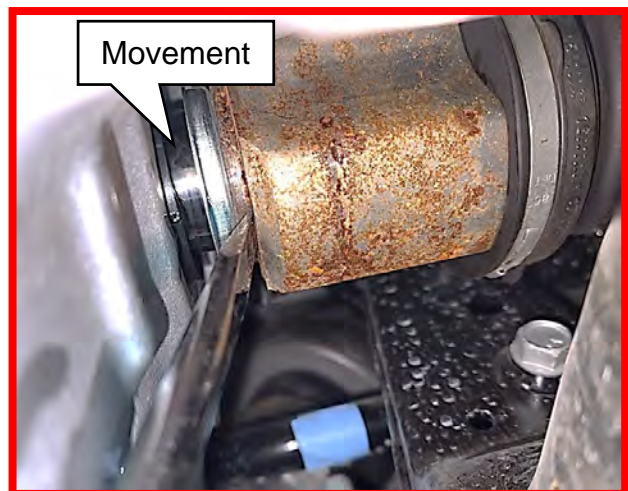
5. Did the Front LH Drive Shaft Inner Joint move outward when gently prying away from the transaxle case?

YES: Drive Shaft moved, No Good Result: Continue to step 6.

6. Submit a video with the movement and the applicable VIN to VCAT for pre-approval, then continue to step 7 on page 5 to replace the Front LH Drive Shaft and the CVT.
