VOLUNTARY RECALL CAMPAIGN

FA24-003D
 NTB24-024D
 June 10, 2024

VOLUNTARY SAFETY RECALL CAMPAIGN 2024 SENTRA; FRONT LH DRIVE SHAFT

CAMPAIGN ID #: PMA37

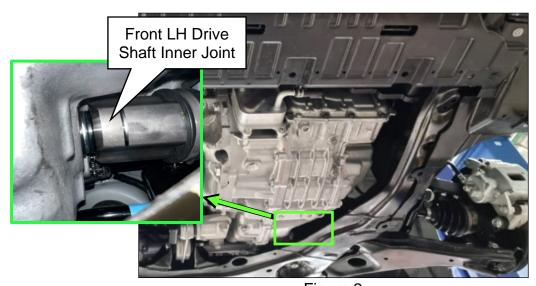
Figure 2

3. Locate the Front LH (driver side) Drive Shaft Inner Joint.

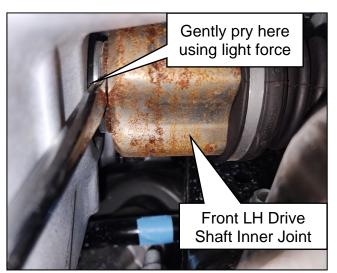
Figure 3

HINT: When the Front LH Drive Shaft is NOT fully seated in the transaxle, the Drive Shaft will move outward easily with little to no pry force.

- a. Place a long flat-blade screwdriver between the Front LH Drive Shaft and the transaxle case, as shown in Figure 3.
- Using light force, gently pry the Front LH Drive Shaft outward (away from the transaxle case) while watching the Front LH Drive Shaft Inner Joint for movement.

- 5. Did the Front LH Drive Shaft Inner Joint move outward when gently prying away from the transaxle case?
 - Document the results on the repair order.

NO: Drive Shaft did NOT move, Good Result: No further action is necessary. Reinstall the Front Under Cover and proceed to **CLAIMS INFORMATION** on the last page.

YES: Drive Shaft moved, No Good Result: Continue to step 6.
