# VOLUNTARY RECALL CAMPAIGN

| Classification:<br>FA24-003 | Reference:<br>NTB24-024 | Date:<br>May 2, 2024 |

## VOLUNTARY SAFETY RECALL CAMPAIGN 2024 SENTRA; FRONT LH DRIVE SHAFT

**CAMPAIGN ID #:** PMA37  
**APPLIED VEHICLES:** 2024 Sentra (B18)

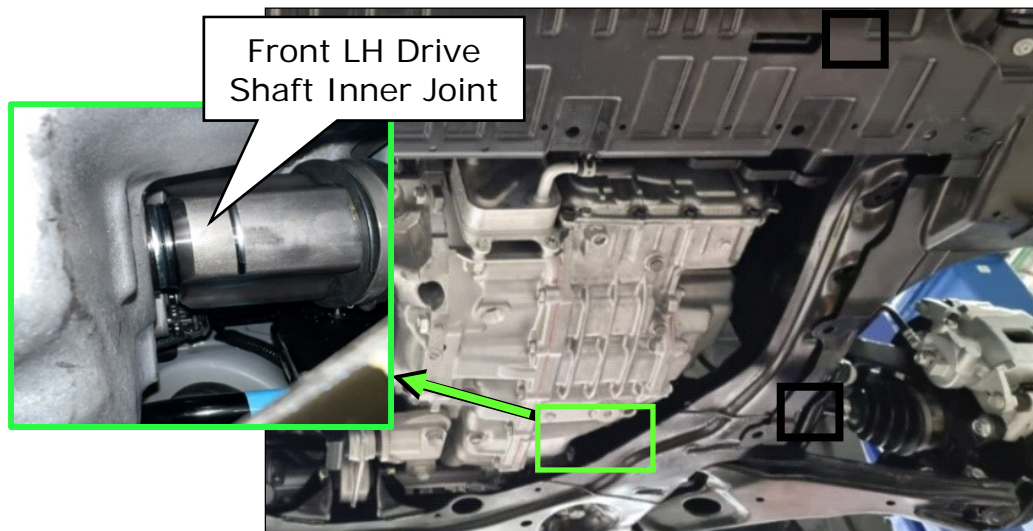
Figure 2

3. Locate the Front LH (driver side) Drive Shaft Inner Joint.

- Verify the Front LH Drive Shaft is fully seated in the transaxle.

**HINT:** When the Front LH Drive Shaft is NOT fully seated in the transaxle, the Drive Shaft will move outward easily with little to no pry force.

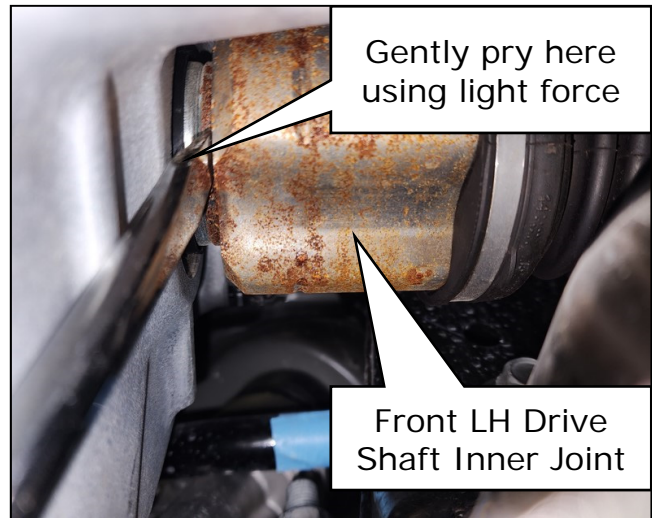
Figure 3

- Place a long flat-blade screwdriver between the Front LH Drive Shaft and the transaxle case, as shown in Figure 3.
- Using light force, gently pry the Front LH Drive Shaft outward (away from the transaxle case) while watching the Front LH Drive Shaft Inner Joint for movement.

- Did the Front LH Drive Shaft Inner Joint move outward when gently prying away from the transaxle case?

**NO:** Drive Shaft did NOT move, Good Result: No further action is necessary. Reinstall the Front Under Cover and proceed to **CLAIMS INFORMATION** on the last page.

**YES:** Drive Shaft moved, No Good Result: Continue to step 6.
