VOLUNTARY RECALL CAMPAIGN

Classification: FA24-003C	Reference: NTB24-024C	Date: May 23, 2024
------------------------------	--------------------------	-----------------------

VOLUNTARY SAFETY RECALL CAMPAIGN 2024 SENTRA; FRONT LH DRIVE SHAFT

CAMPAIGN ID #: PMA37
APPLIED VEHICLES: 2024 Sentra (B18)

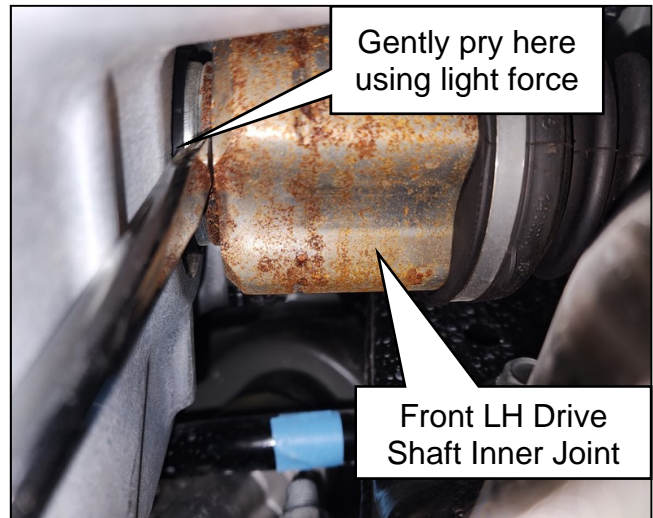
Figure 3

- Place a long flat-blade screwdriver between the Front LH Drive Shaft and the transaxle case, as shown in Figure 3.
- Using light force, gently pry the Front LH Drive Shaft outward (away from the transaxle case) while watching the Front LH Drive Shaft Inner Joint for movement.

- Did the Front LH Drive Shaft Inner Joint move outward when gently prying away from the transaxle case?

NO: Drive Shaft did NOT move, Good Result: No further action is necessary. Reinstall the Front Under Cover and proceed to **CLAIMS INFORMATION** on the last page.

YES: Drive Shaft moved, No Good Result: Continue to step 6.
